CITY OF SPOKANE VALLEY BRIDGE REPAIR REPORT

Bridge Number SPOKV-4511	Bridge Name Sullivan Rd Over Spokane River	Structure ID 08139800
Specific Location on Bridge North Expansion Joint		Repair Photos YES <input checked="" type="checkbox"/> NO <input type="checkbox"/>
REPAIRS ASSIGNED TO: <input type="checkbox"/> COSV Maintenance <input checked="" type="checkbox"/> Contract / Number Inland Maint. Contract <input type="checkbox"/> Capital Project		ORIGIN OF REPAIRS: Deterioration over insp. cycles. <input checked="" type="checkbox"/> Bridge Manager <input type="checkbox"/> COSV Maintenance <input type="checkbox"/> Site Visit
		<input type="checkbox"/> From Repair List Repair No./ Date Repaired /

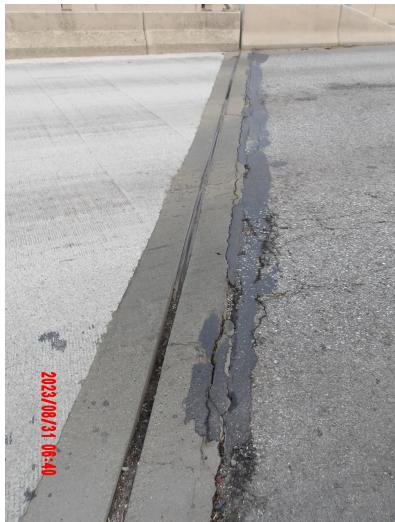
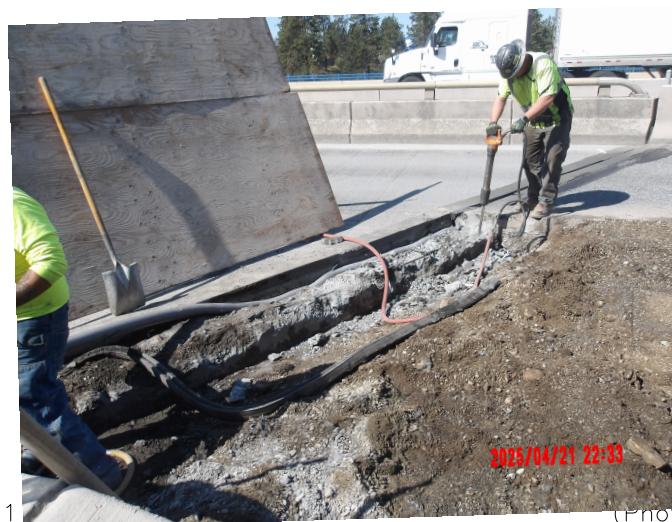
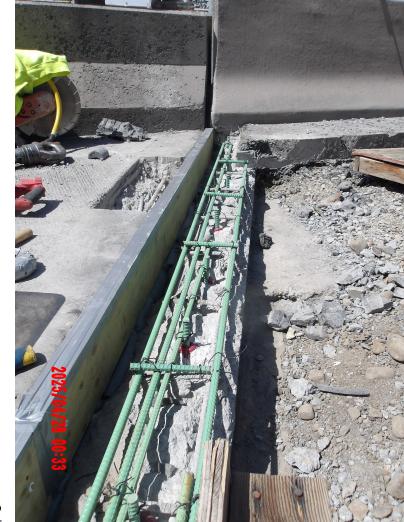
(Photo 2)

Crews unearthed the joint & found a decomposed concrete back/end wall. The joint was previously repaired in Sept. 2017 after 4508 (2016) was built. Crews chipped away loose concrete, removed deteriorated rebar, added #5 bar (3 hor. bars, w/ties, doweled into back wall) poured a high-early concrete cap to the back wall, then a 2" Kwik Bond PPC (Polyester Polymer Concrete) 1121 header, added Emseal EMV-0300 seal, with silicon.

N.A. Degerstrom, under Inland Asphalt COSV Maintenance Contract, rebuilt the north joint. Concrete end wall, polyester polymer concrete header, #5 green bar, new Emseal rubber gland. New asphalt approaches, 6" over 8"+ CSTC.

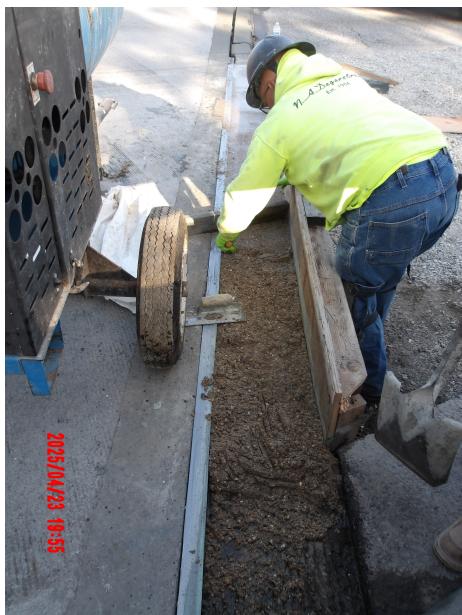
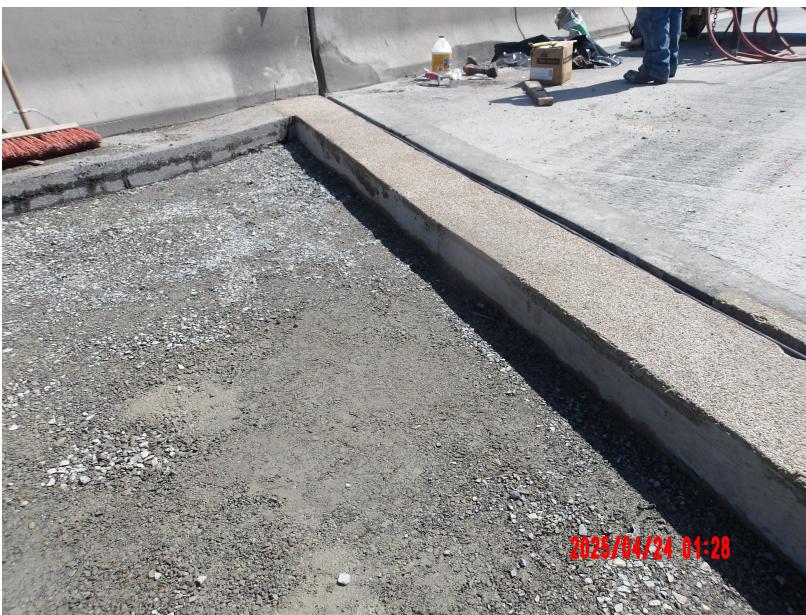
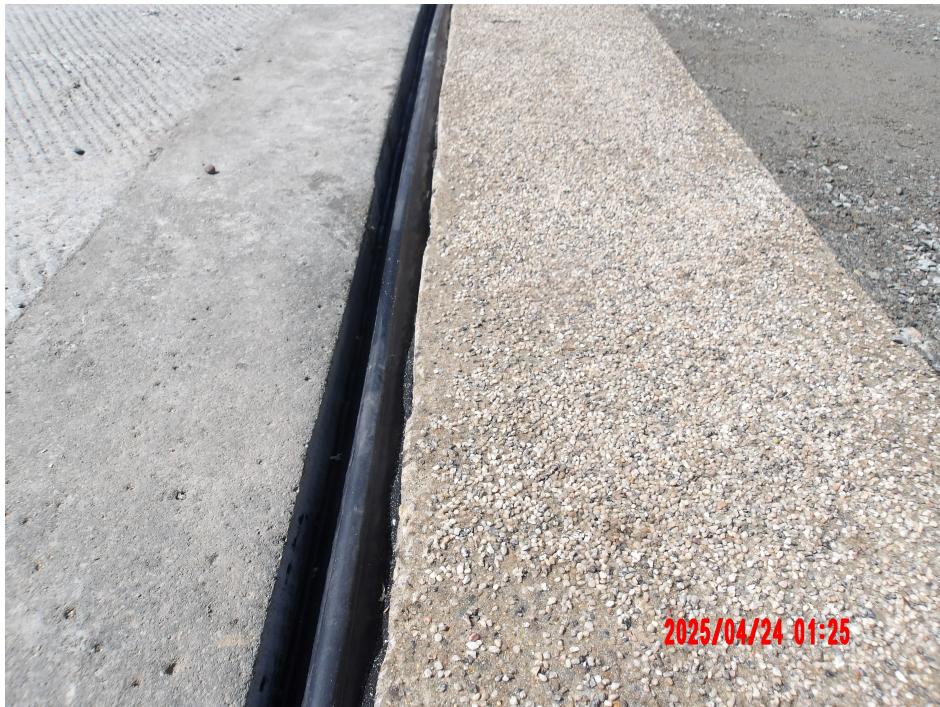
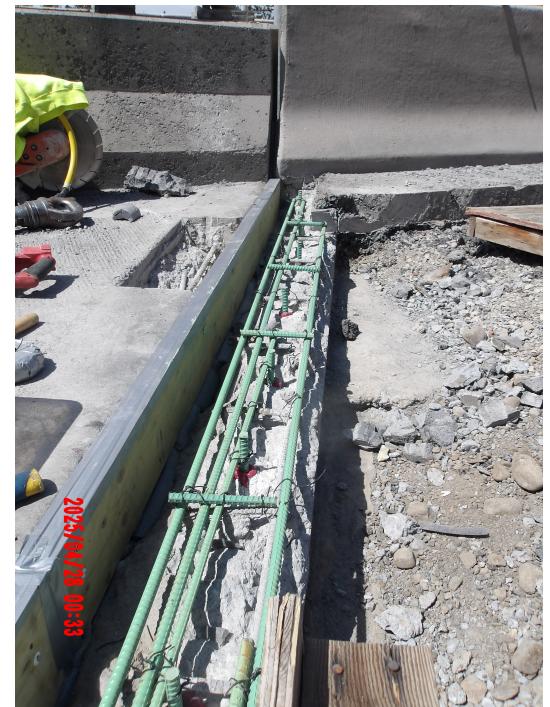
As the joint was rebuilt I surmised how it got to this point. In Sept. 2017 the joint was rebuilt by MJK due to the fact that it was damaged when crews installed Modified Concrete Overlay. This happened once 4508 (2016) was complete. Not sure if the steel angle nosings were in place at that time or not. MJK removed the header material, found spalled concrete & rebar with serious section loss. Crews did their due diligence in removing this material, adding some bar, cleaned other rebar, poured a Wabo-Crete material a full 7" deep, 8" wide in places, even welded rebar to existing bar, then installed a DS Brown style 2" compression seal.

Over the last 8 years the joint deteriorated to the point I had to fix it. Joint was open 3". I used the Inland Asphalt maintenance contract & hired N.A. Degerstrom & crew (Jason Desjarlais, John Brueher, Ryan Presho, Peter Nelson+) to repair the joint in two phases due to TC, poured 12" wide, approx. 3"+ of concrete cap w/bar, then 2" of KB PPC 1121. We then paved approach with 6" HMA Cl. 3/8" 64H-28 over existing CSTC (added approx. 2"). The Emseal EMV-0300 seal was added prior to paving. Crews came back the day after to sawcut a 1/2" x 1" joint & fill with Crafco 231 between PPC and HMA.
