**Public Works Department**

Subject: **2023 ANNUAL BRIDGE REPORT**

The bridges of the Spokane Valley road system have been inspected in accordance with the guidelines set forth by both the FHWA National Bridge Inspection Standards and the Washington State Bridge Inspection Manual and herewith I submit a report of the findings of these inspections. These findings will be taken into consideration in the preparation of the proposed 2025 Capital Bridge Budget and 2024-2029 Six Year Construction Programs.

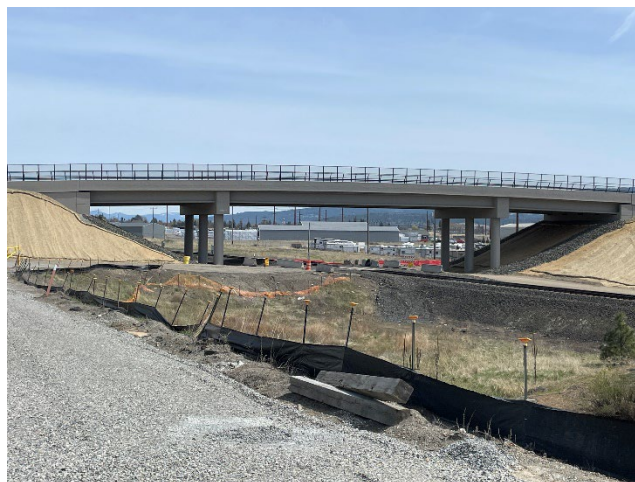
*Barker Rd Over BNSF RR*

- The Barker Road Bridge over the BNSF RR Tracks (SPOKV-5502) was completed in the spring of 2023. The Initial Inspection was completed on June 1, 2023. All bridge elements are sound.

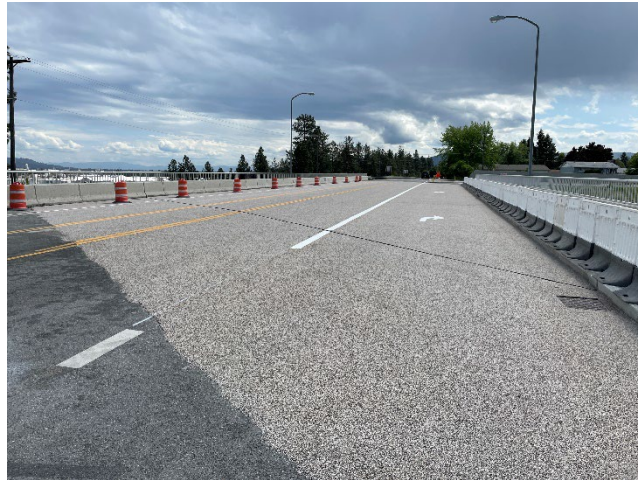
*Mission Ave over Evergreen Rd*

- The Mission Avenue over Evergreen Road bridge was resurfaced with a Federal Grant. The deck was re-surfaced with an epoxy based two-layer system to help preserve the superstructure from water intrusion.

All elements were found to be sound. In June the deck was overlaid with a 2-layer polymer-based overlay through a federal grant. New compression seals were installed as part of the grant. There was also some ADA-related sidewalk work completed. Some minor repairs were also noted.

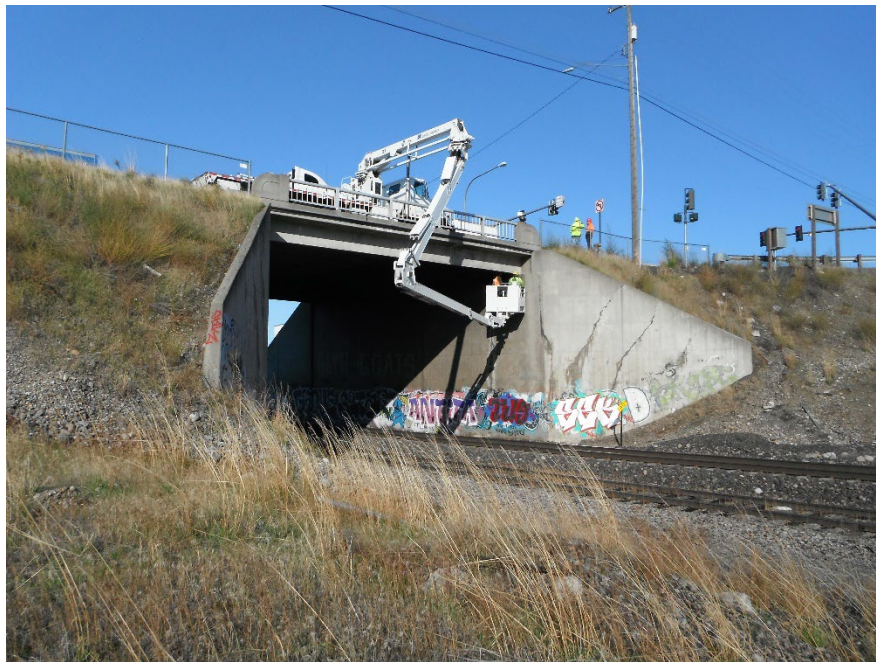
*Sullivan Road over BNSF RR, SPOKV-4502*

All elements were found to be stable, with no changes. The bridge has been found to be rated Fair. Many girders have hairline diagonal cracks in the web, with map cracking prevalent in girder ends and top flanges. Concrete Abutments have several spalls and delaminations. Bearing pads J through O (6), at both abutments in poor condition. Pads are split, cracked and crushed. Some minor repairs noted.

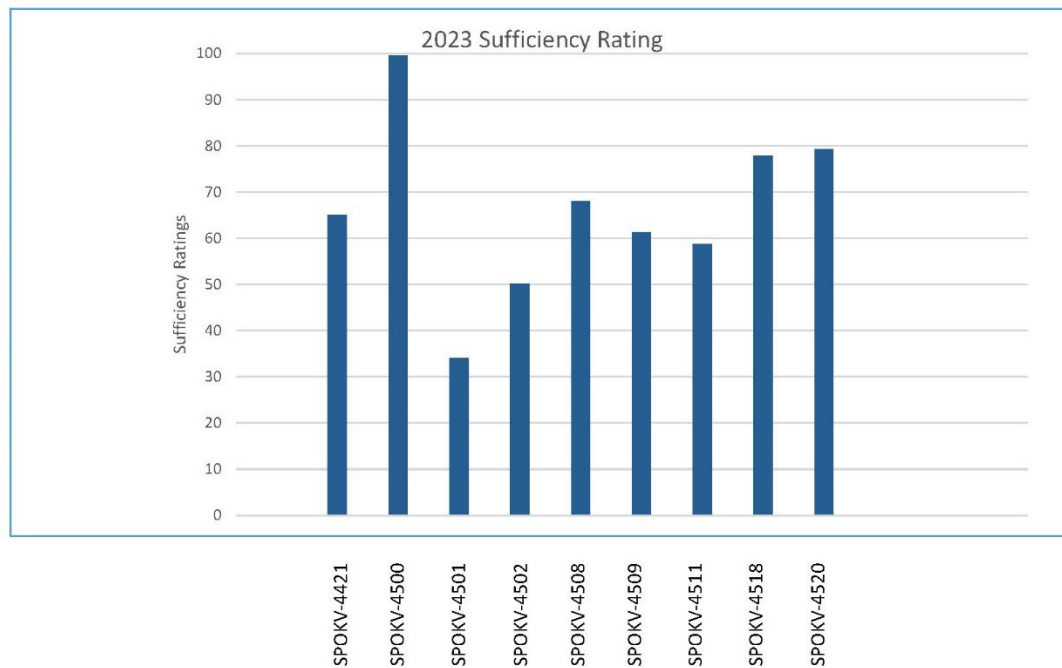
Figure 1, below, shows the sufficiency rating for the 9 Spokane Valley owned bridges (not including the railroad owned bridges and pedestrian structures) that were inspected in 2023.

*Sufficiency ratings for the 9 Spokane Valley owned bridges that were inspected in 2023.*

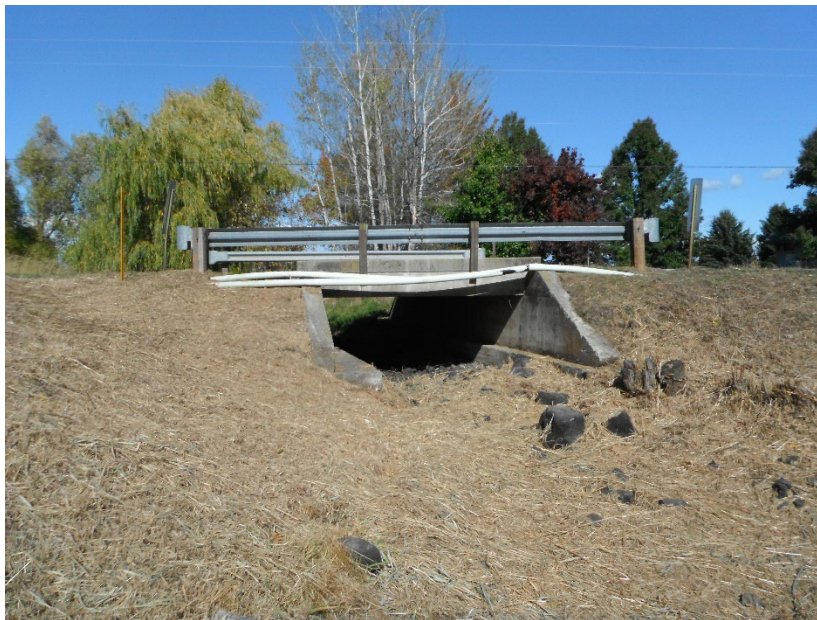
*Thorpe Road Bridge over Chester Creek, SPOKV-4421*

Generally, in fair shape. There is some minor hairline web/flange cracking in the Prestressed Concrete Multiple Web Girder Units that is being monitored. The west approach roadway has some settling. Spokane Valley maintenance crews have re-arranged the ballast under the structure to inhibit erosion of the concrete caps. Some minor repairs noted.

**Thorpe Road Bridge over Chester Creek Superstructure Replacement Project** is in the design stages. This project will replace the current superstructure with new girders and a new deck. A feasibility study was completed in 2023. The study identified several alternatives for replacing the superstructure. The City's Structural On-Call Consultant will design a superstructure based on recommendations from city staff.

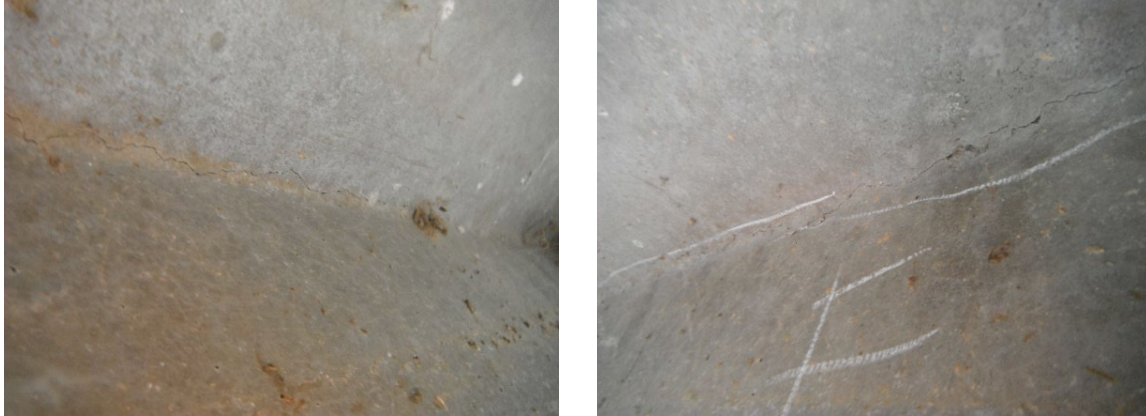
*Web-to-Flange interface cracking, Thorpe Road bridge over Chester Creek, SPOKV-4421.*

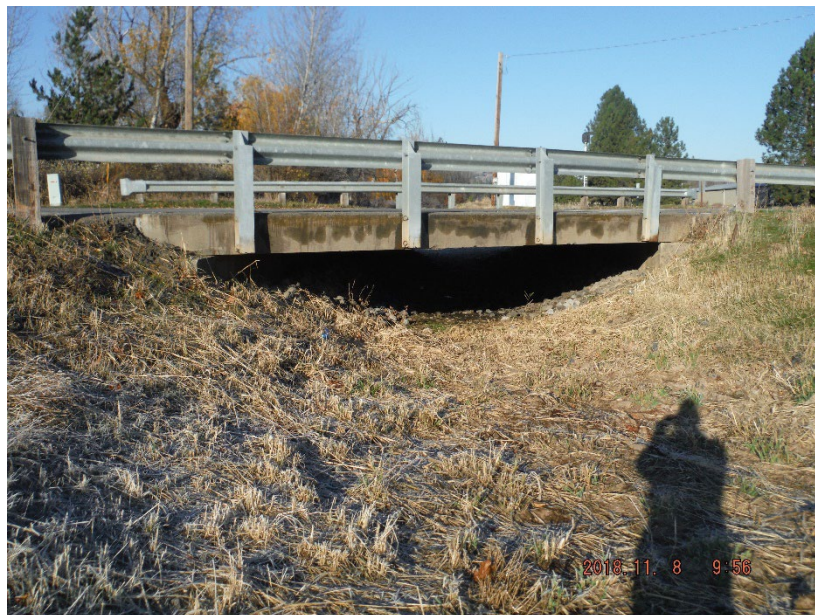
*Sands Road Bridge over Chester Creek, SPOKV-4520*

This inspection brought forth some concerns regarding various elements. First, there are many hairline cracks along the flange to web interface of the multi-web girders that I have been monitoring over the last few inspections. Generally, they are stable, but some have grown in length. A couple show shear cracking. Strength or performance are not affected. I will continue to monitor these defects. The existing riprap along the concrete abutments was re-positioned to prevent further erosion of the concrete abutments. The deck shows signs of wear since the 2-layer polymer overlay was installed in 2015. There are numerous spalls and longitudinal cracks, 4' spacing, in the deck that need to be repaired.

**Sands Road Bridge over Chester Creek Superstructure Replacement Project** is in the planning stages only. This project would replace the existing superstructure with a new pre-stressed concrete slab bridge with a cast-in-place deck and would include new asphalt approaches. The existing multi-web girders are showing signs of increased stresses upon the girders. The latest inspection reports show cracking at the web-to-flange interfaces with a shear crack developing at the end of one of the girders. The bridge currently has pre-stressed concrete multi-web girders with an epoxy overlay deck. Cracks are showing through the deck along the lines where the 4' wide girders are connected. This project is currently in the Scoping Phase only.

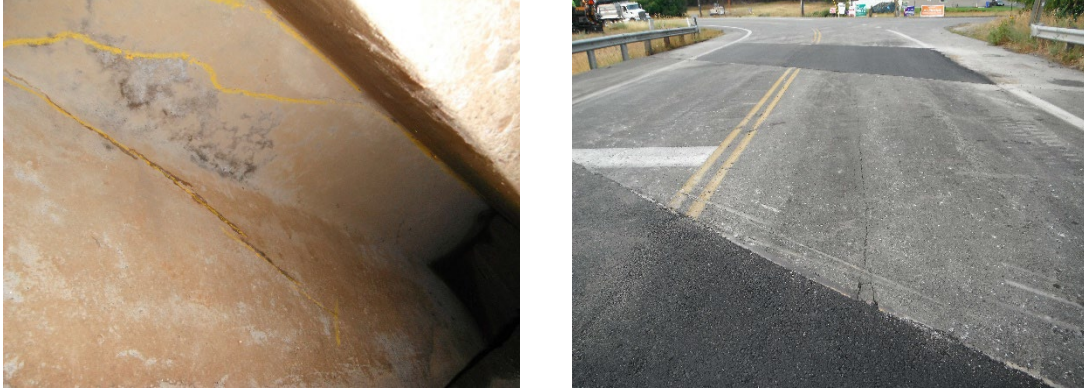
*Shear crack at north end of Girder C, east side, and reflective cracking in the bridge deck, SPOKV-4520*

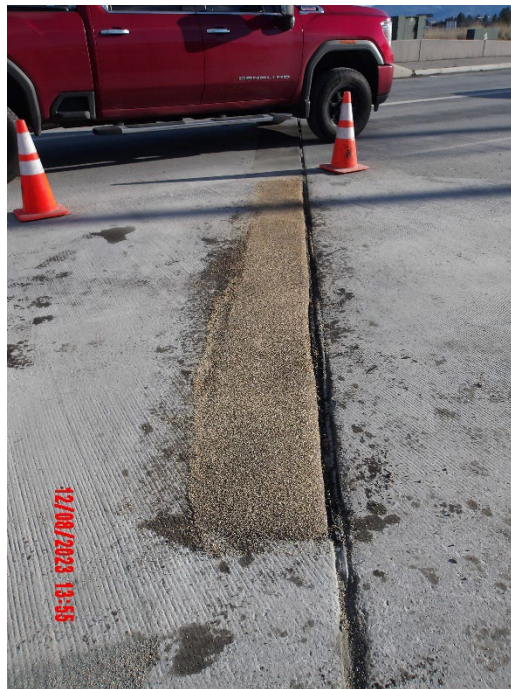
Most elements were found to be in good condition. The south end of the bridge, at the compression seal, keeps delaminating and having to be repaired. Compression seals are failing and need to be replaced, also. Sidewalks are showing signs of settling, may need to be repaired in the near future. Some minor repairs were also noted.

*Sullivan Road over Spokane River south approach deck repair, SPOKV-4508*

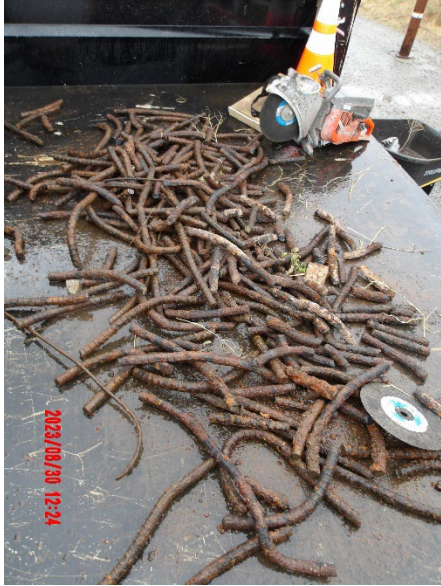
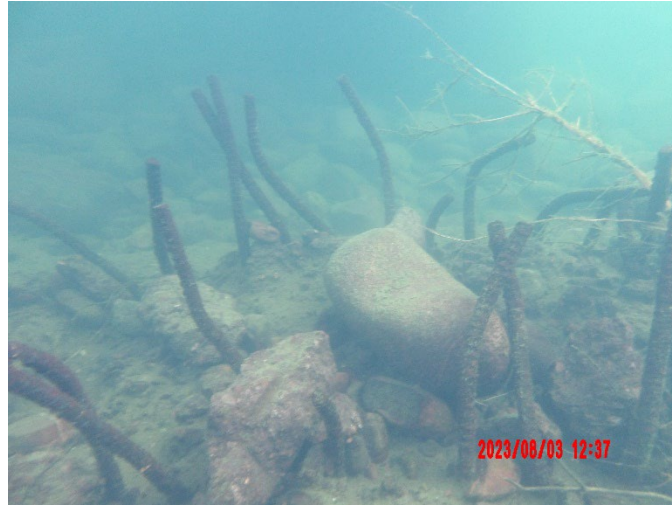
*Barker Bridge Rebar Reclamation Project, SPOKV-5503*

One major repair that was completed was the replacement of the original compression seal in the Barker Road over Spokane River bridge. This was completed in May by N.A. Degerstrom. Another repair that was completed was the removal of the existing rebar that was left over from the demolition of the Barker Road bridge back in 2010. Staff were alerted to a complaint

of rebar protruding from the old concrete foundations. This was noticed when the summer river flows dropped to their lowest levels. This was obviously a safety concern, so staff was able to hire a Contractor, get the appropriate permits and approvals to cut and remove the rebar from the river bottom. This was accomplished in the first week of September prior to water levels rising.

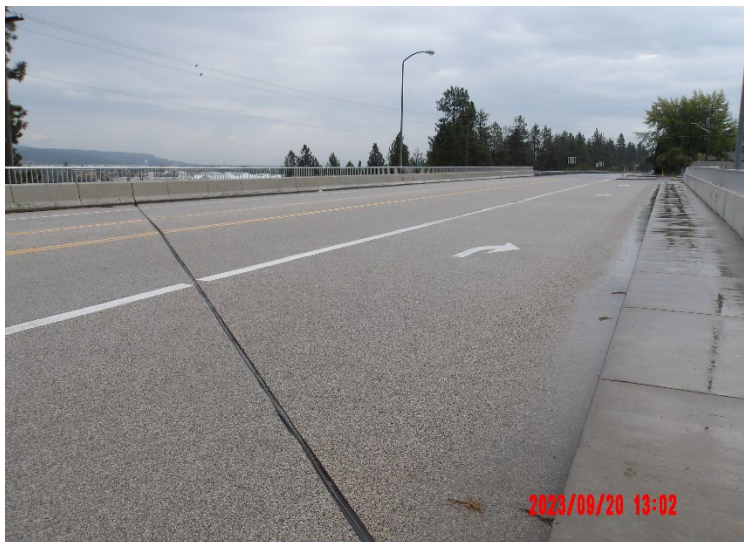
*Mission Avenue over Evergreen bridge with new deck overlay and new compression seals, SPOKV-4518.*

In July 2021, the city was awarded \$261,100 to repair the deck of the Mission Avenue over Evergreen Road bridge (4518). Construction was completed in summer 2023. The city's contractor installed a two-part epoxy sealer on the deck to help seal out water from penetration into the deck. New compression seals and upgraded ADA sidewalks were also installed as part of the project.
