FINAL STUDY REPORT

CITY OF SPOKANE VALLEY RIDGEMONT ESTATES

The City of Spokane Valley (City) contracted Osborn Consulting (Osborn) and subconsultants GeoEngineers and Simpson Engineers to conduct a study that evaluates site conditions and develops design alternatives for a proposed Ridgemont Estates Roadway and Stormwater Improvement Project.

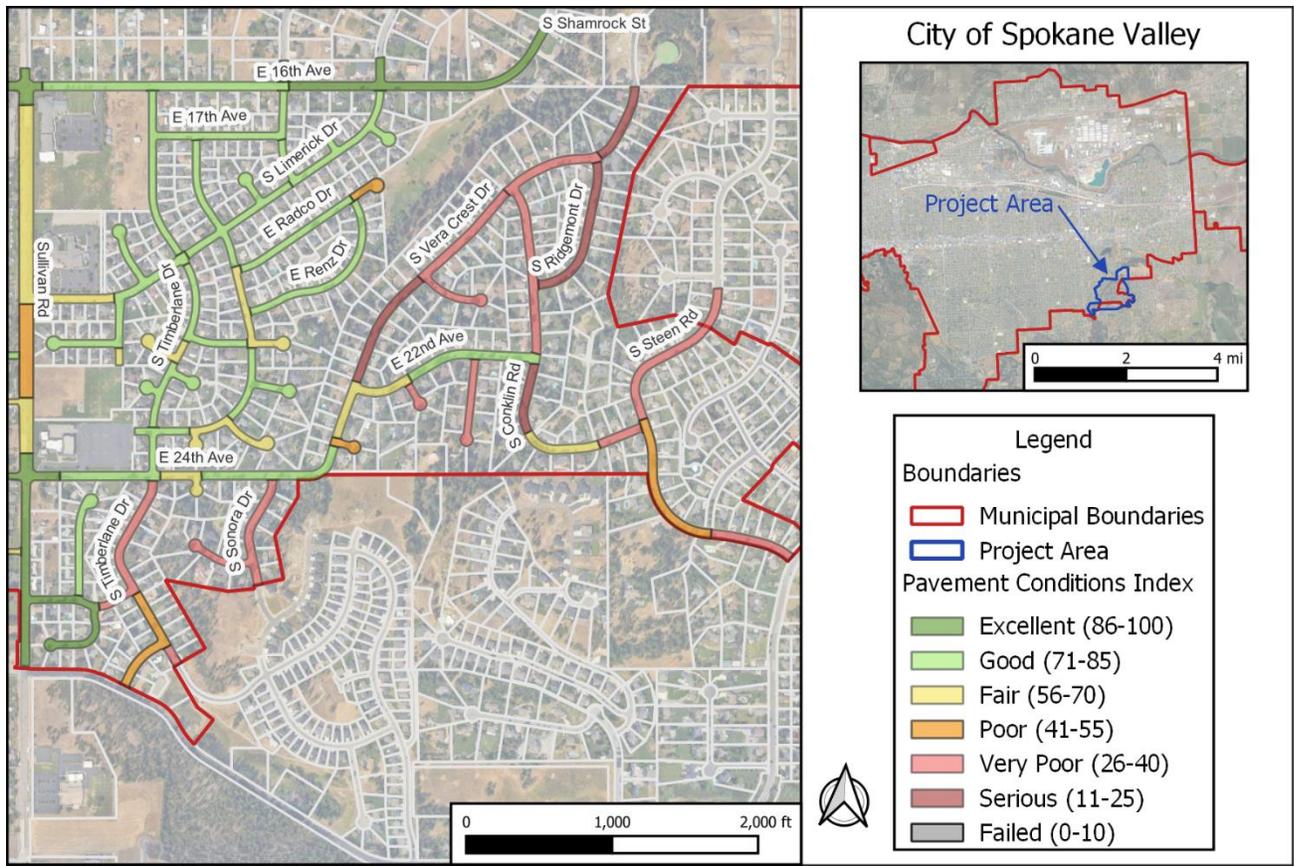
Figure 2-1: The project area and its relative location with Pavement Condition Index

The anticipated project area is identified by the City's Pavement Management Program and the Pavement Condition Index (PCI), which provides measurement to the condition of roadway surfaces. The index is measured on a scale of 0 to 100. Color shading is then associated to provide reference.

The final project area will prioritize those roadways shaded red and indexed as roadways in very poor or serious condition. The primary roadways considered include Vera Crest Drive, Conklin Road, Ridgemont Drive, Timberlane Drive, and Sonora Drive. Secondary roadways in this area will also be considered. Shown in **Figure 2-1**. Roadways not shaded in red may be considered as project area to accommodate levels of improvement to the stormwater system.

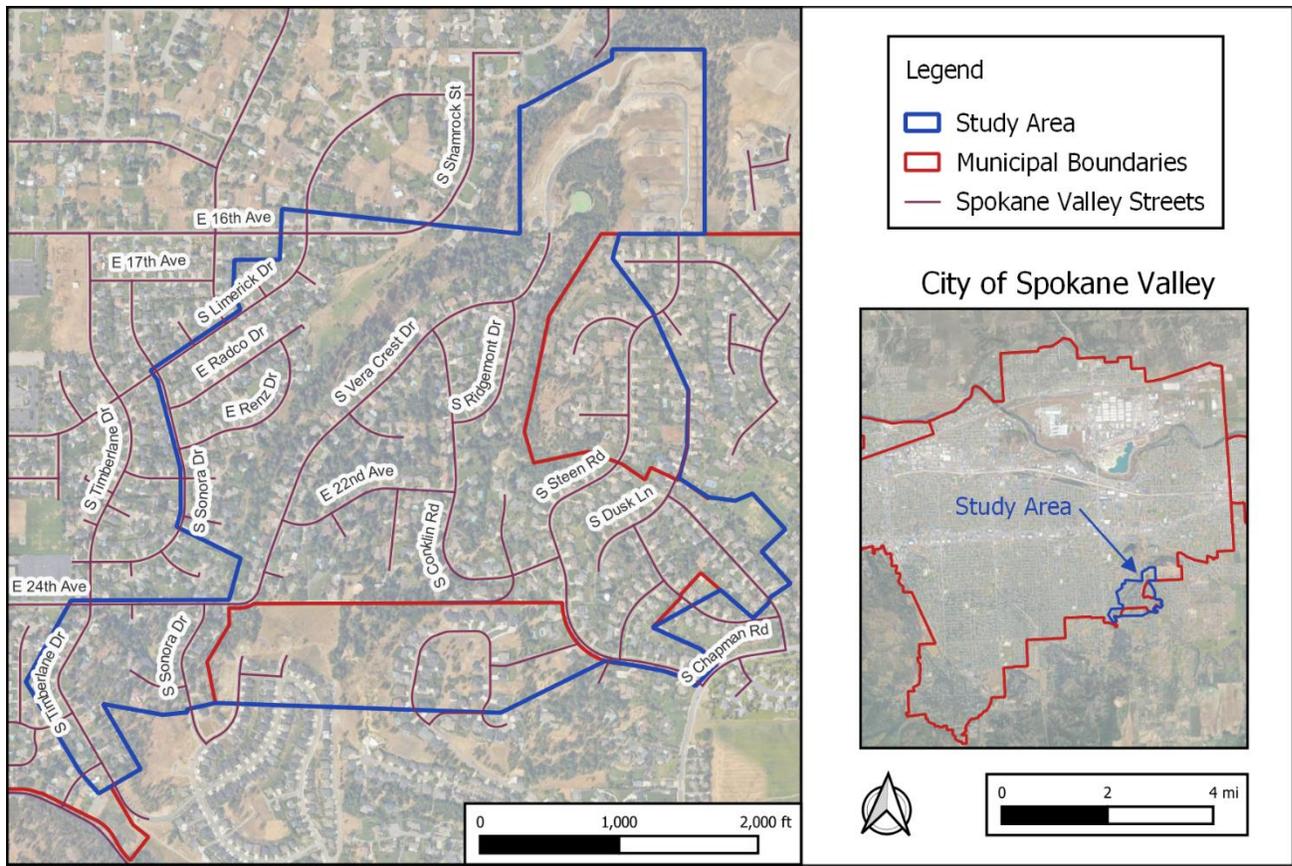
Figure 2-2. The study area and its relative location

A study area was identified to evaluate the site conditions contributing to the failing roadways in the project area. The study area was determined to be the area necessary to complete the hydrologic, hydraulic and geotechnical analysis.

The study area is characterized by single-family residential housing developments located at the southeast city limits bordering unincorporated Spokane County. Land and drainage features include steep hillsides, moderate tree coverage, and a stormwater system consisting of pipes, culverts, open channels, and drywells, as well as detention and infiltration ponds.

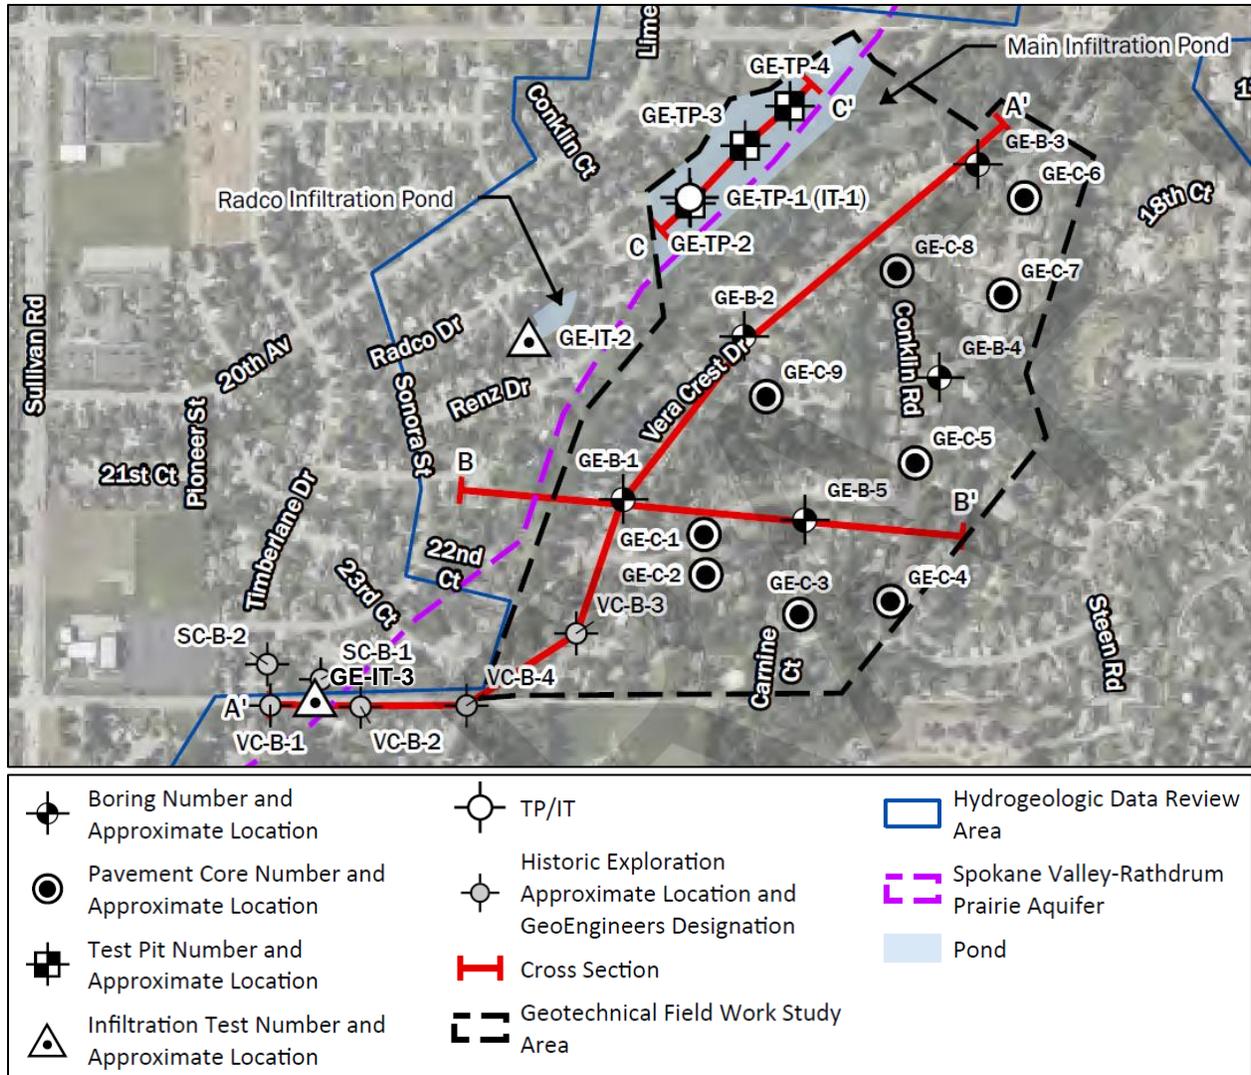
Figure 3-1: Geotechnical exploration map

GeoEngineers conducted a comprehensive geotechnical and hydrogeologic evaluation of the study area to investigate the subsurface conditions and characterize the local soil strata and permeability. The geotechnical report reviewed the existing data and previous geotechnical reports and included geotechnical borings at selected locations throughout the study area. For the report, GeoEngineers also conducted laboratory testing to analyze soil samples, full-scale infiltration testing at selected drywells, and groundwater modeling for the potential infiltration ponds. The full report is provided in **Appendix B**. The locations investigated are shown in **Figure 3-1**, which was extracted from **Figure 2** in **Appendix B**.

- **Groundwater Conditions:** Groundwater monitoring was performed at four locations (Borings GE-B-2 through GE-B-5 on **Figure 3-1**). Monitoring took place in November 2023 until June 2024. Monitoring covered the time periods when groundwater fluctuations are anticipated most including the wet period during spring snow melt and rain events and the summer irrigation season. Monitoring results are graphed in **Figure 12** in **Appendix B** and show that groundwater steadily built up in the glaciofluvial pocket within the Latah formation (monitoring well GE-B-2,

- **Infiltration Rates:** Infiltration testing was performed at the surface of East 16th Avenue Pond (GE-TP-1 on **Figure 3-1**), at a drywell in the Radco Pond (GE-IT-2), and at a drywell on East 24th Avenue (GE-IT-3). Results are discussed in detail in **Section 10.0 of Appendix B** and a brief summary of the results is provided in **Table 3-3**. The infiltration rates for the 16th Ave and Radco Ponds correlated well with the glaciofluvial soils in the area that are known to have high infiltration rates. GeoEngineers concluded the drywell at East 24th Avenue likely has reduced infiltration capacity due to sediment loading over time.

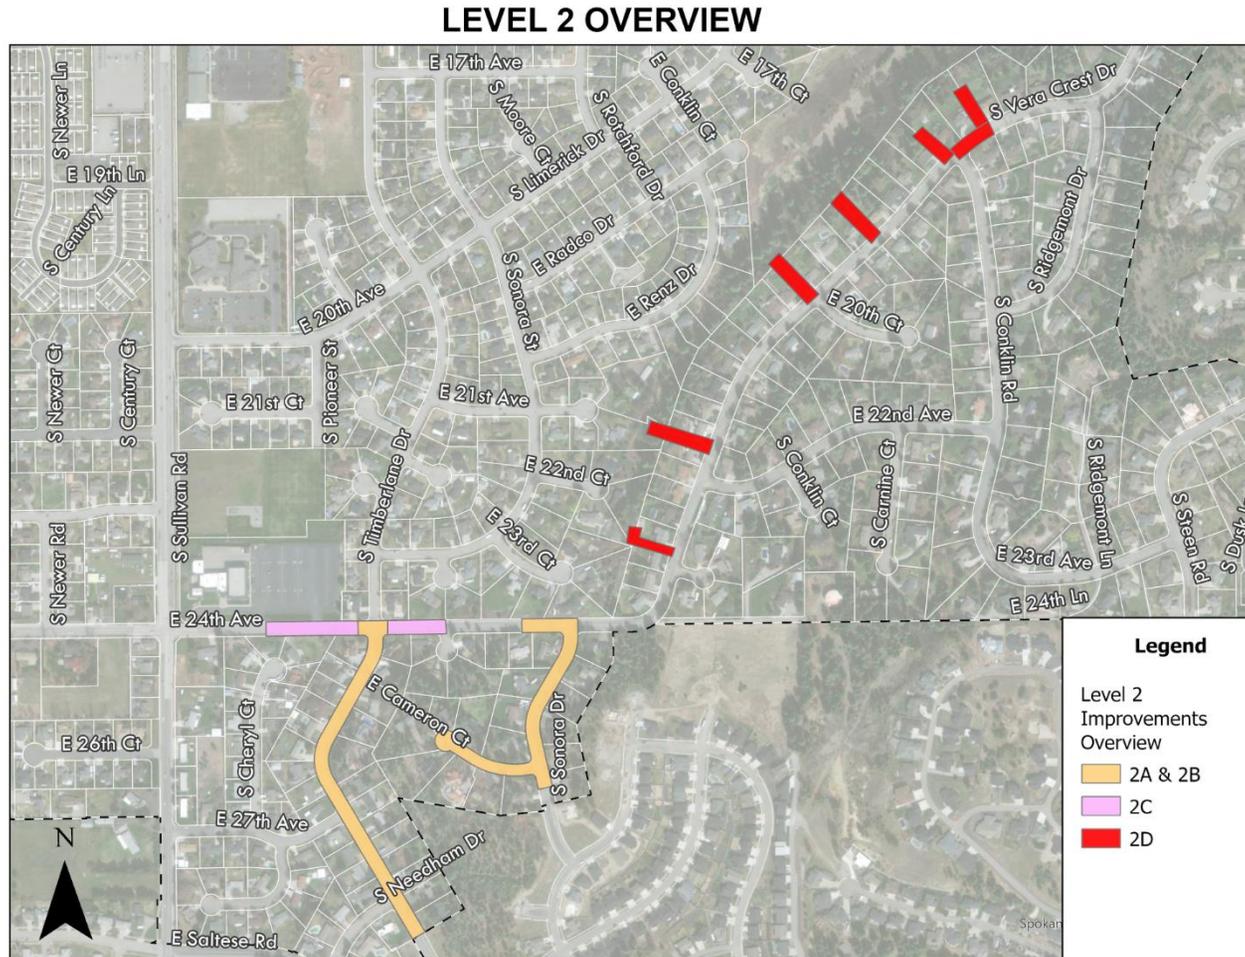
Figure 5-3: Overview of Level 2 improvements

The proposed Level 2 improvements are depicted in **Figure 5-3** and the menu of improvements is described in the following pages.

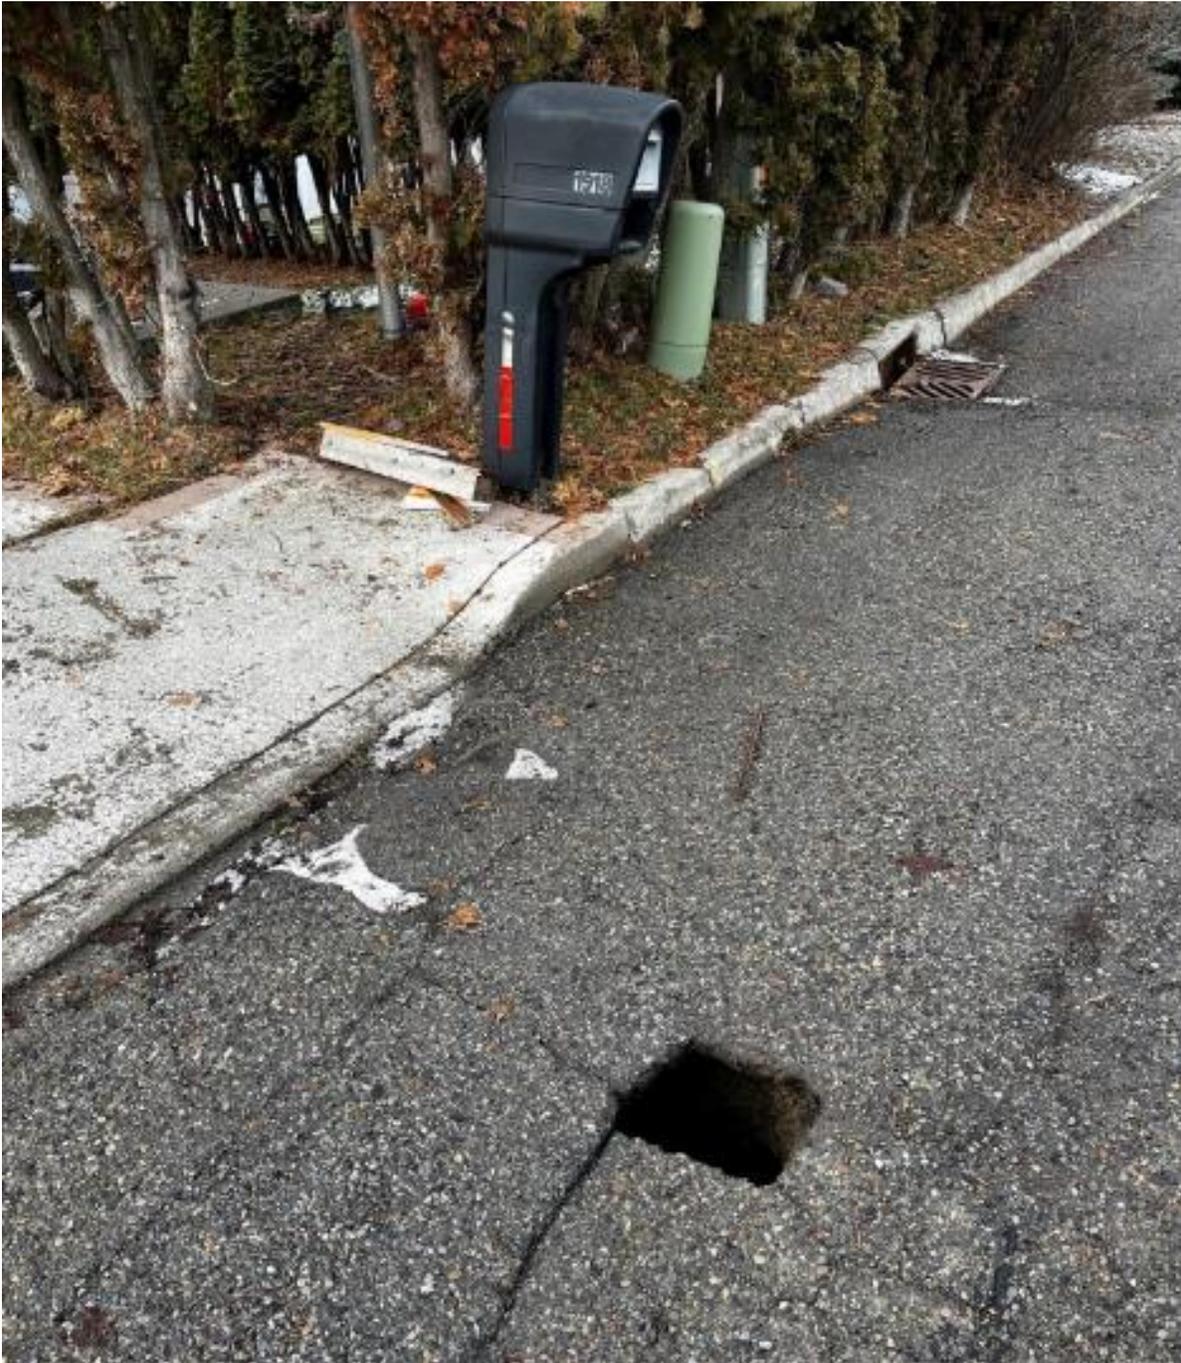
Figure 1: Sinkhole at the intersection of Conklin Road and Ridgemont Drive observed by city maintenance crew and submitted as a QAlert 12/27/2023. Photo taken by maintenance crew; hole was then covered by large metal plate.

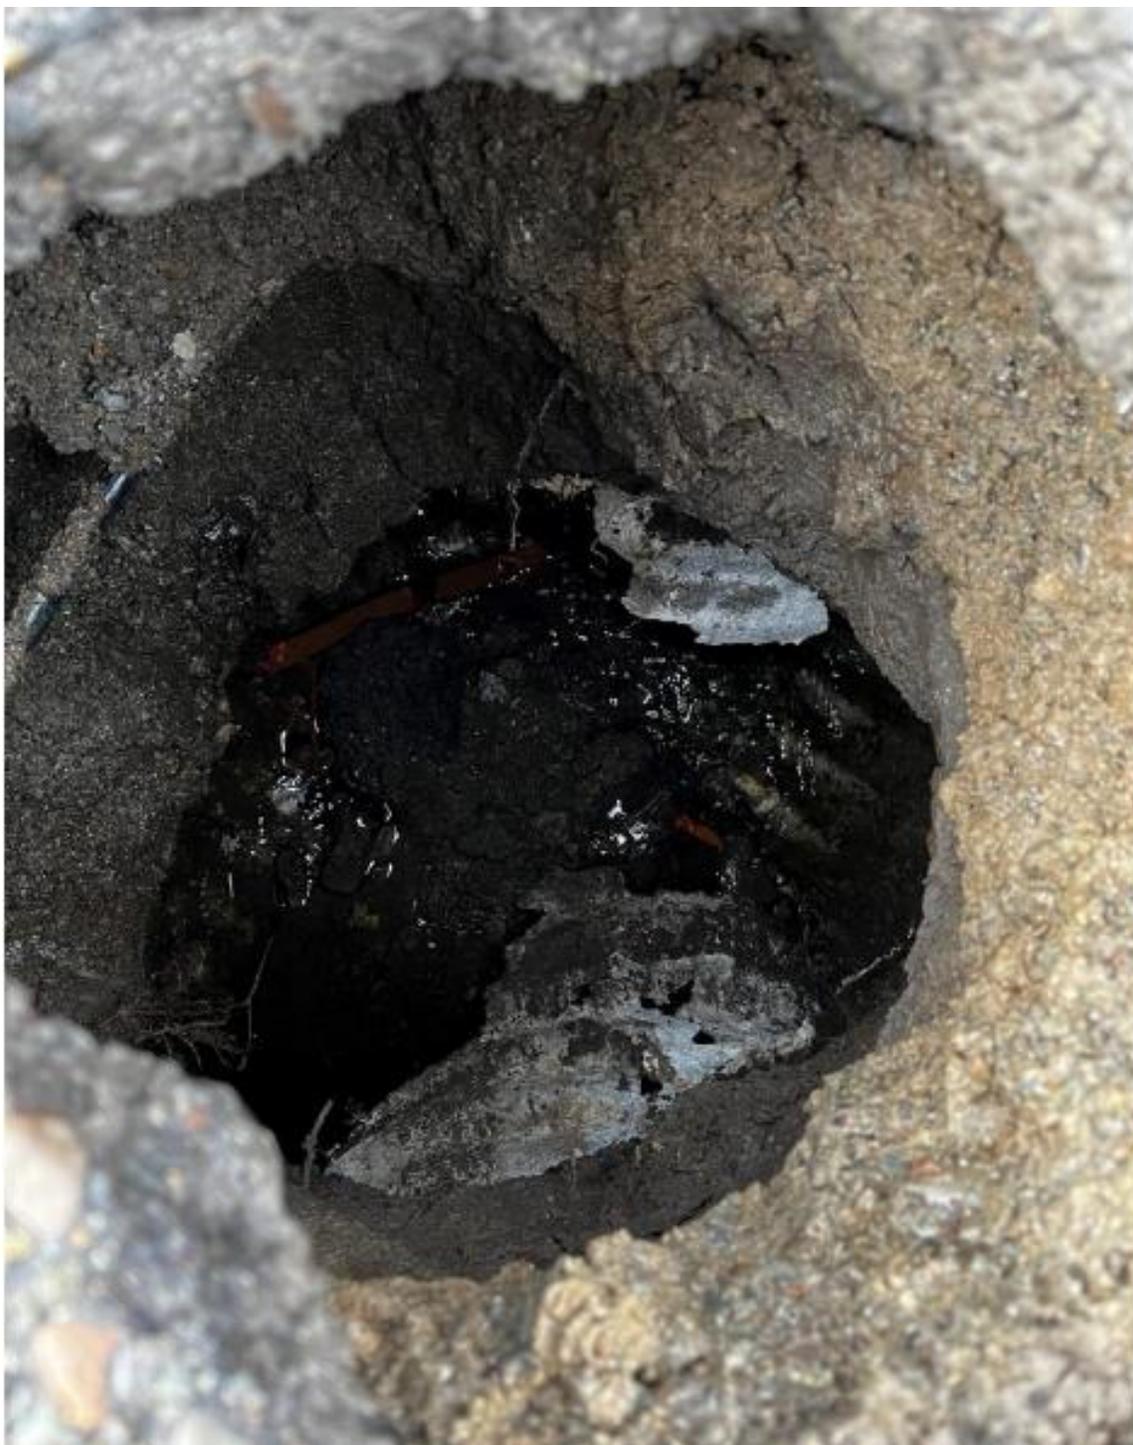
Figure 2: Photo taken inside the sinkhole located at the intersection of Conklin Road and Ridgemont Drive. Soils have eroded and top of culvert has rusted and collapsed. Photo taken 12/27/2023.

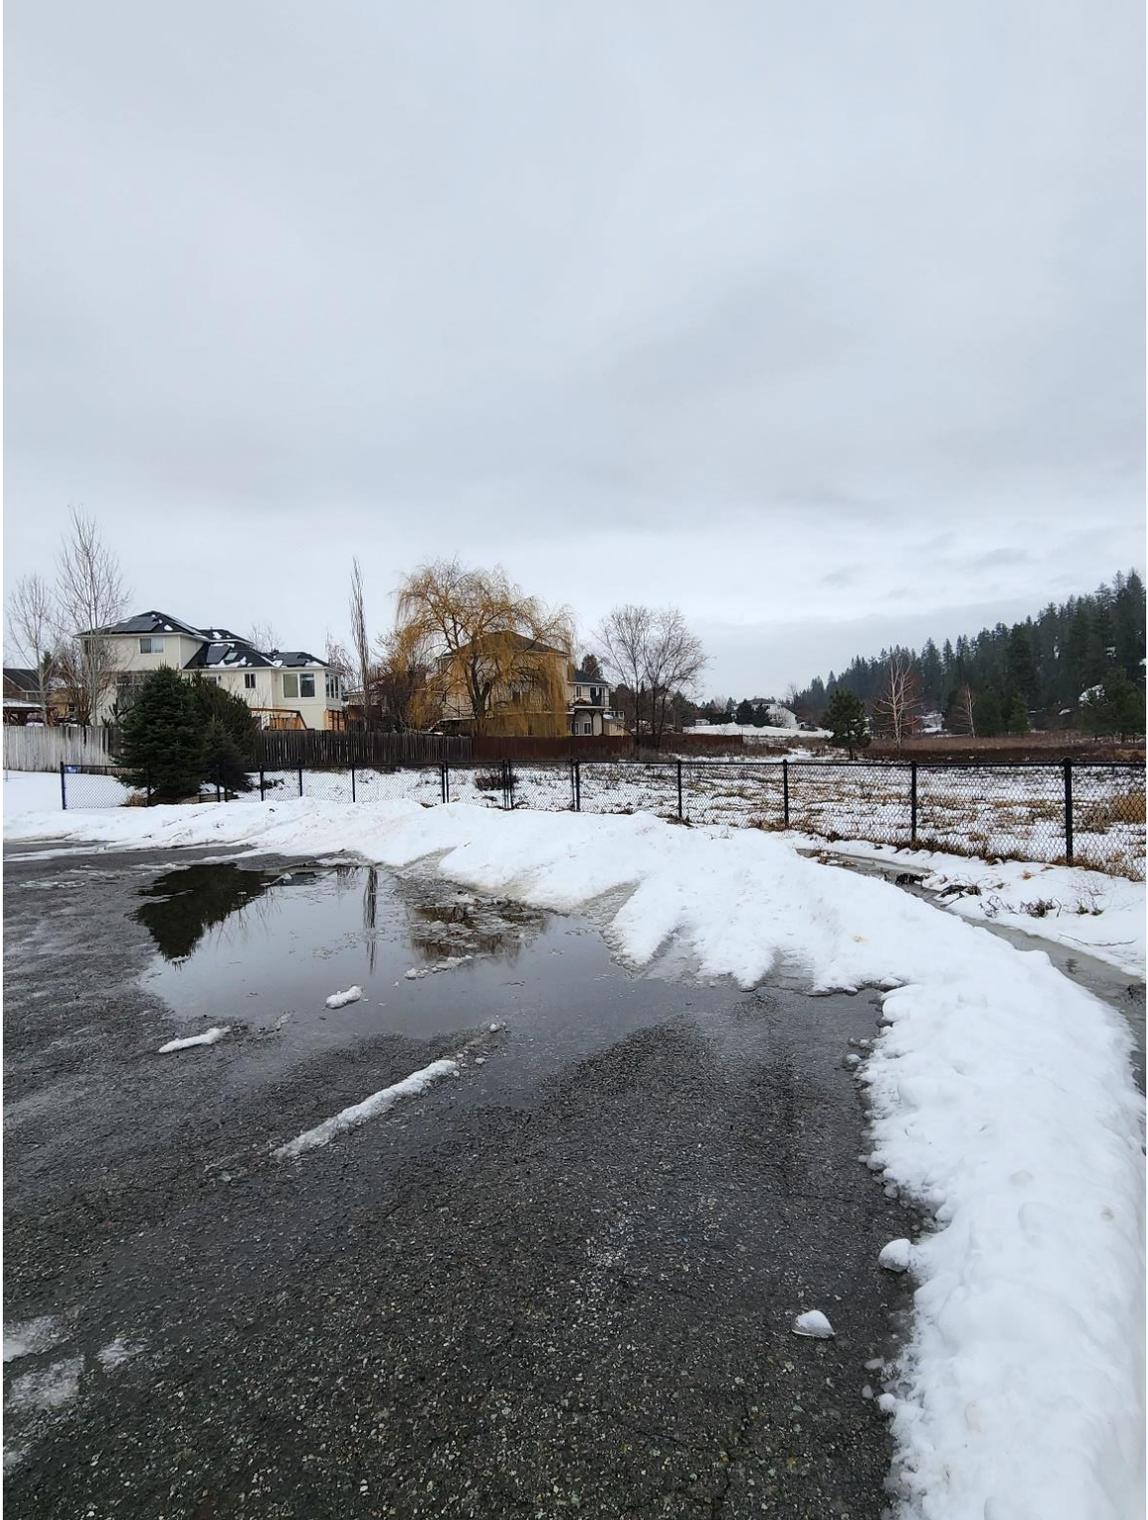
Figure 3: Ponding water at the Radco Drive cul-de-sac. Heavy ponding with nowhere for the water to drain causing damage to the road. Photo taken 1/22/2024.

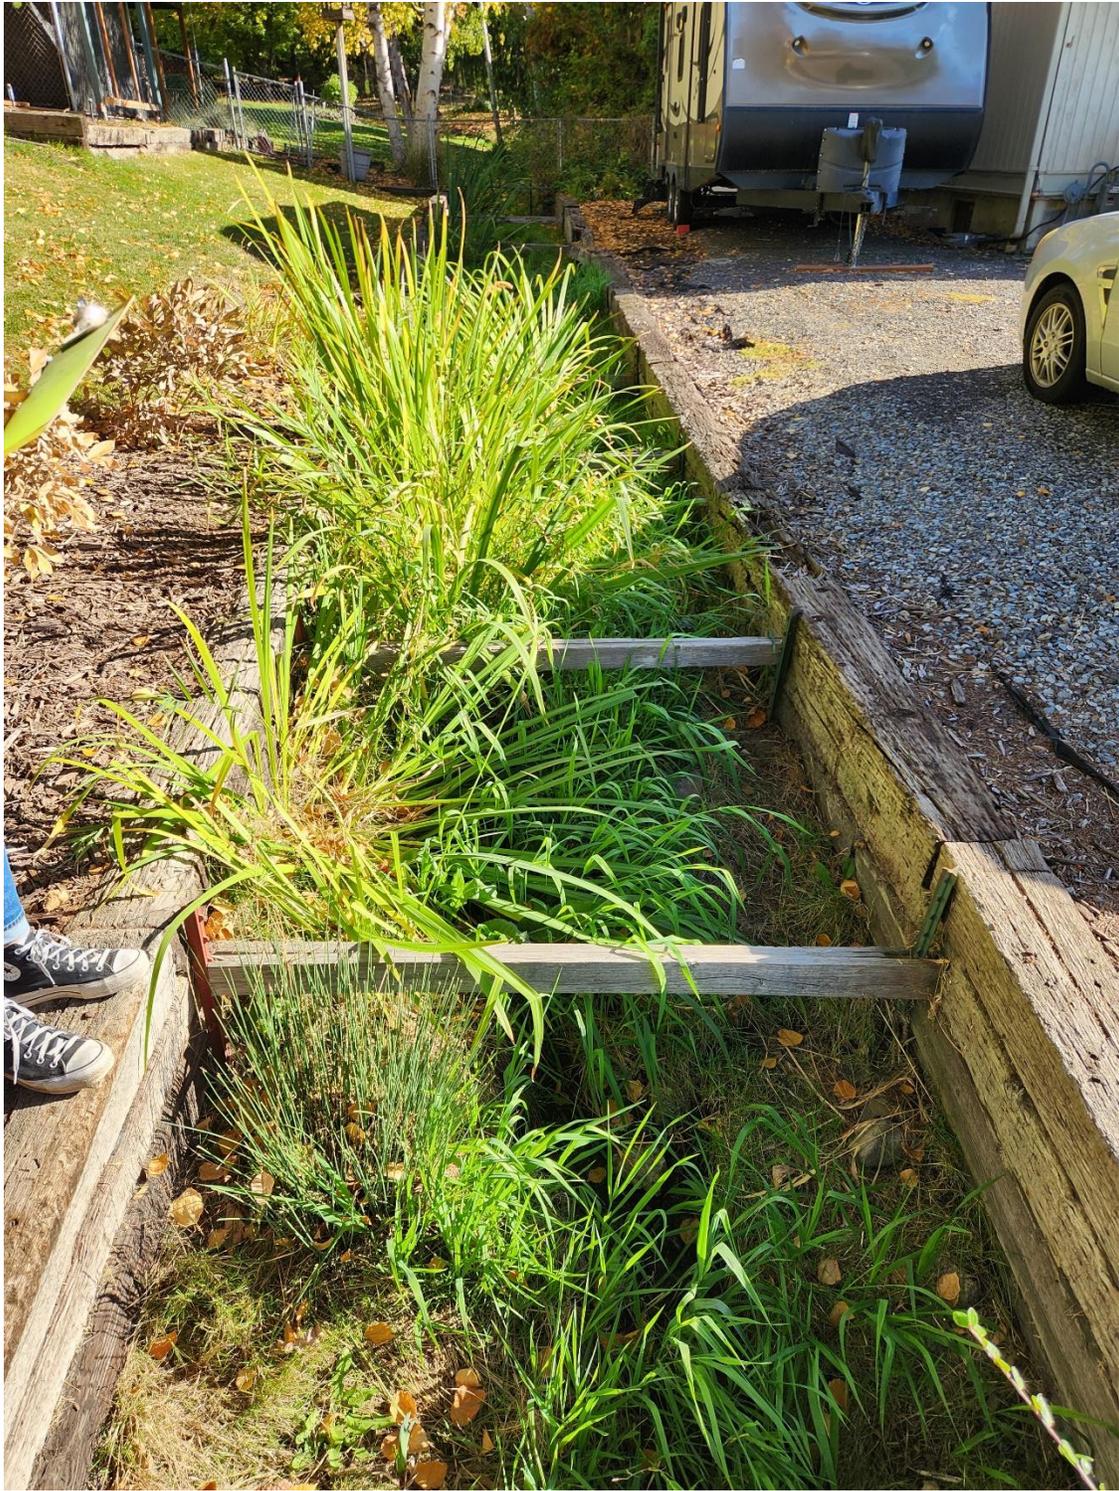
Figure 5: Downstream end of open channel ditch located between Conklin Road and Vera Crest Drive. Flow in this channel drains to the 16th Avenue infiltration pond. Photo taken 1/17/2024.

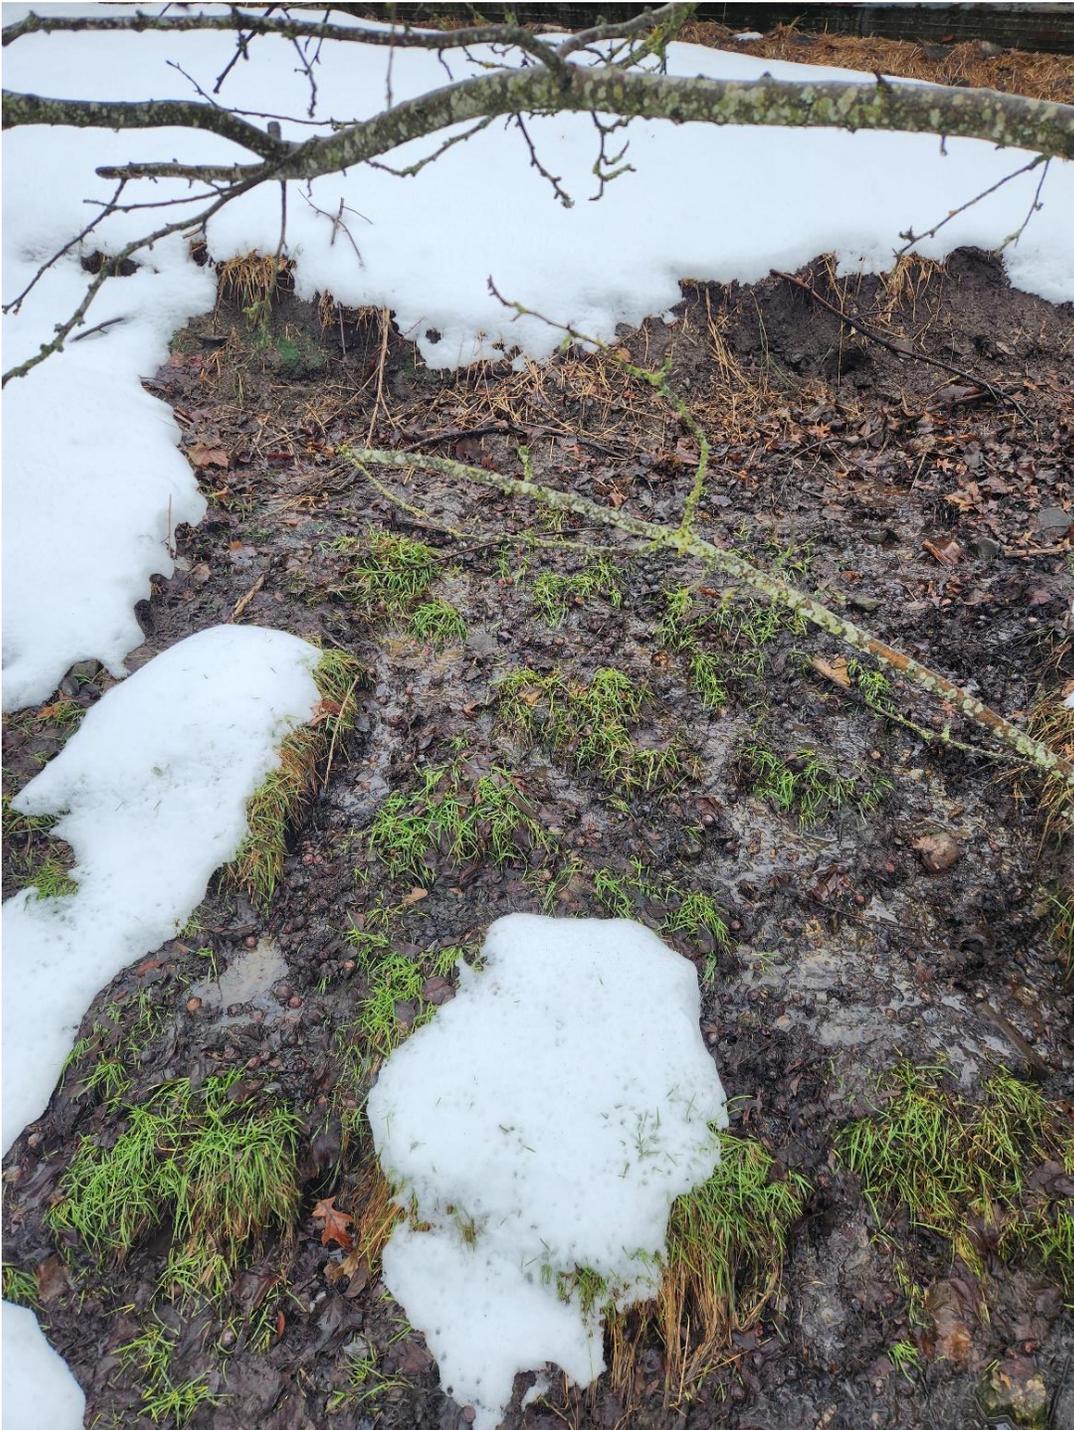
Figure 6: Ground water seeping out of hillside at the top of the Radco open channel ditch. Observed by Osborn in the field during wet conditions. The pipe which runs down this hillside is 50% collapsed and is likely infiltrates water into hillside. Photo taken 1/22/2024.

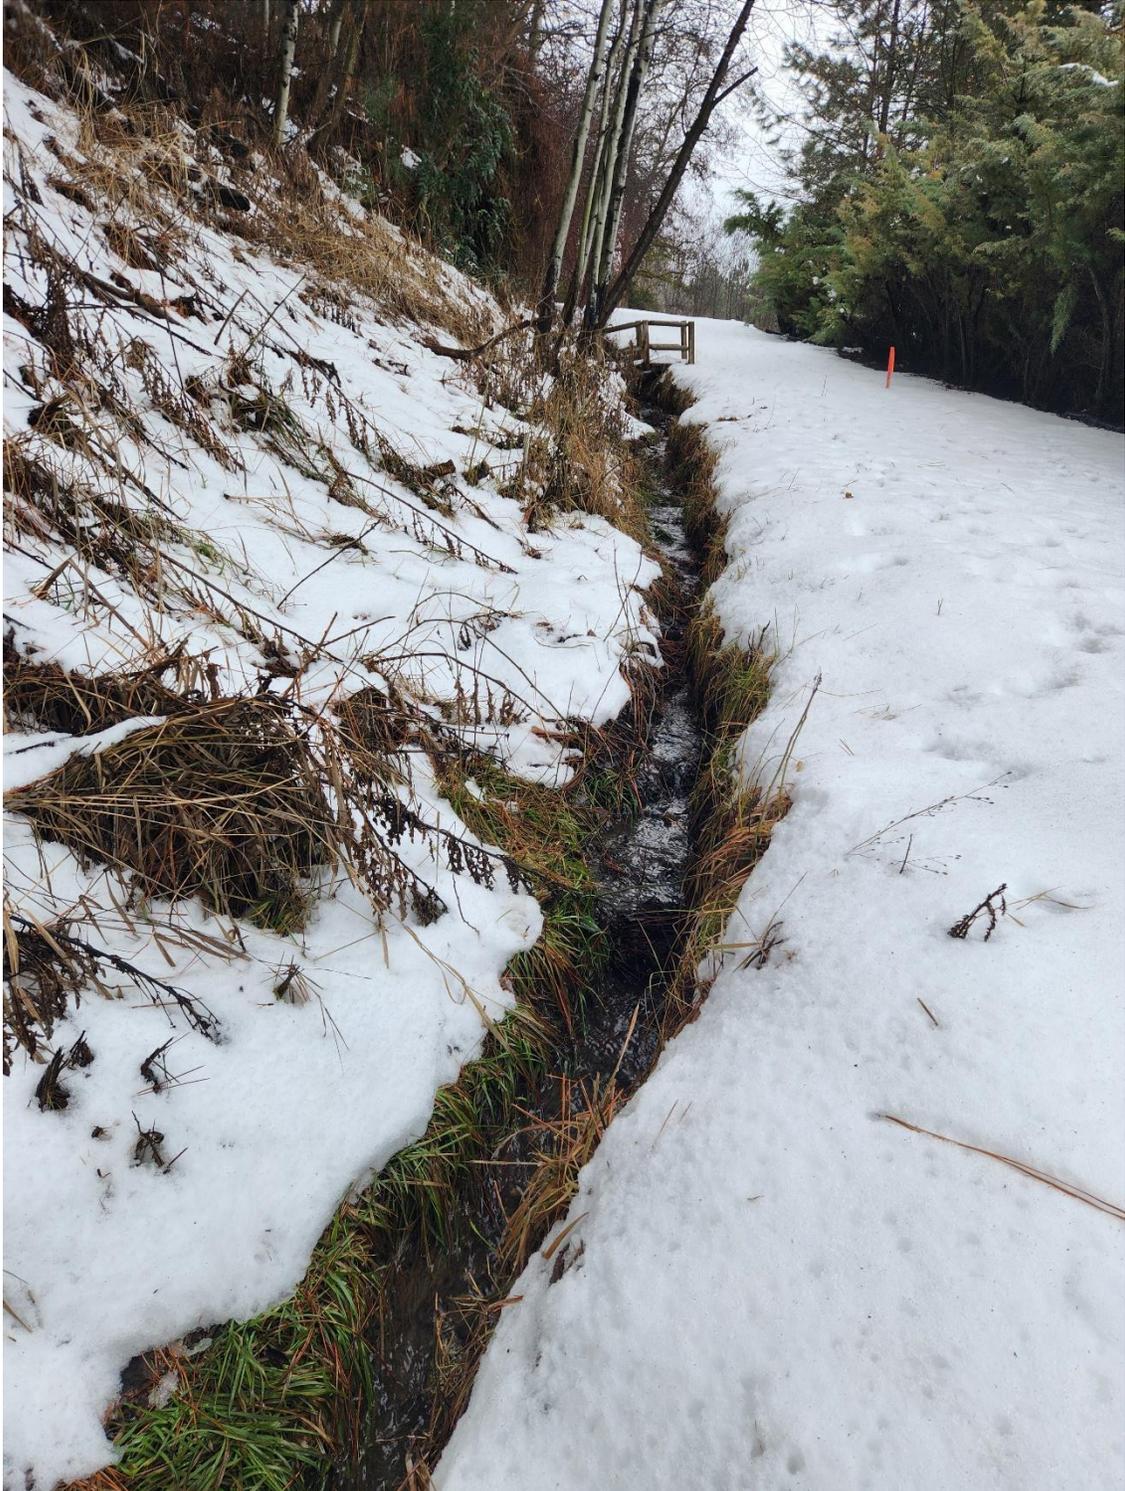
Figure 7: Upstream end of the Radco open channel ditch. Flow is clearly visible in the open channel, but seems to dissipate the further down the open channel you go. Photo taken 1/22/2024.

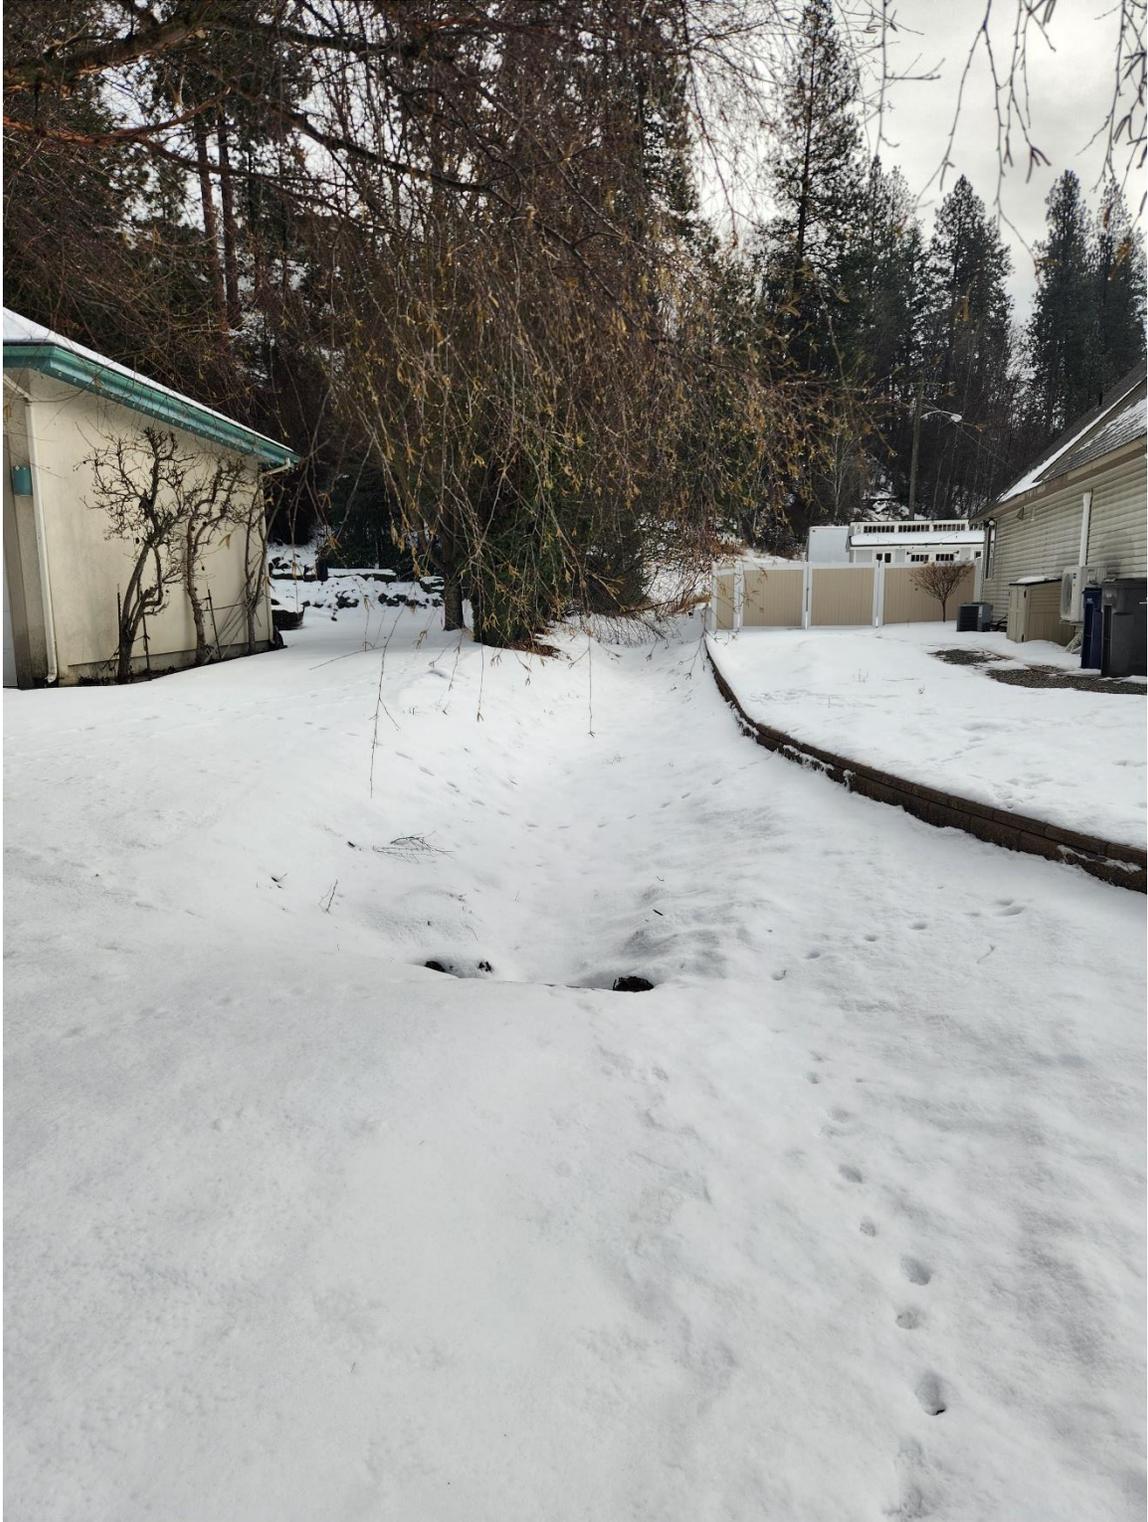
Figure 9: Downstream end of Radco open channel ditch. Flow did not reach the end of the open channel ditch; pipe was observed to be dry (see Figure 10). This supports the theory that flow does not reach the Radco infiltration pond. Photo taken 1/22/2024.

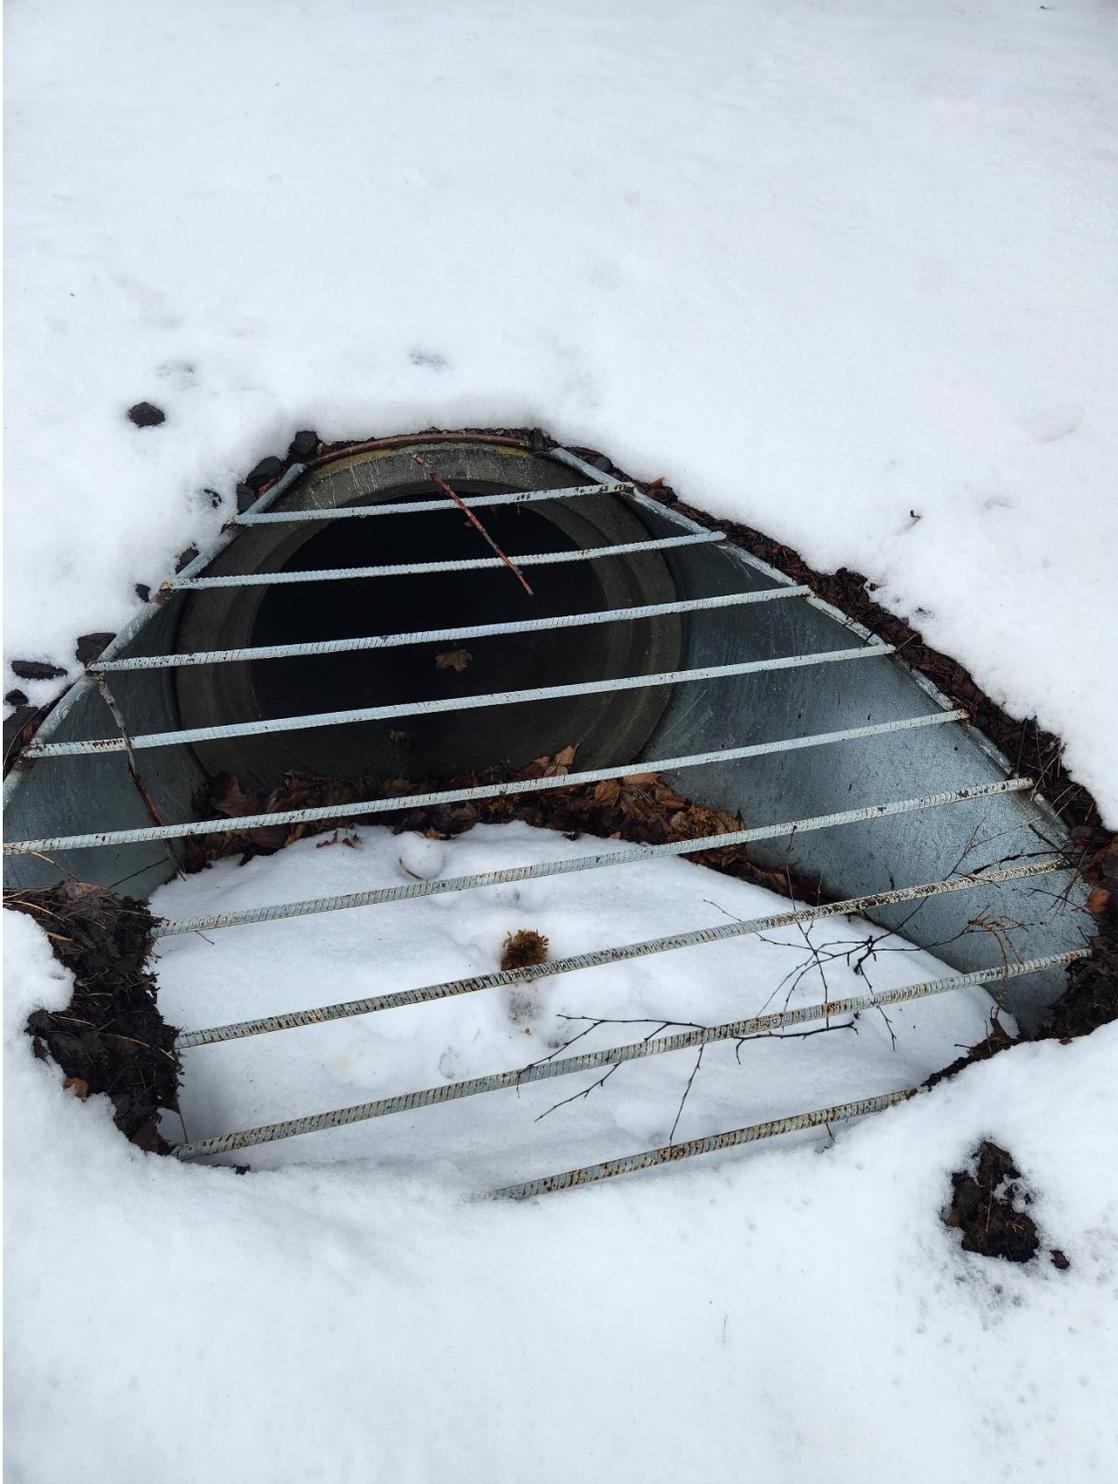
Figure 10: Inlet pipe located at the end of the Radco open channel ditch. Despite flow being present higher up in this open channel ditch, flow does not reach this inlet pipe and has been observed to be dry. Photo taken 1/22/2024.

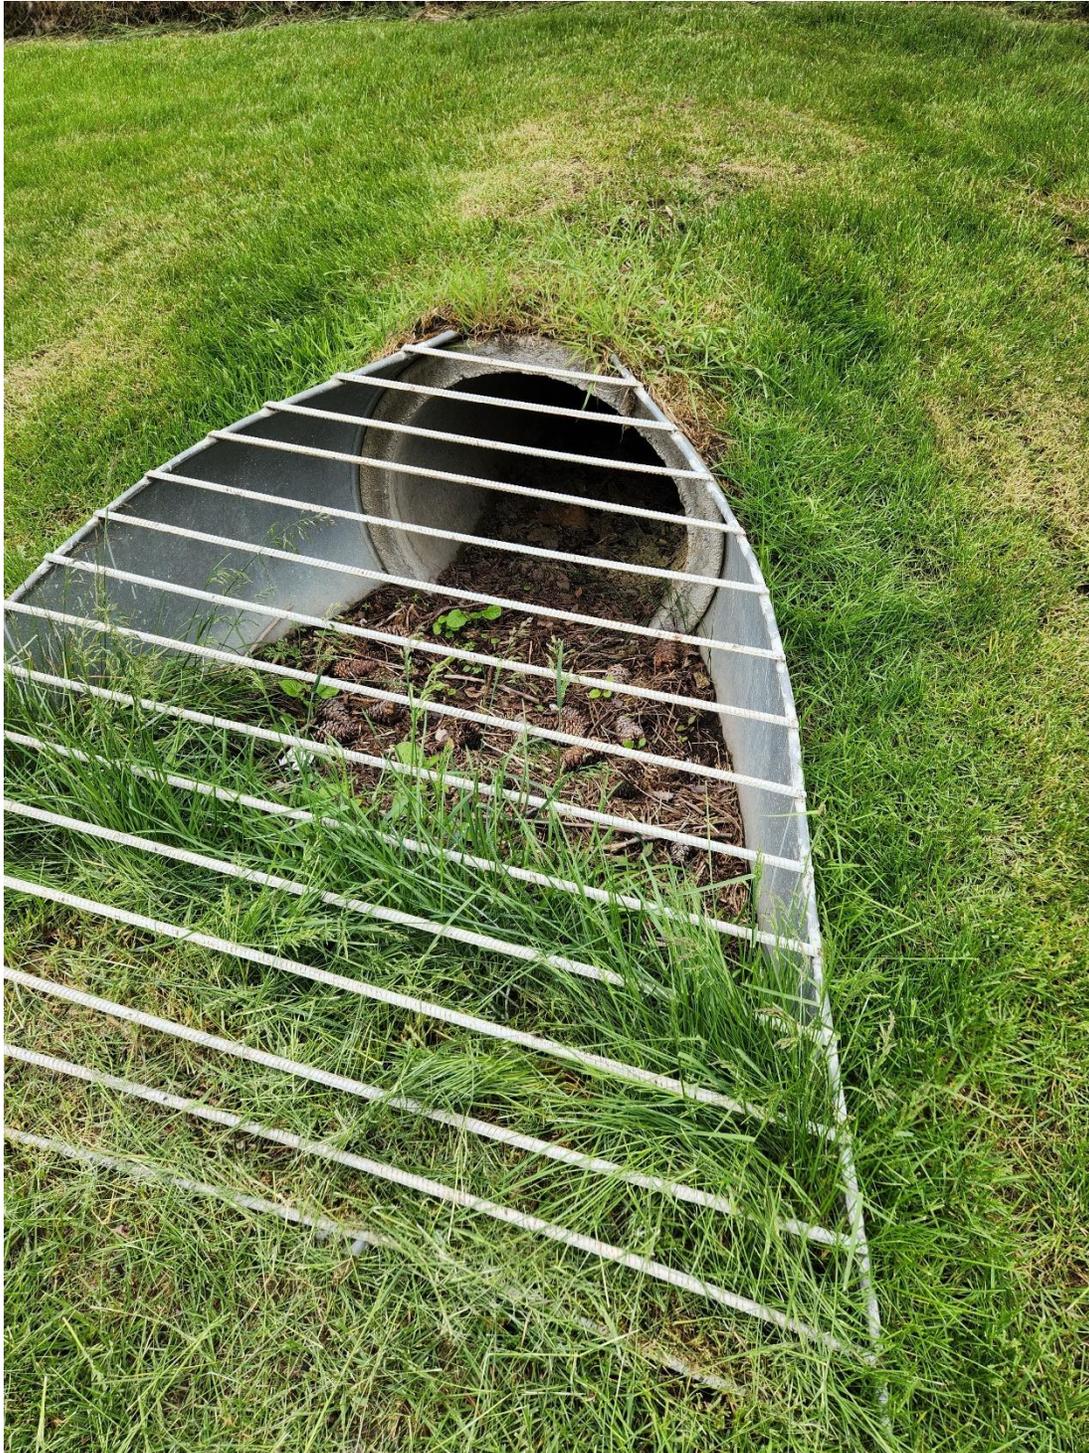
Figure 12: Outlet pipe to the Radco infiltration pond intended to convey flow from the Radco open channel ditch. Pipe observed to be dry throughout various site visits, reinforcing the belief that water is not reaching this pond. Photo taken 5/28/2024.

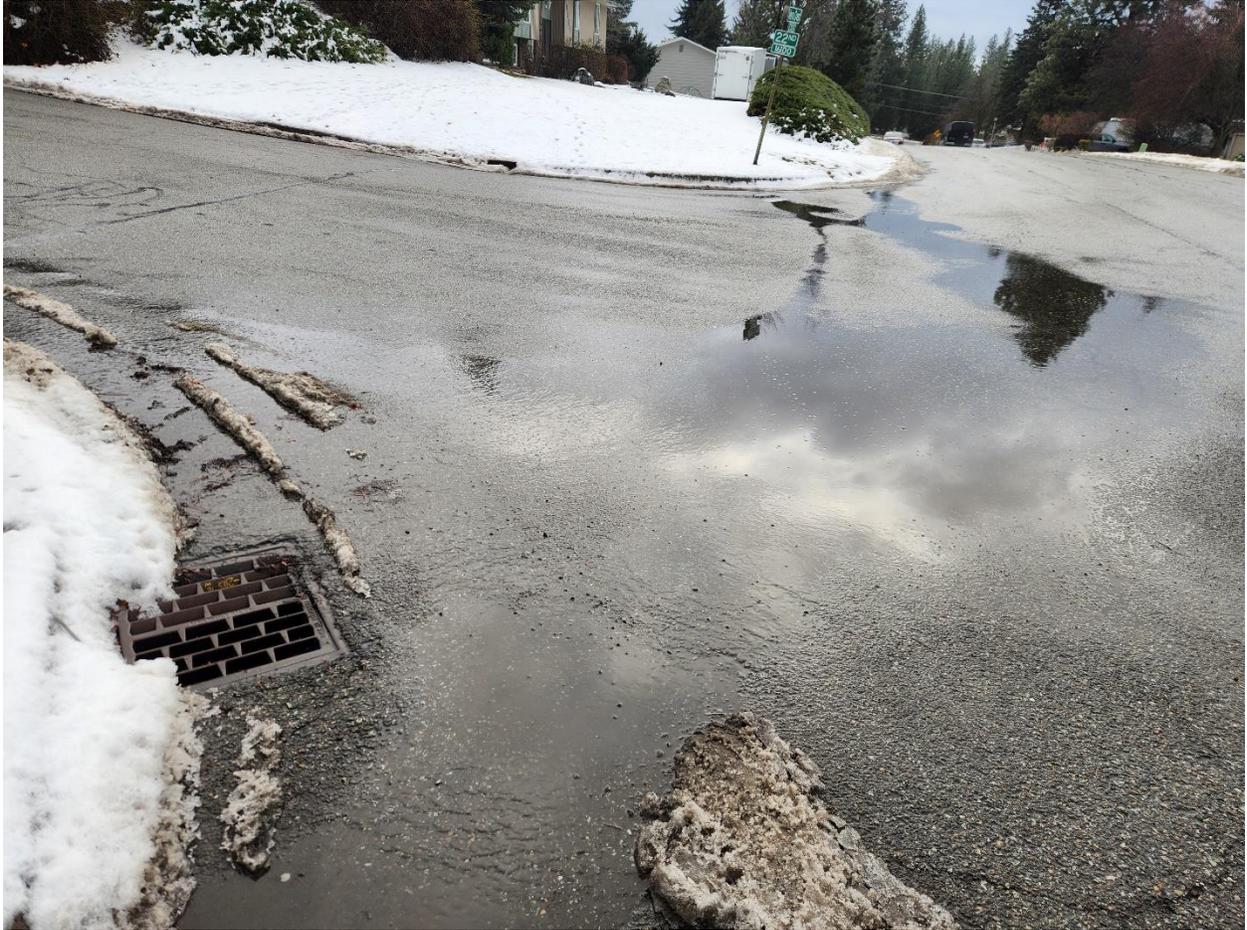
Figure 15: Ponding water at the intersection of 22nd Avenue and Vera Crest Drive. Water has been observed to pond here during various site visits, failing to reach the catch basin shown in the picture. Photo taken 1/22/2024.
