FINAL STUDY REPORT

CITY OF SPOKANE VALLEY RIDGEMONT ESTATES

The City of Spokane Valley (City) contracted Osborn Consulting (Osborn) and subconsultants GeoEngineers and Simpson Engineers to conduct a study that evaluates site conditions and develops design alternatives for a proposed Ridgemont Estates Roadway and Stormwater Improvement Project.

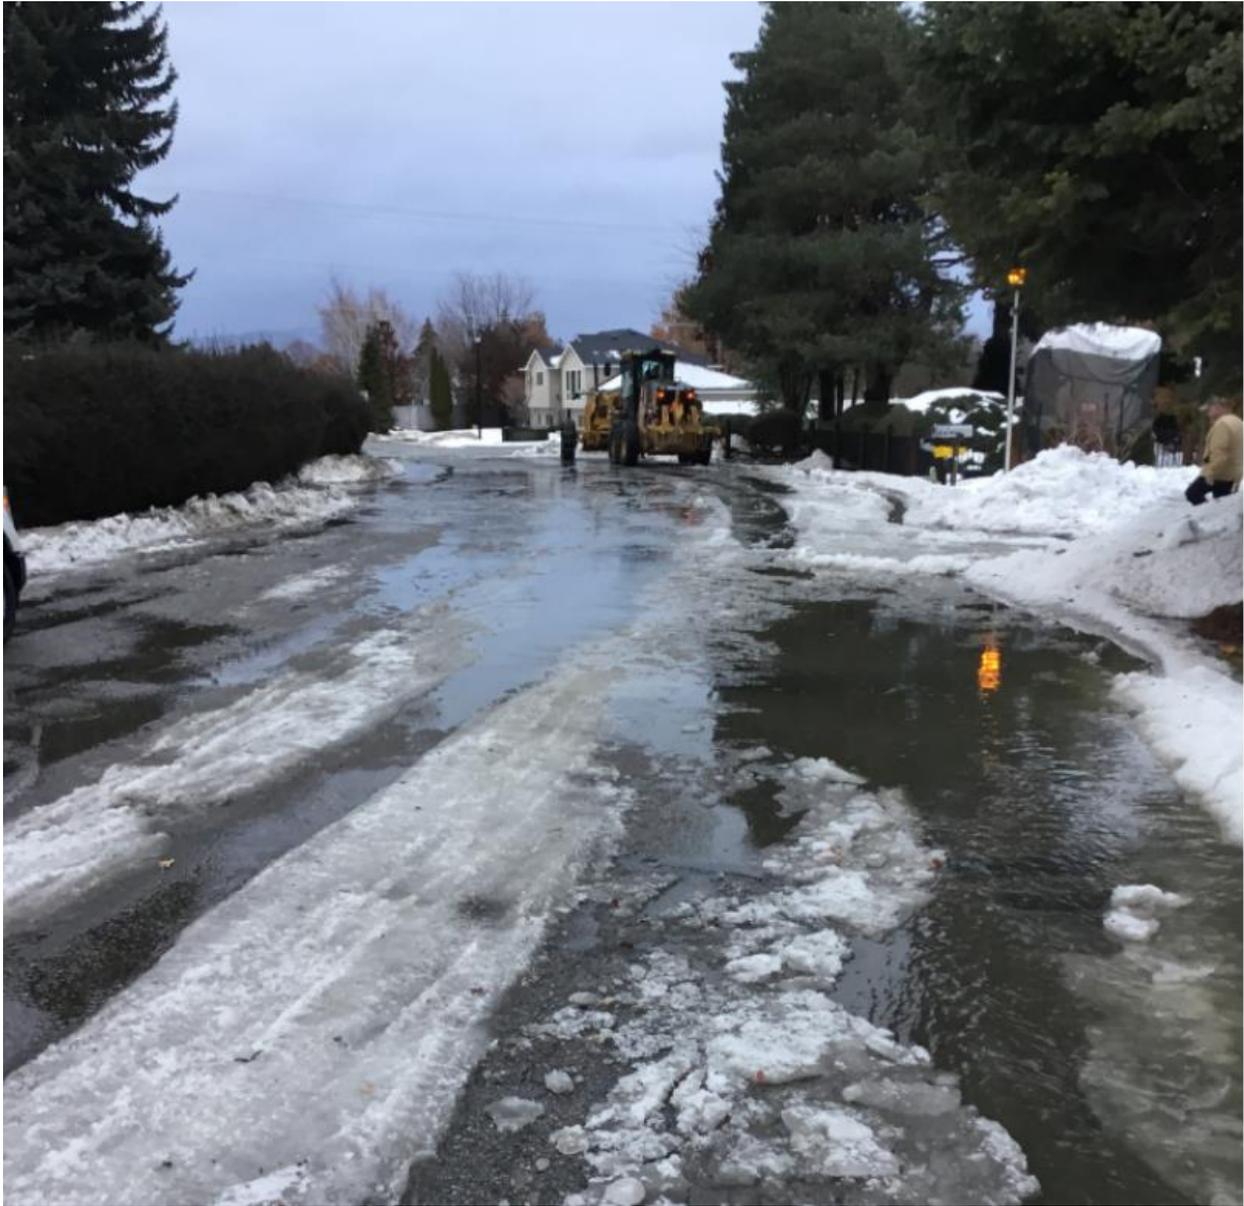
Figure 16: Qalert submitted by residents living on Timberlane Drive. Residents stated that water was ponding in the roadway and flooding over their driveway and into their garage. Photo submitted by residents on 12/27/2024.

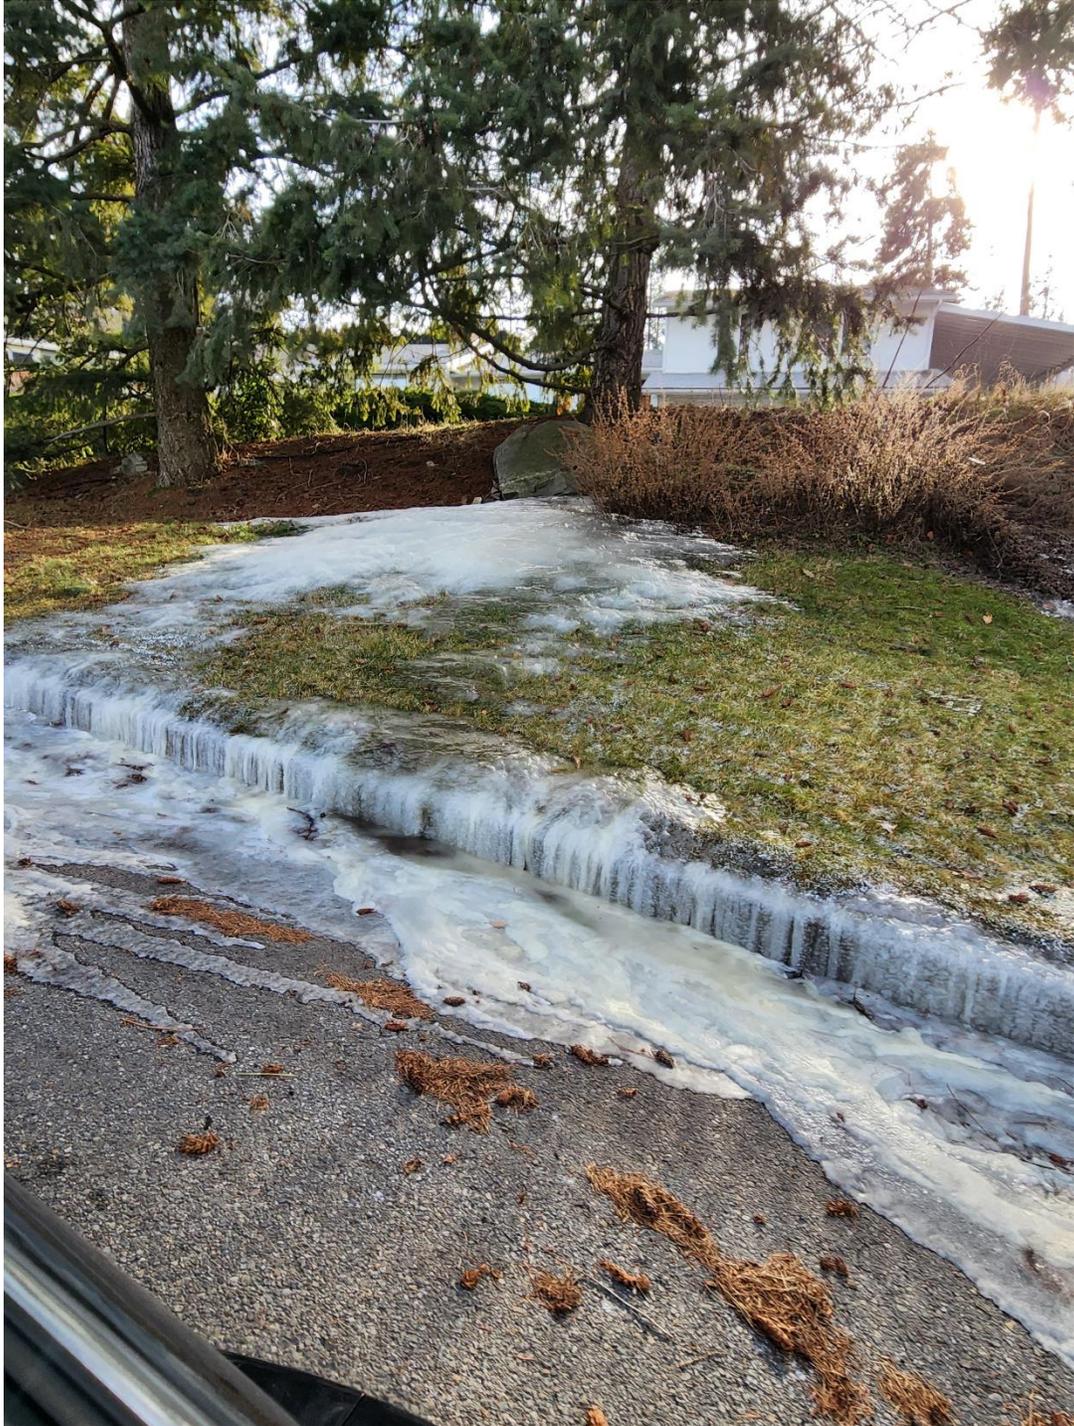
Figure 17: Qalert submitted by resident with groundwater springs on 24th Avenue 6/3/2019. Osborn observed these conditions in the field and took this picture during abnormally cold weather. Photo taken 1/16/2024.

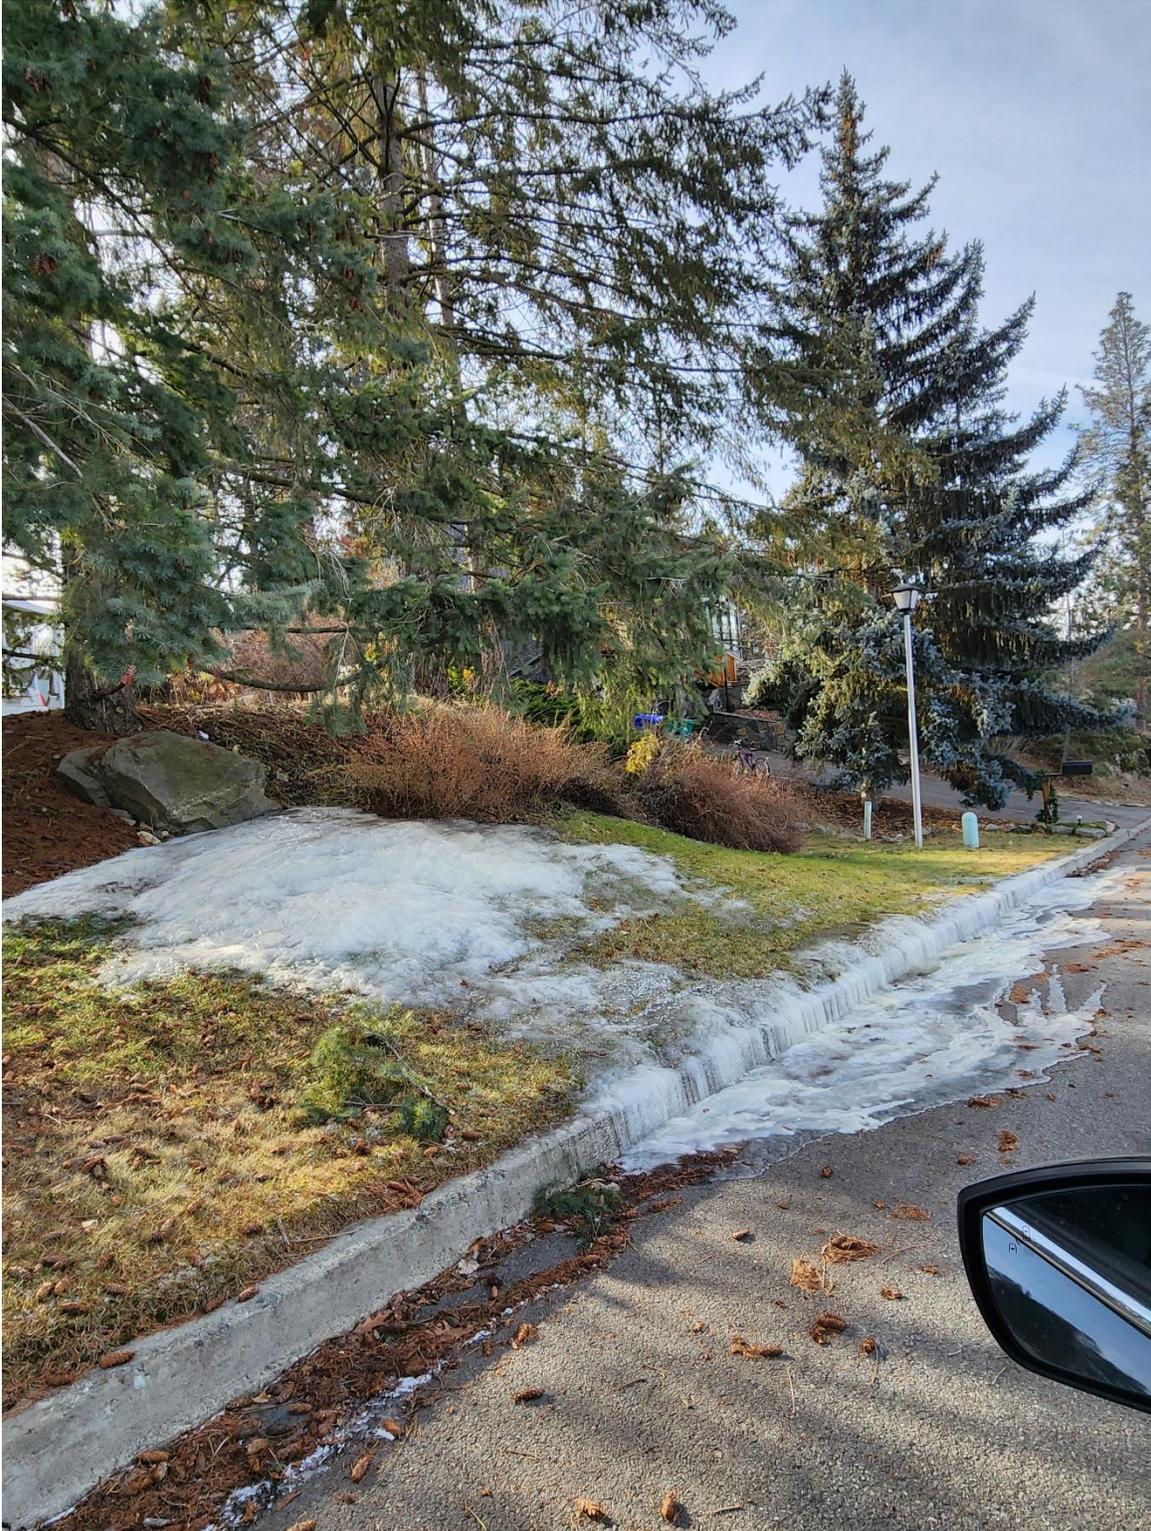
Figure 18: Qalert submitted by resident with groundwater springs on 24th Avenue 6/3/2019. Osborn observed these conditions in the field and took this picture during abnormally cold weather. Photo taken 1/16/2024.

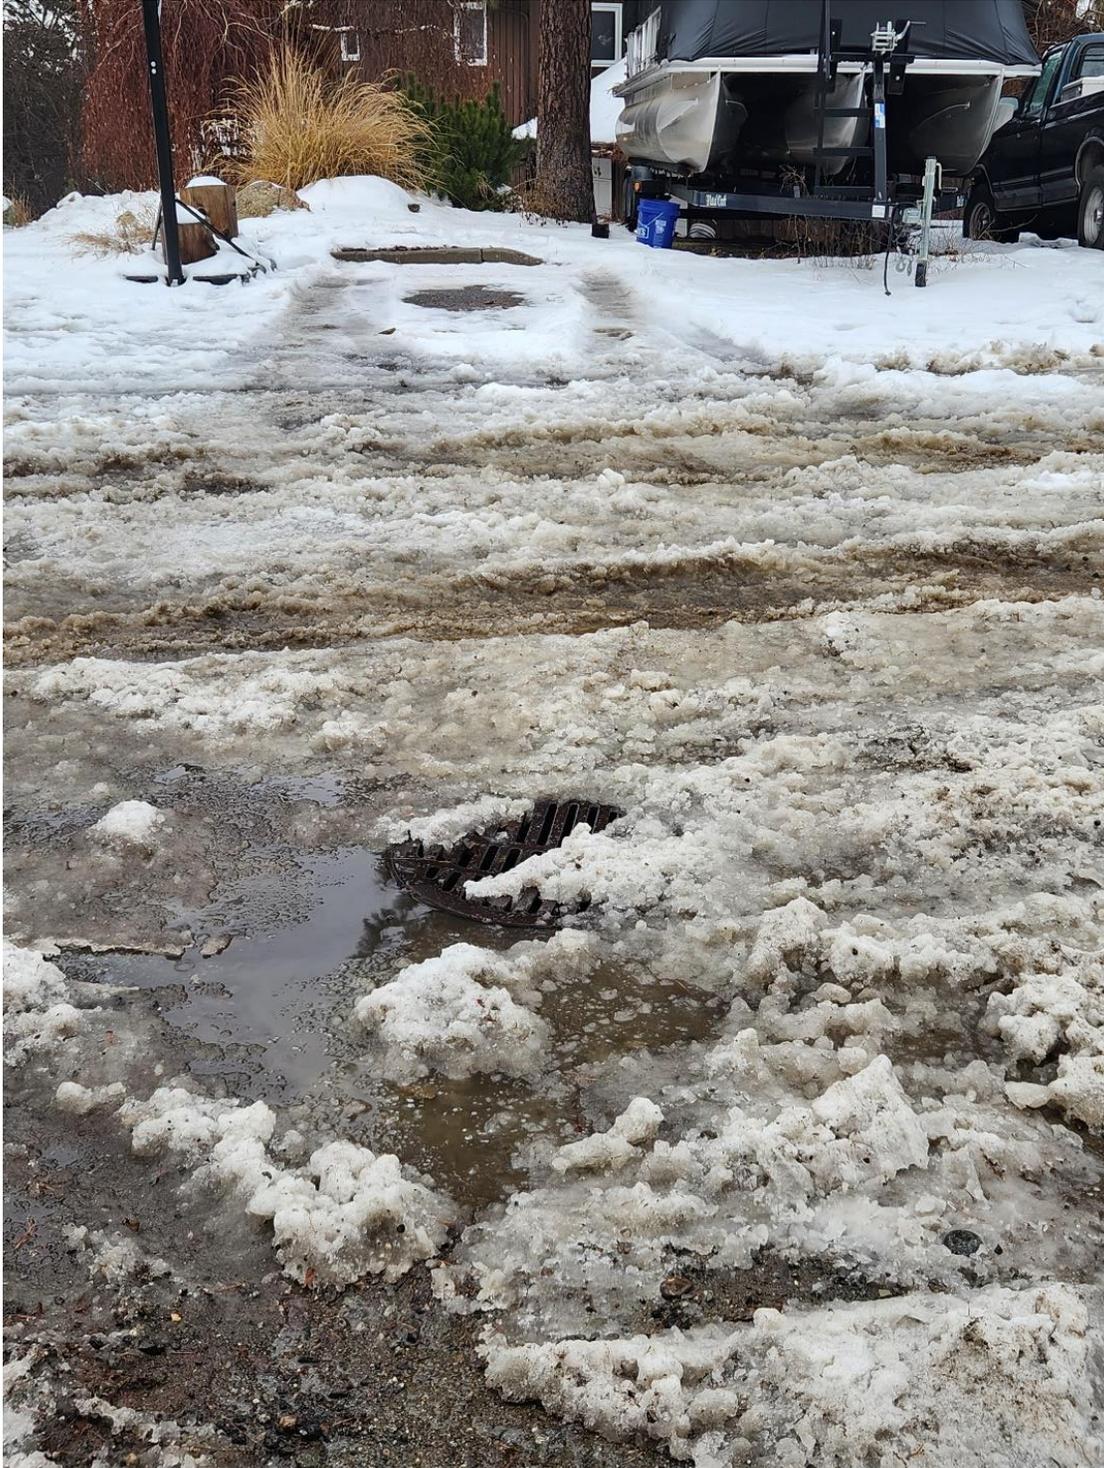
Figure 24: Failing drywell observed in Cameron Court cul-de-sac by Osborn. Photo taken 1/22/2024.

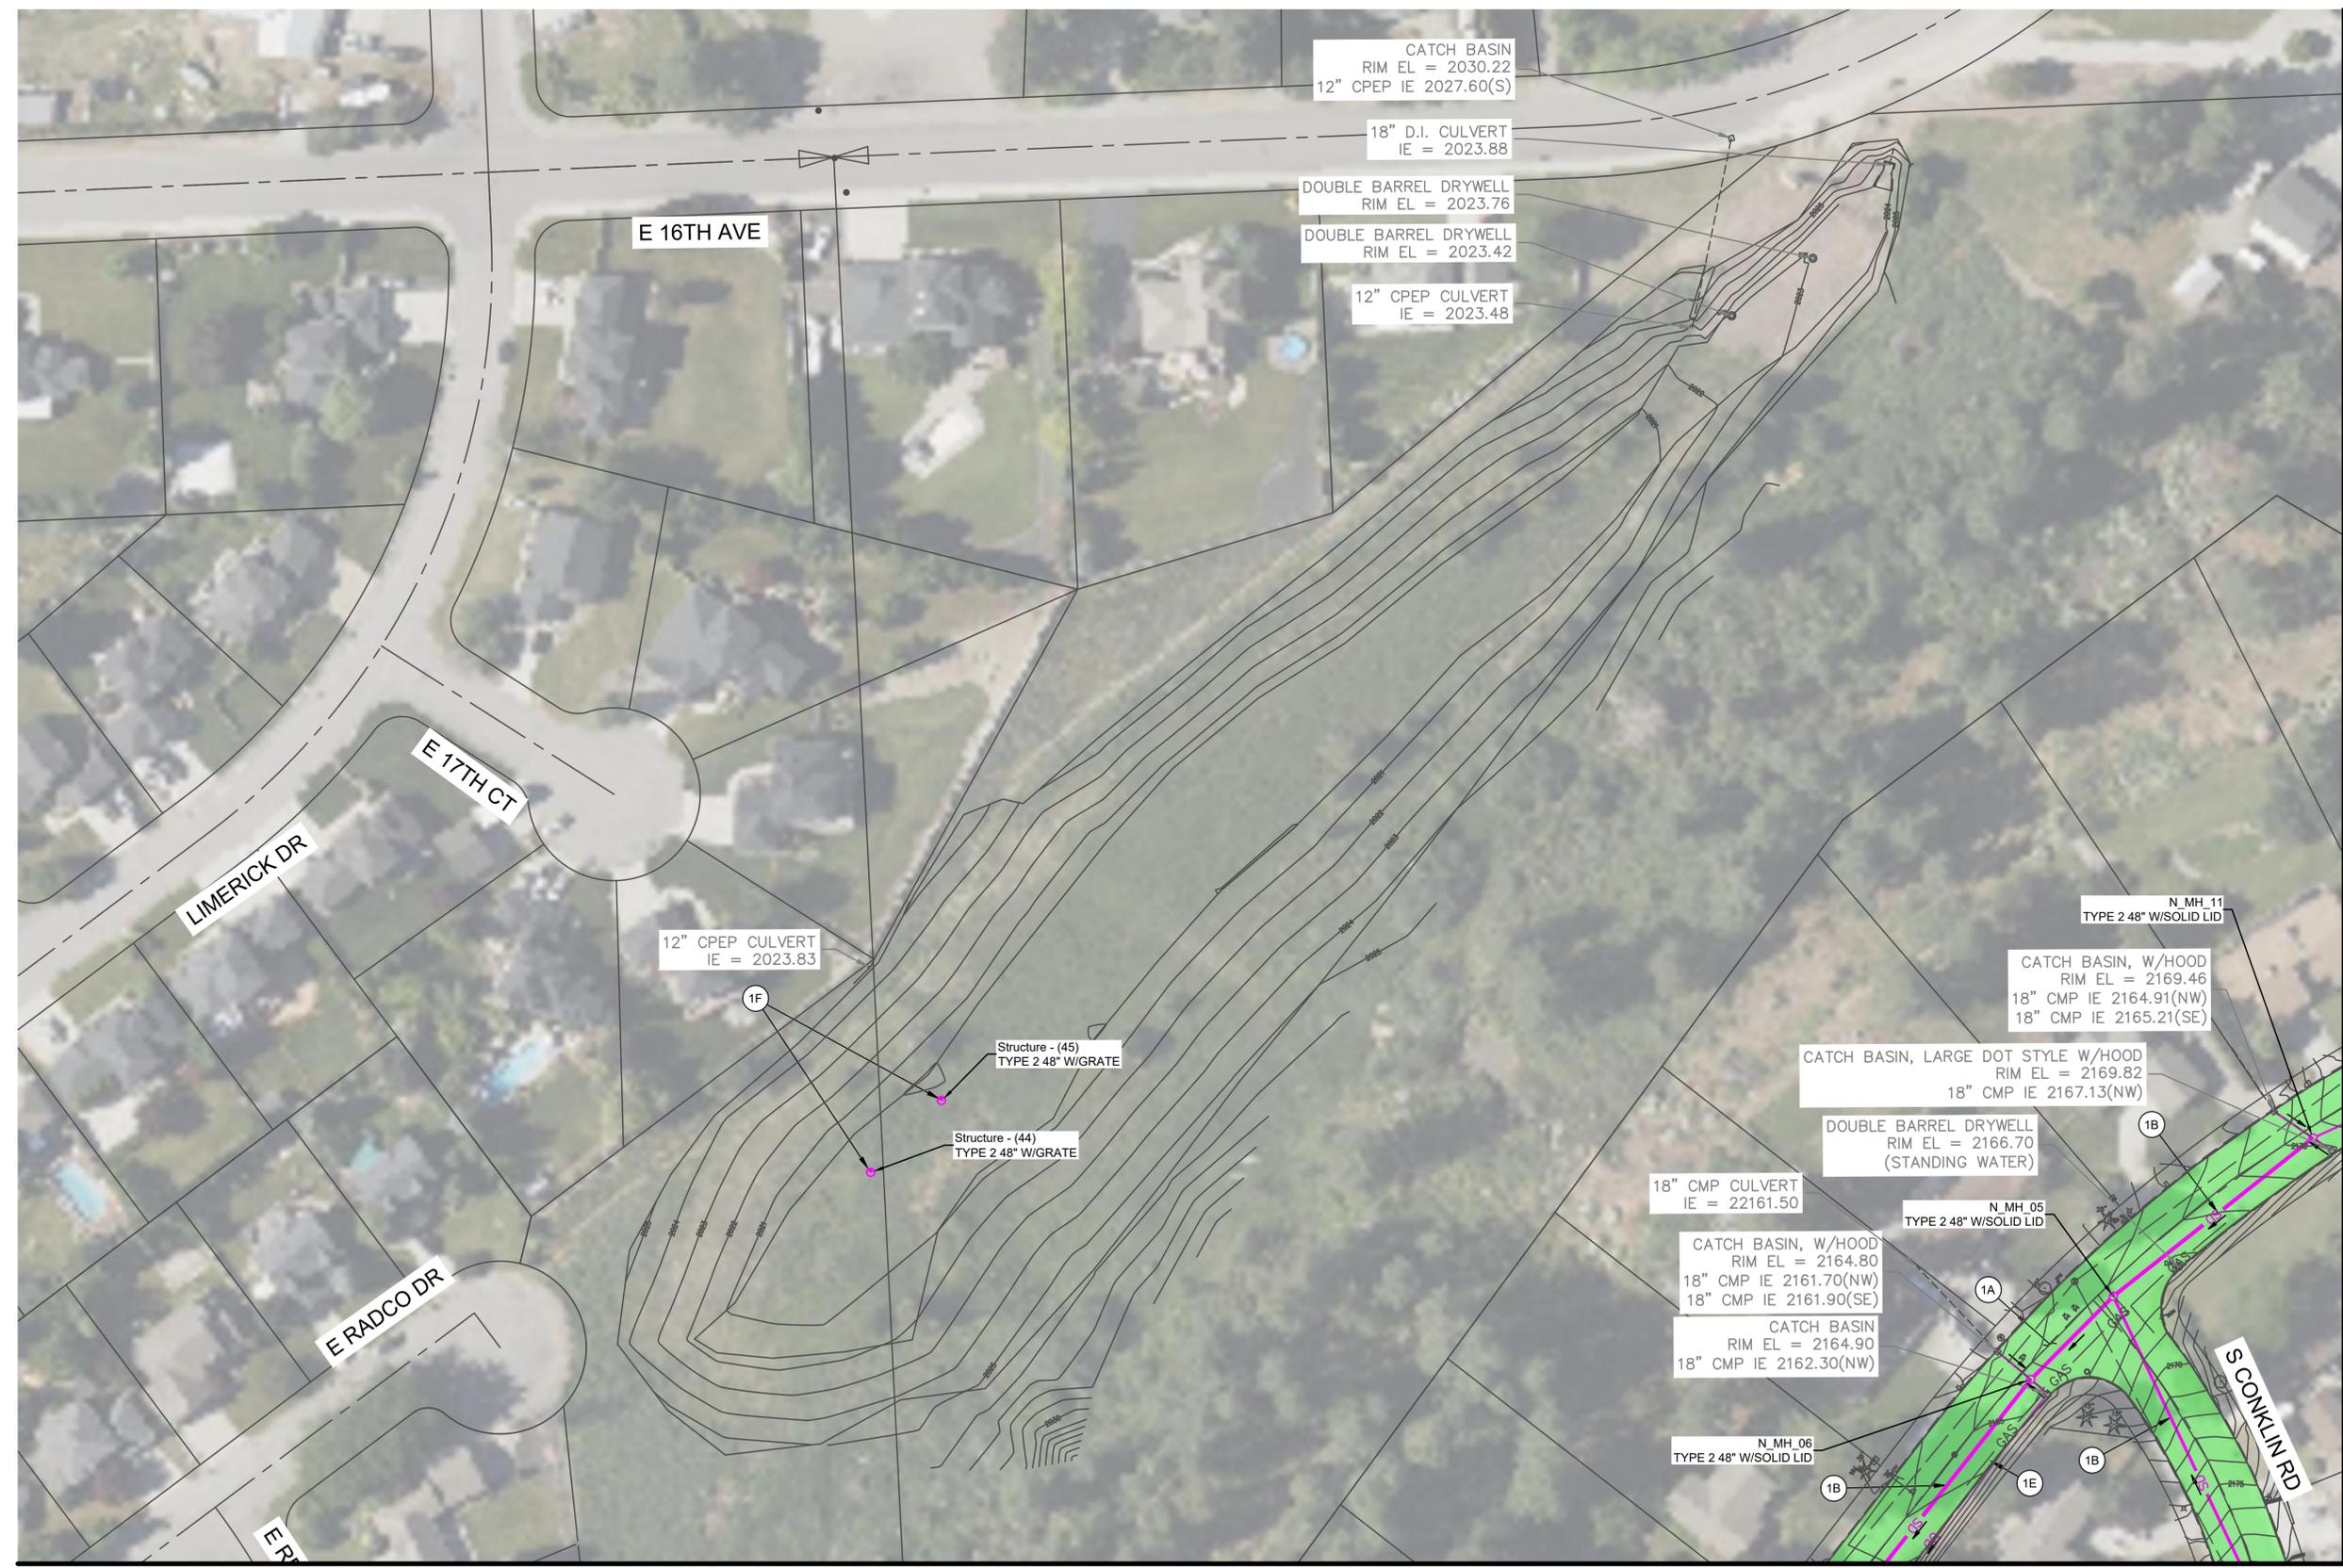
- 1A. ROADWAY PAVING - FULL ASPHALT REPLACEMENT.
- 1B. VERA CREST RD STORM MAIN. INSTALL NEW 12" STORM MAIN WITH 48" TYPE 2 CB STRUCTURES AND CONNECT TO REPLACED MANHOLE STRUCTURES. ABANDON EXISTING OPEN CHANNEL THRU RESIDENTIAL NEIGHBORHOOD. ABANDON EXISTING OUTFALL NORTHWEST OF CONKLIN STORMWATER TO BE ROUTED TO OUTFALL NORTHWEST OF VERA CREST DR & E 20TH CT. EXISTING OUTFALL SOUTHWEST OF CONKLIN RD TO BE ABANDONED. STORMWATER TO BE ROUTED TO OUTFALL NORTHWEST OF VERA CREST DR & E 20TH CT.
- 1E. VERA CREST RD GROUNDWATER COLLECTION. INSTALL UNDERDRAIN ALONG THE NORTHEAST CURB TO CATCH POTENTIAL GROUNDWATER SEE PAGE XXX.
- 1F. INSTALL NEW DRYWELLS AT 16TH AVE AND TO REACH INFILTRATIVE SOILS.

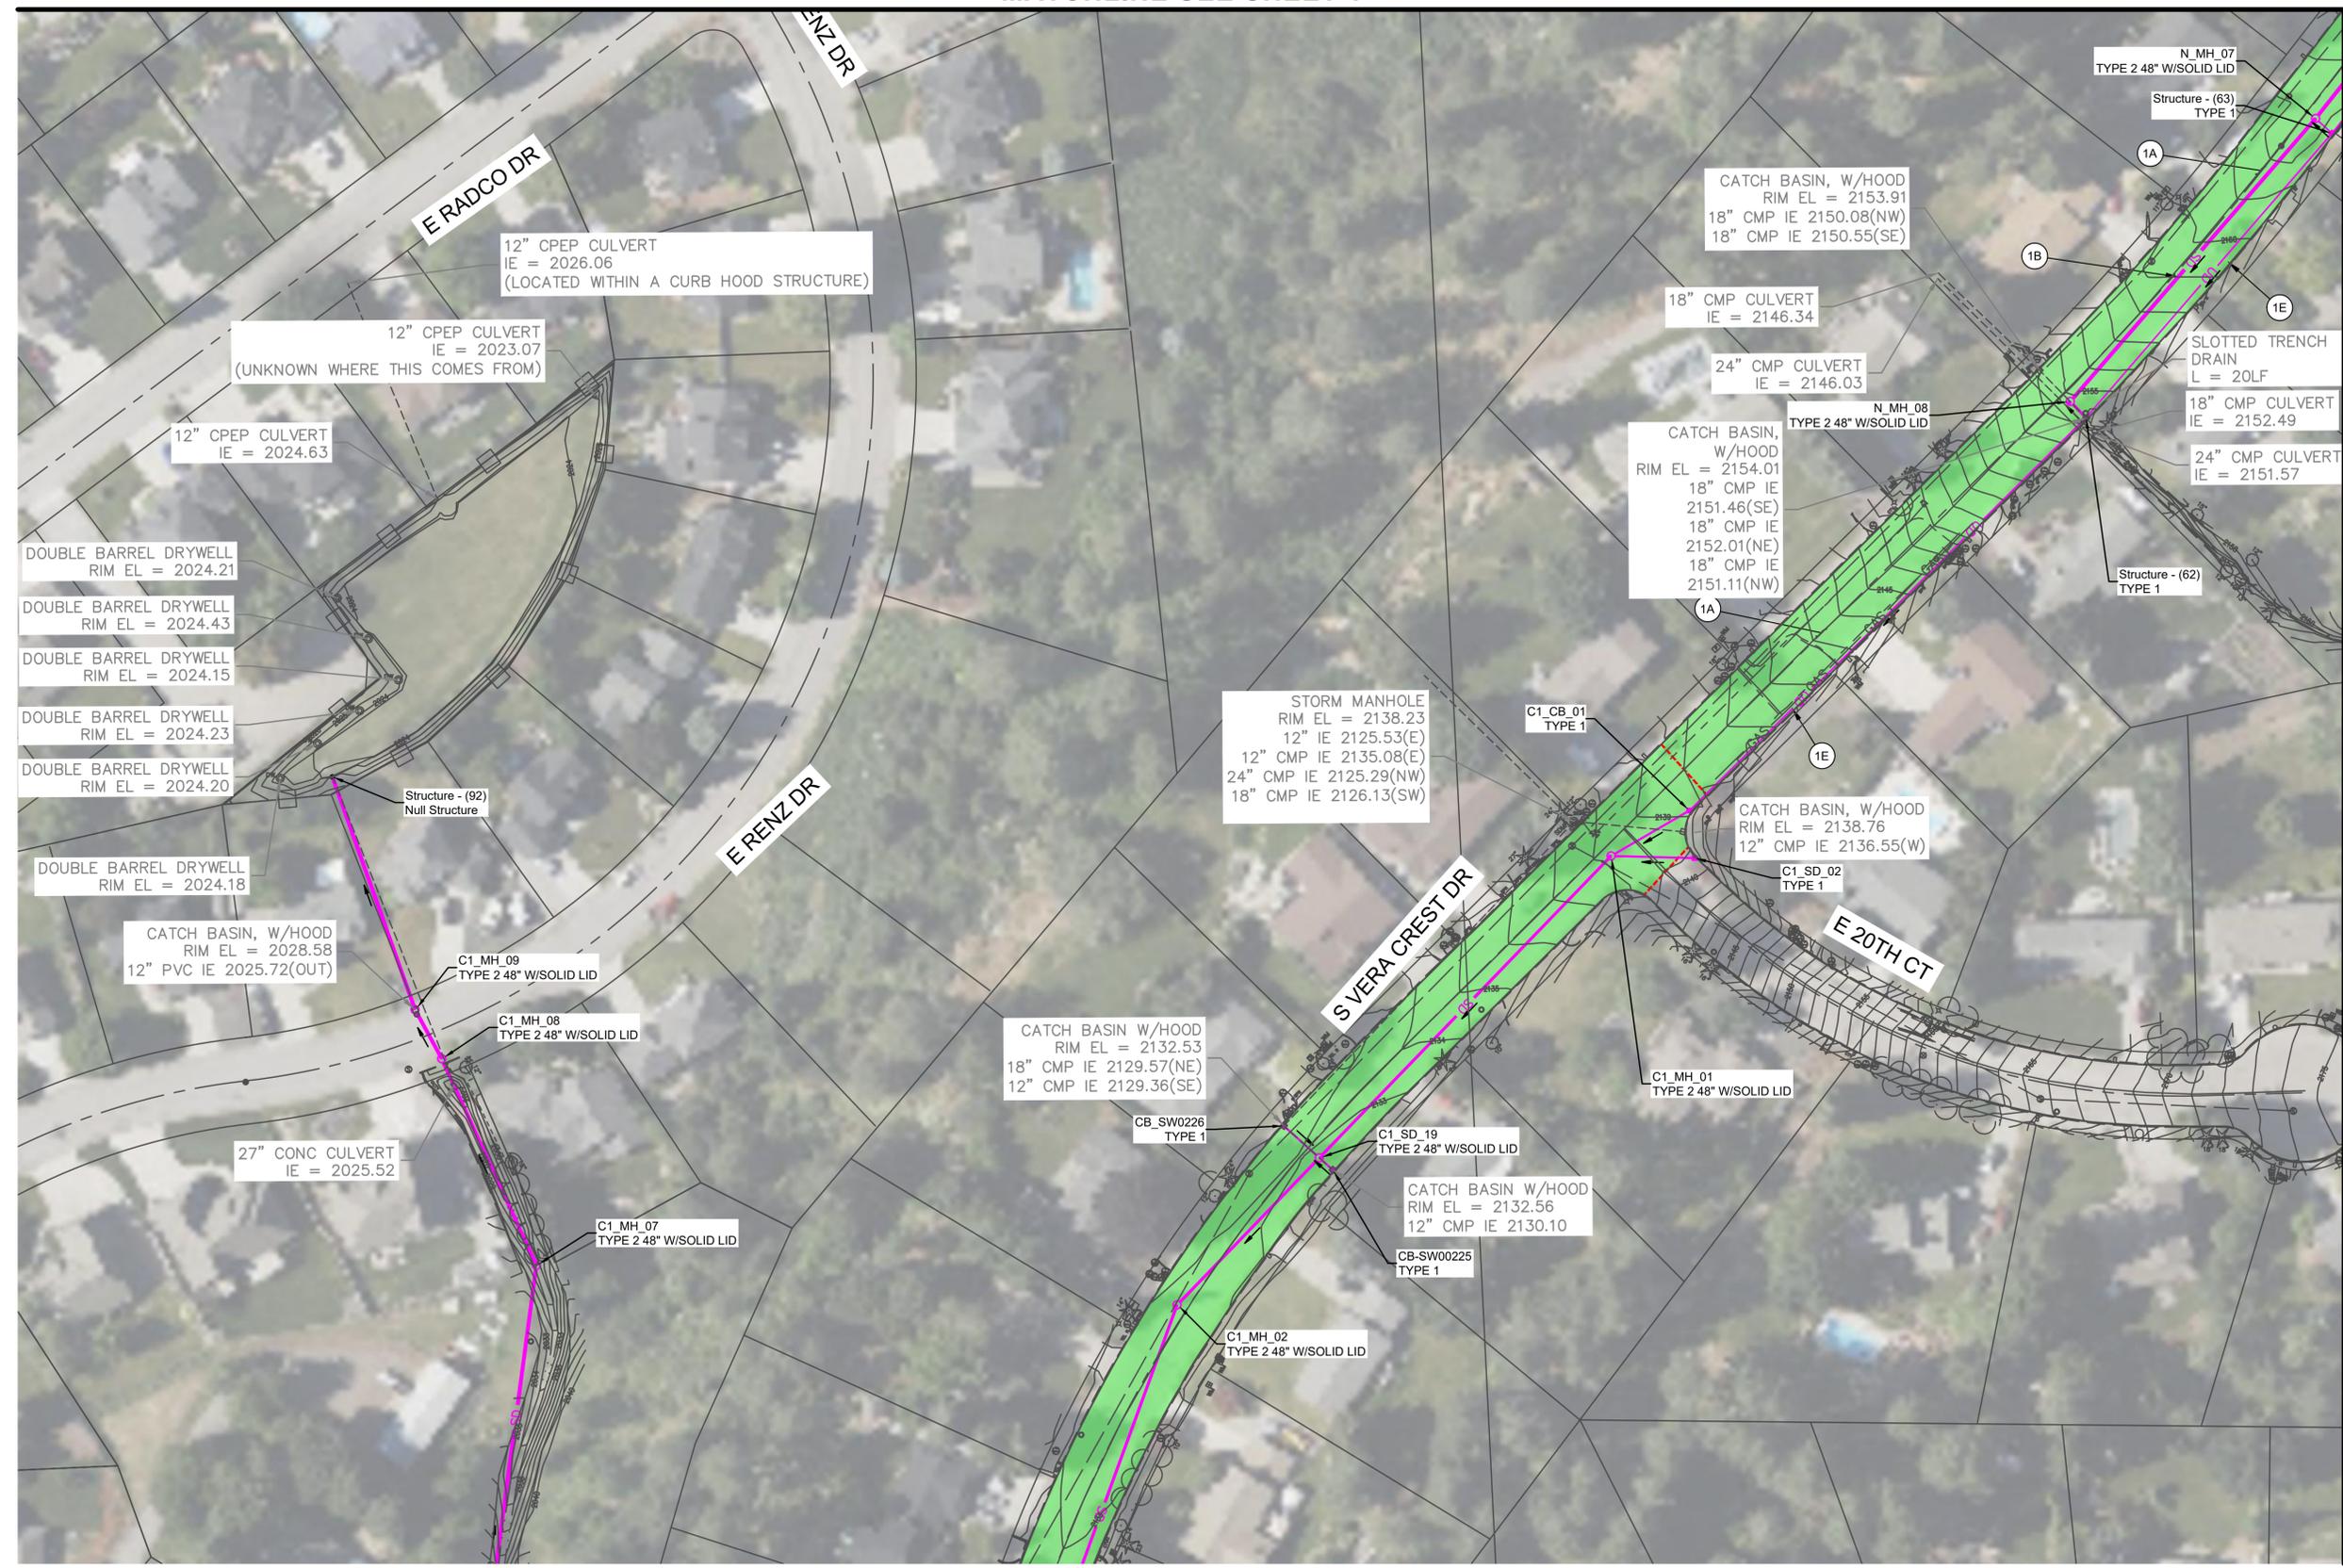
- 1A. ROADWAY PAVING - FULL ASPHALT REPLACEMENT.
- 1B. VERA CREST RD STORM MAIN. INSTALL NEW 12" STORM MAIN WITH 48" TYPE 2 CB STRUCTURES AND CONNECT TO REPLACED MANHOLE STRUCTURES. ABANDON EXISTING OPEN CHANNEL THRU RESIDENTIAL NEIGHBORHOOD. ABANDON EXISTING 12" OUTFALL AT VERA CREST DR & E 20TH CT. EXISTING OUTFALL PIPE NORTHWEST OF VERA CREST DR & E 20TH CT TO BE REPLACED.
- 1E. VERA CREST RD GROUNDWATER COLLECTION. INSTALL UNDERDRAIN ALONG THE NORTHEAST CURB TO CATCH POTENTIAL GROUNDWATER SEE PAGE XXX.

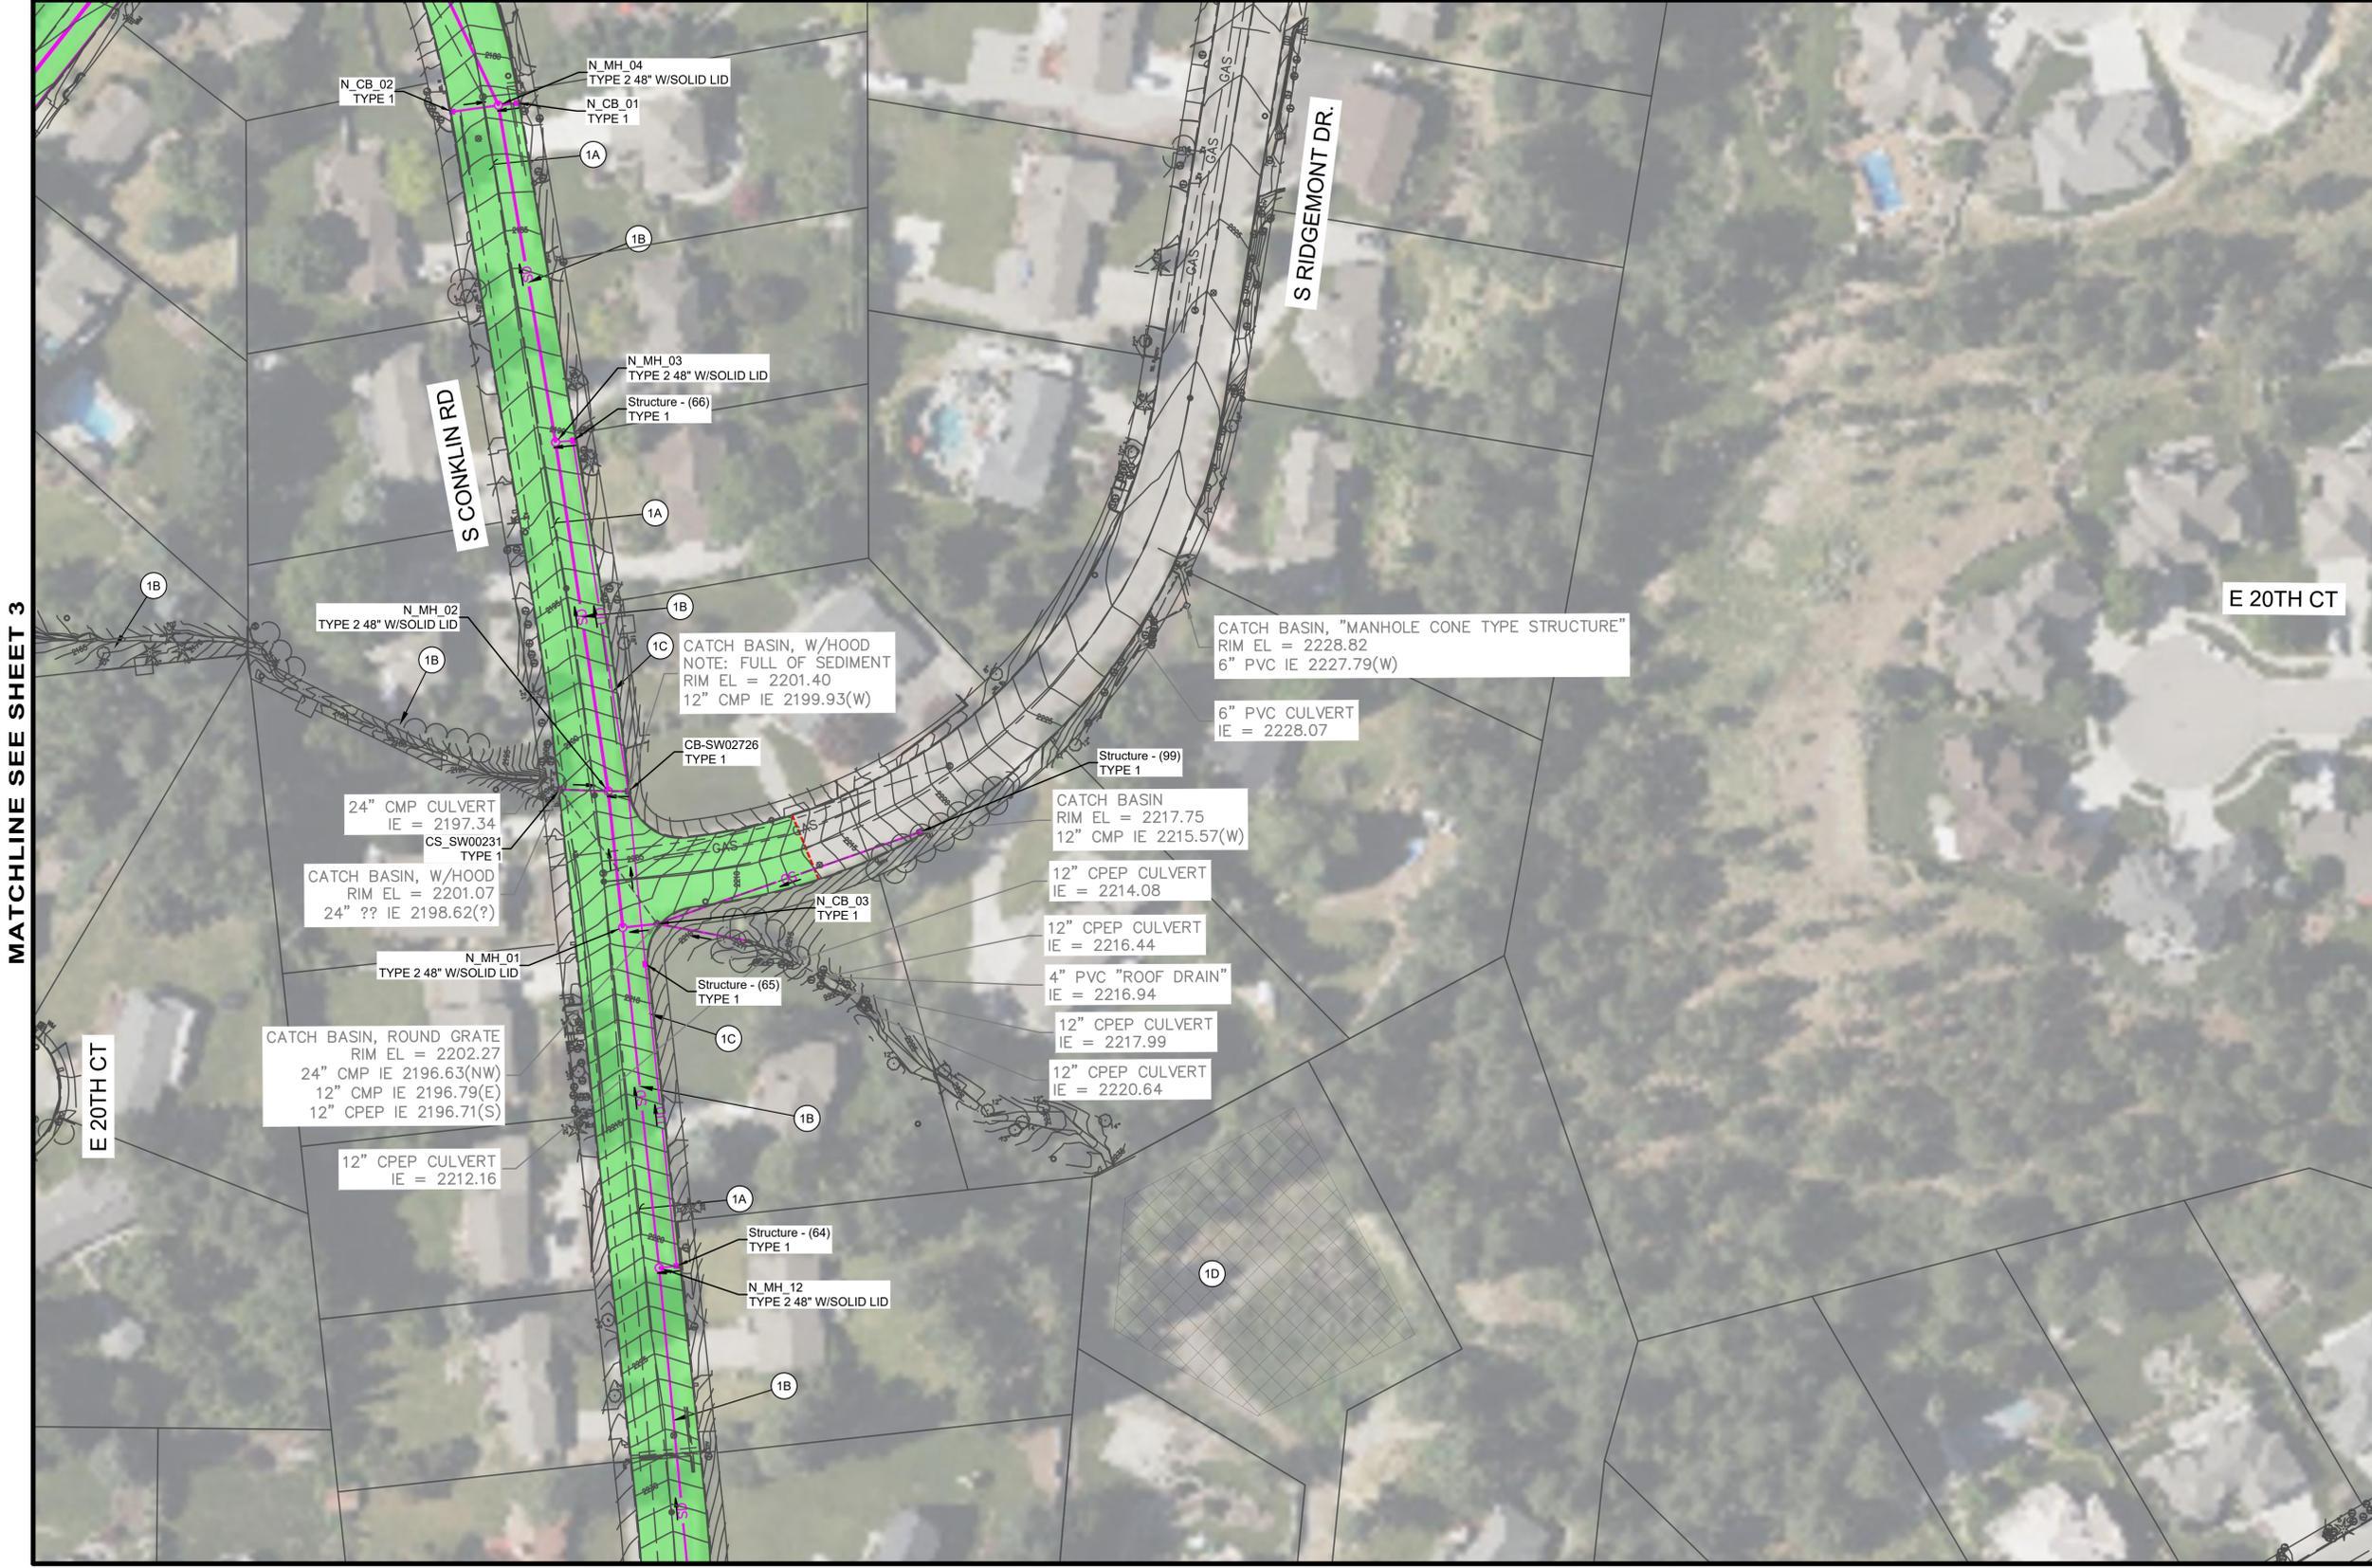
- 1A. ROADWAY PAVING - FULL ASPHALT REPLACEMENT.
- 1B. CONKLIN ROAD STORM MAIN. INSTALL NEW 12" STORM MAIN WITH 48" TYPE 2 CB STRUCTURES AND CONNECT TO REPLACED MANHOLE STRUCTURES. ABANDON EXISTING OPEN CHANNEL THRU RESIDENTIAL NEIGHBORHOOD.
- 1C. CONKLIN GROUNDWATER COLLECTION. INSTALL UNDERDRAIN ALONG THE NORTHEAST CURB TO CATCH POTENTIAL GROUNDWATER SEE PAGE XXX.
- 1D. INSTALL IMPERMEABLE LINER AT EXISTING INFILTRATION POND.

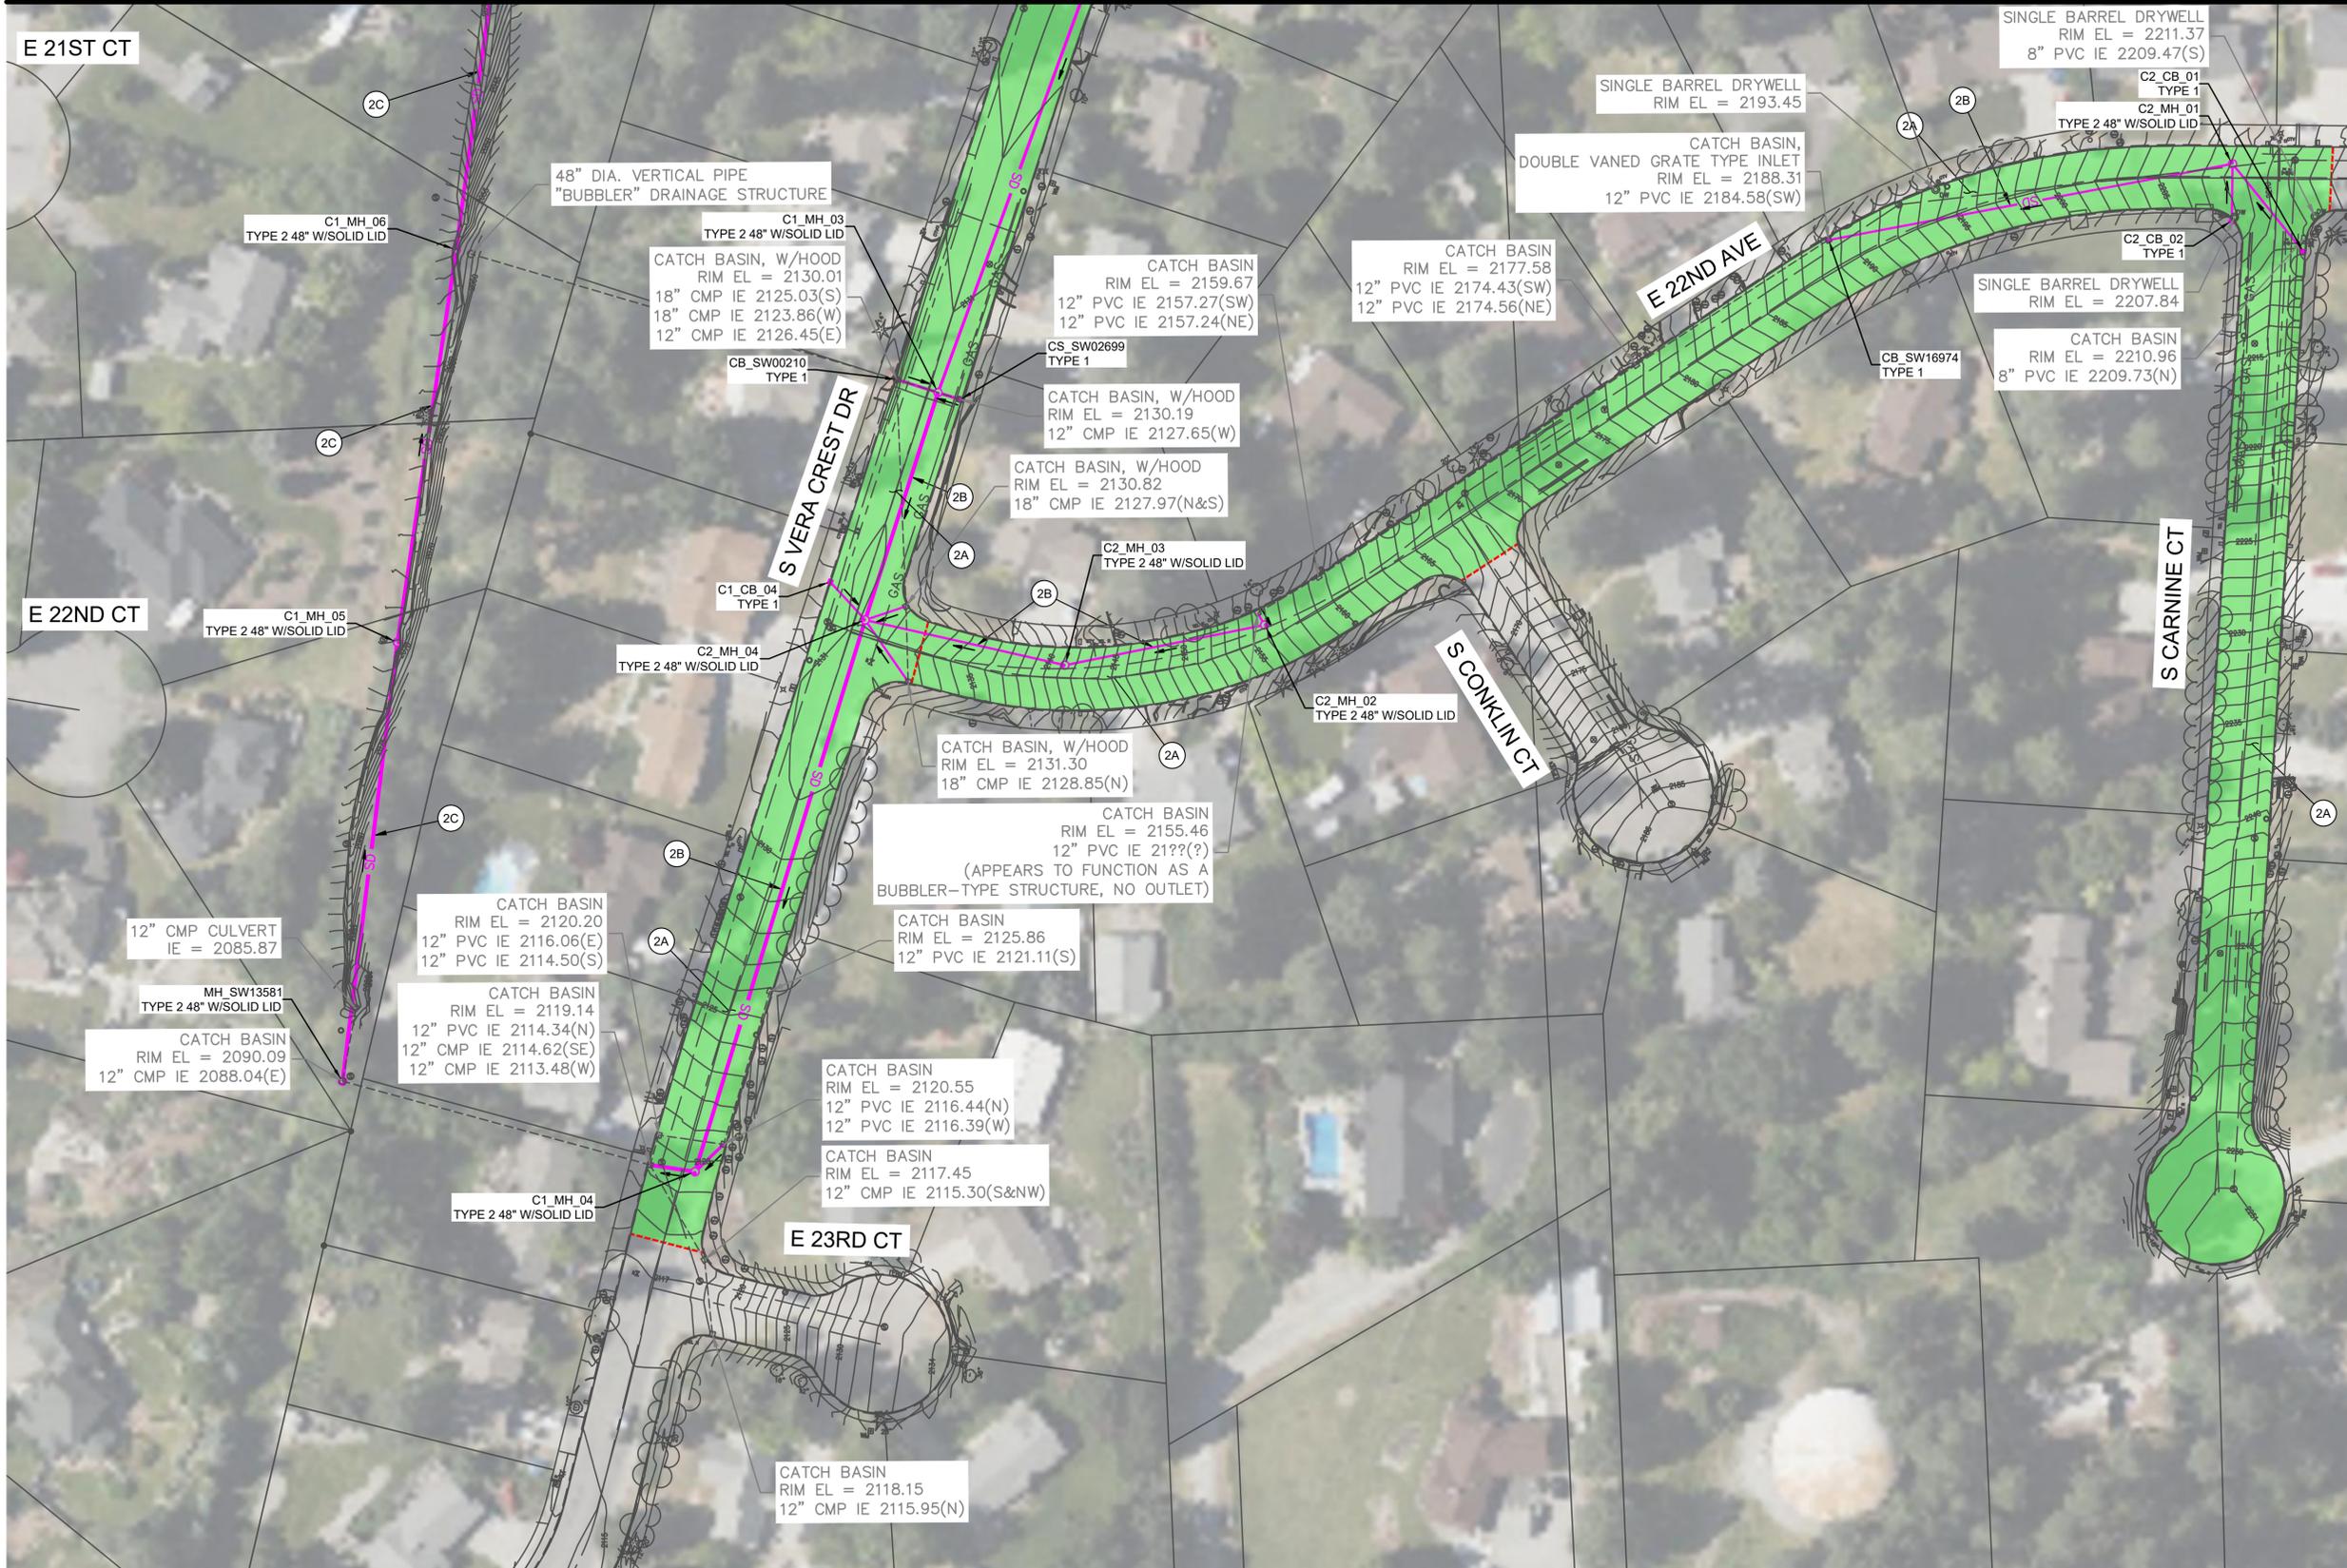
- # **RADCO POND DESIGN**
ALTERNATIVE AREA PRIORITY LIST:
- 2A. ROADWAY PAVING - FULL ASPHALT REPLACEMENT.
 - 2B. VERA CREST RD AND 22ND STORM MAIN. INSTALL NEW 12" STORM MAIN WITH 48" TYPE 2 CB STRUCTURES AND CONNECT TO REPLACED MANHOLE STRUCTURES. EXISTING OUTFALL NORTH OF VERA CREST DR & E 23RD CT. REPLACE DAMAGED 12" CMP PIPE. EXISTING OUTFALL NORTH OF VERA CREST DR & E 22ND AVE. EX 12" CMP PIPE TO REMAIN. SECONDARY OVERFLOW TO BE INSTALLED TO FLOW TO OUTFALL AT VERA CREST DR & E 23RD CT.
 - 2C. TIGHTLINE OPEN CHANNEL. ADD TRENCH WITH DRAIN ROCK TO COLLECT SUBSURFACE DRAINS.
