Supplemental Hydrogeologic and  
Geotechnical Assessment Report

Ridgemont Estates Stormwater Improvements  
Spokane Valley, Washington

File No. 11264-044-01  
December 4, 2025

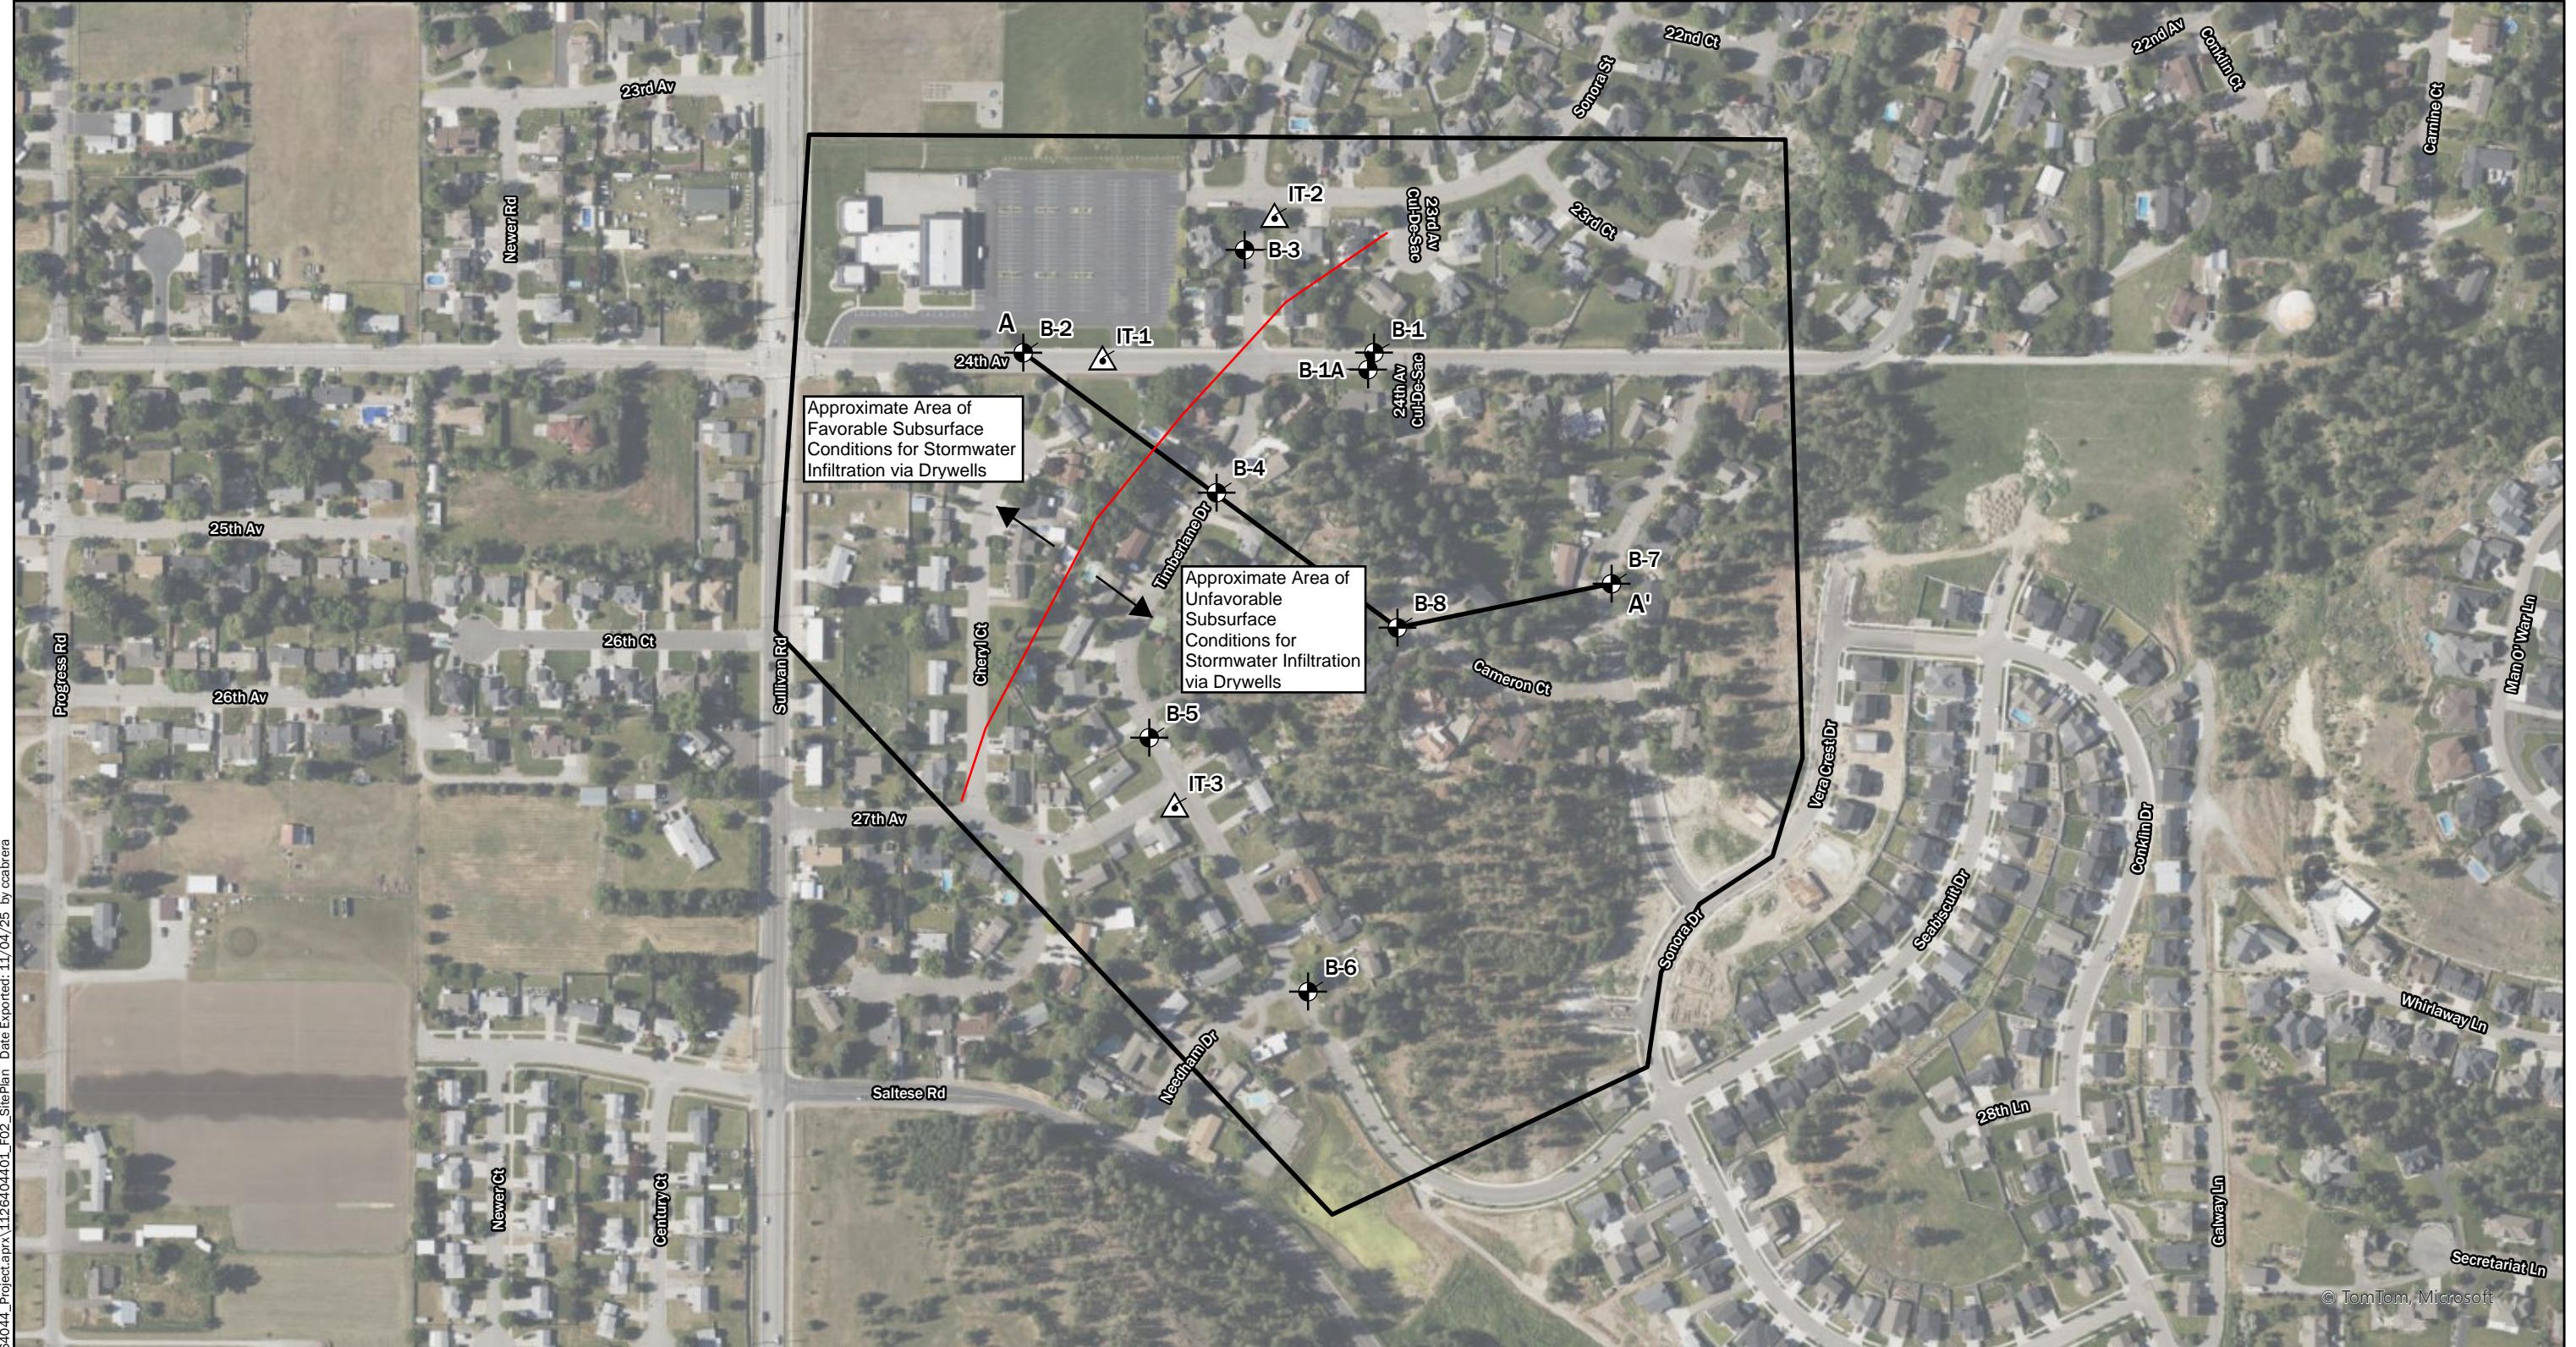
The goal of this supplemental hydrogeologic and geotechnical assessment is to evaluate subsurface conditions, infiltration rates and existing drywell performance within the Project Area and provide updated pavement design criteria based on a more comprehensive traffic dataset provided by the City. Project results will be used to identify and inform stormwater improvement alternatives for consideration by the City. Our supplemental assessment included field exploration, infiltration testing and analysis. The approximate locations of GeoEngineers’ supplemental explorations and other key site features are presented in the Site Plan, Figure 2.

Subsurface soil and groundwater conditions at the Project Area were explored from September 25 to 28, 2025. Subsurface explorations included drilling nine borings (B-1, B-1A, and B-2 through B-8) at the approximate locations shown in the Site Plan, Figure 2.

From a stormwater infiltration perspective, project results indicate that the project area can be broadly divided into two regions, approximately separated by the red line shown in Figure 2. Northwest of the line, subsurface conditions are generally characterized by relatively coarse-grained glaciofluvial sediments and a relatively thick unsaturated zone. These conditions generally are conducive to subsurface infiltration using drywells, as indicated by drywell testing results at IT-1 and IT-2. Southeast of the line shown in Figure 2, subsurface conditions are generally characterized by a combination of shallow bedrock, shallow fine-grained sediment, and/or shallow groundwater. These conditions generally are not conducive to subsurface infiltration using drywells, as indicated by drywell testing results at IT-3.

It is important to understand, however, that the red dividing line shown in Figure 2 is approximate and appropriate for regional planning purposes only. Subsurface conditions and potential drywell performance should be confirmed through exploration and testing prior to design and/or construction of specific stormwater infiltration facilities.

The red dividing line shown in Figure 2 suggests that a large portion of the Project Area (to the southeast of the line) might not be conducive to drywell-based stormwater infiltration. In this portion of the Project Area, the City could consider conveying stormwater to the northwest for infiltration within the area underlain by a thick sequence of relatively coarse-grained glaciofluvial deposits. This could be accomplished, for example, by siting multiple, relatively closely spaced drywells in an appropriate location northwest of the dividing line. If the City pursues this approach, we recommend that the suitability of the potential infiltration location be evaluated through the following:

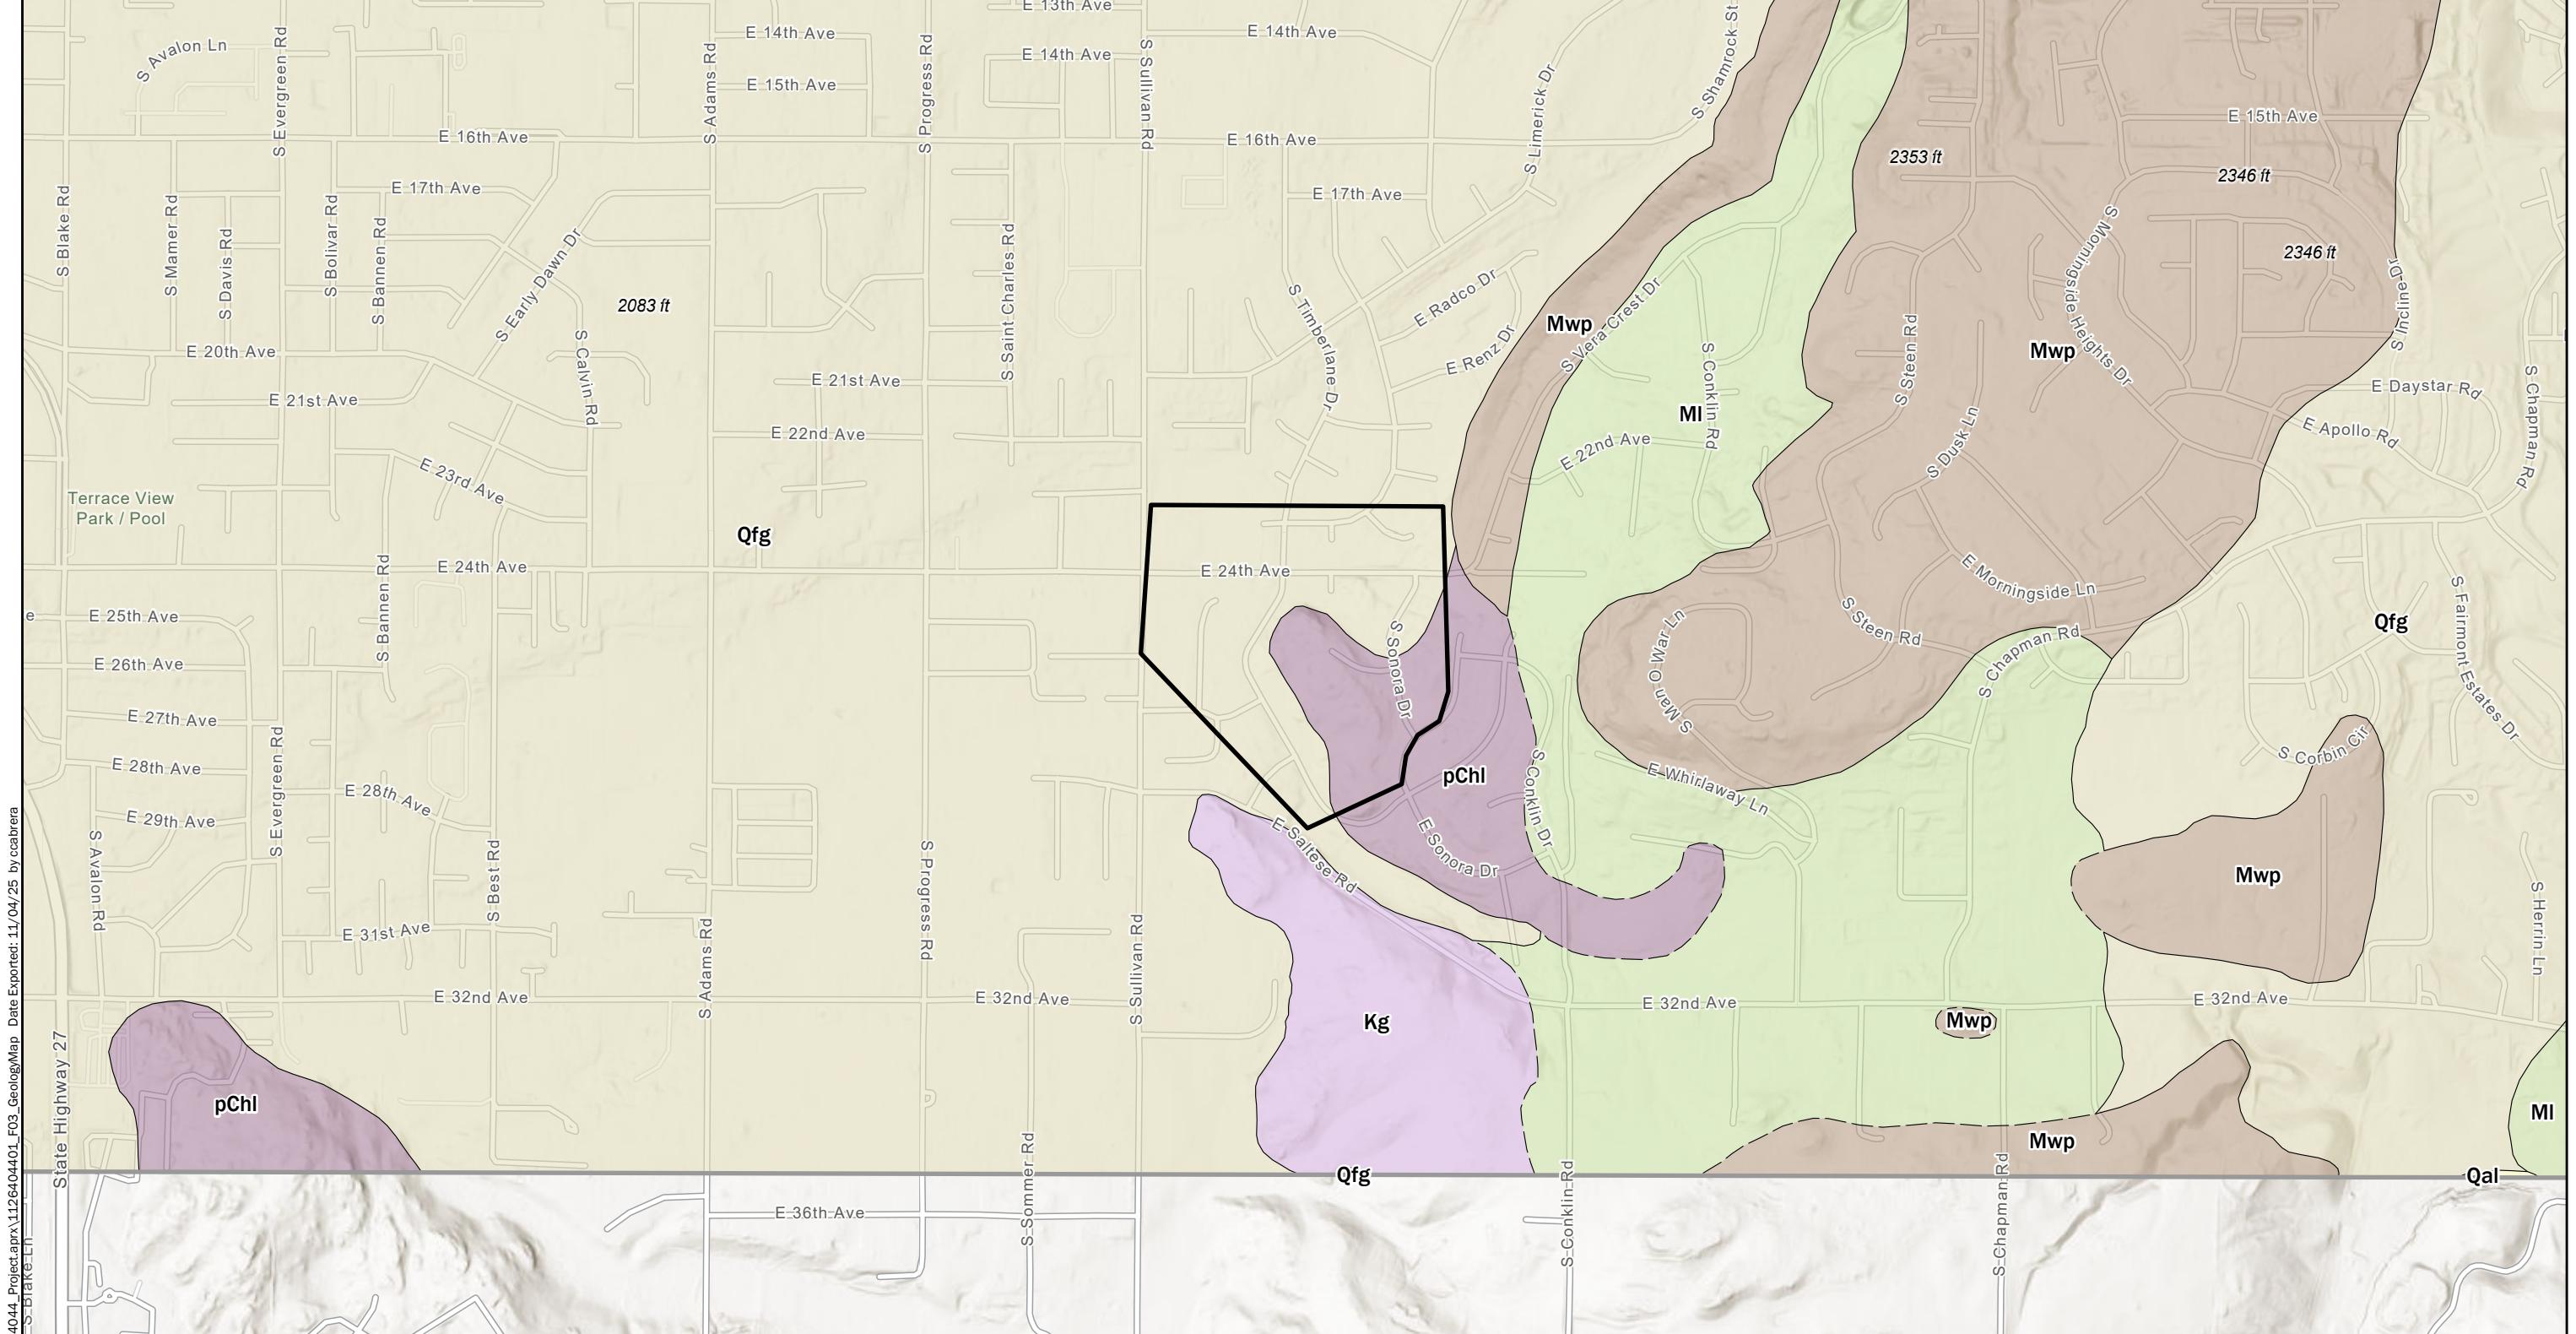
Figure 3

Spokane Valley is situated within the northeast portion of the Columbia Plateau physiographic province. The existing topography of the area developed during the Pleistocene Epoch (about 2.6 million years [Ma] to 11,700 years ago) and the Holocene Epoch (about 11,700 years ago to present). In the Pleistocene, a sequence of catastrophic flood events, generated by the failure of ice dams in western Montana and northern Idaho, deposited hundreds of feet of highly permeable sediments within the Spokane River valley. Along valley flanks, the floods stripped away overlying sediments, leaving erosional features in the underlying basalt surface (Whiteman et al., 1994) and exposing underlying Miocene age (16 to 11.6 Ma) sedimentary rocks such as the Latah Formation and Precambrian age (542 Ma and older) basement rock such as the Hauser Lake Gneiss. More recent stream erosion and alluvium deposition have slightly modified this landscape. GeoEngineers (2025) provides a detailed description of geologic and hydrogeologic units underlying the Project Area. Surficial geologic conditions underlying the Project Area are outlined in the Surficial Geology Map, Figure 3.

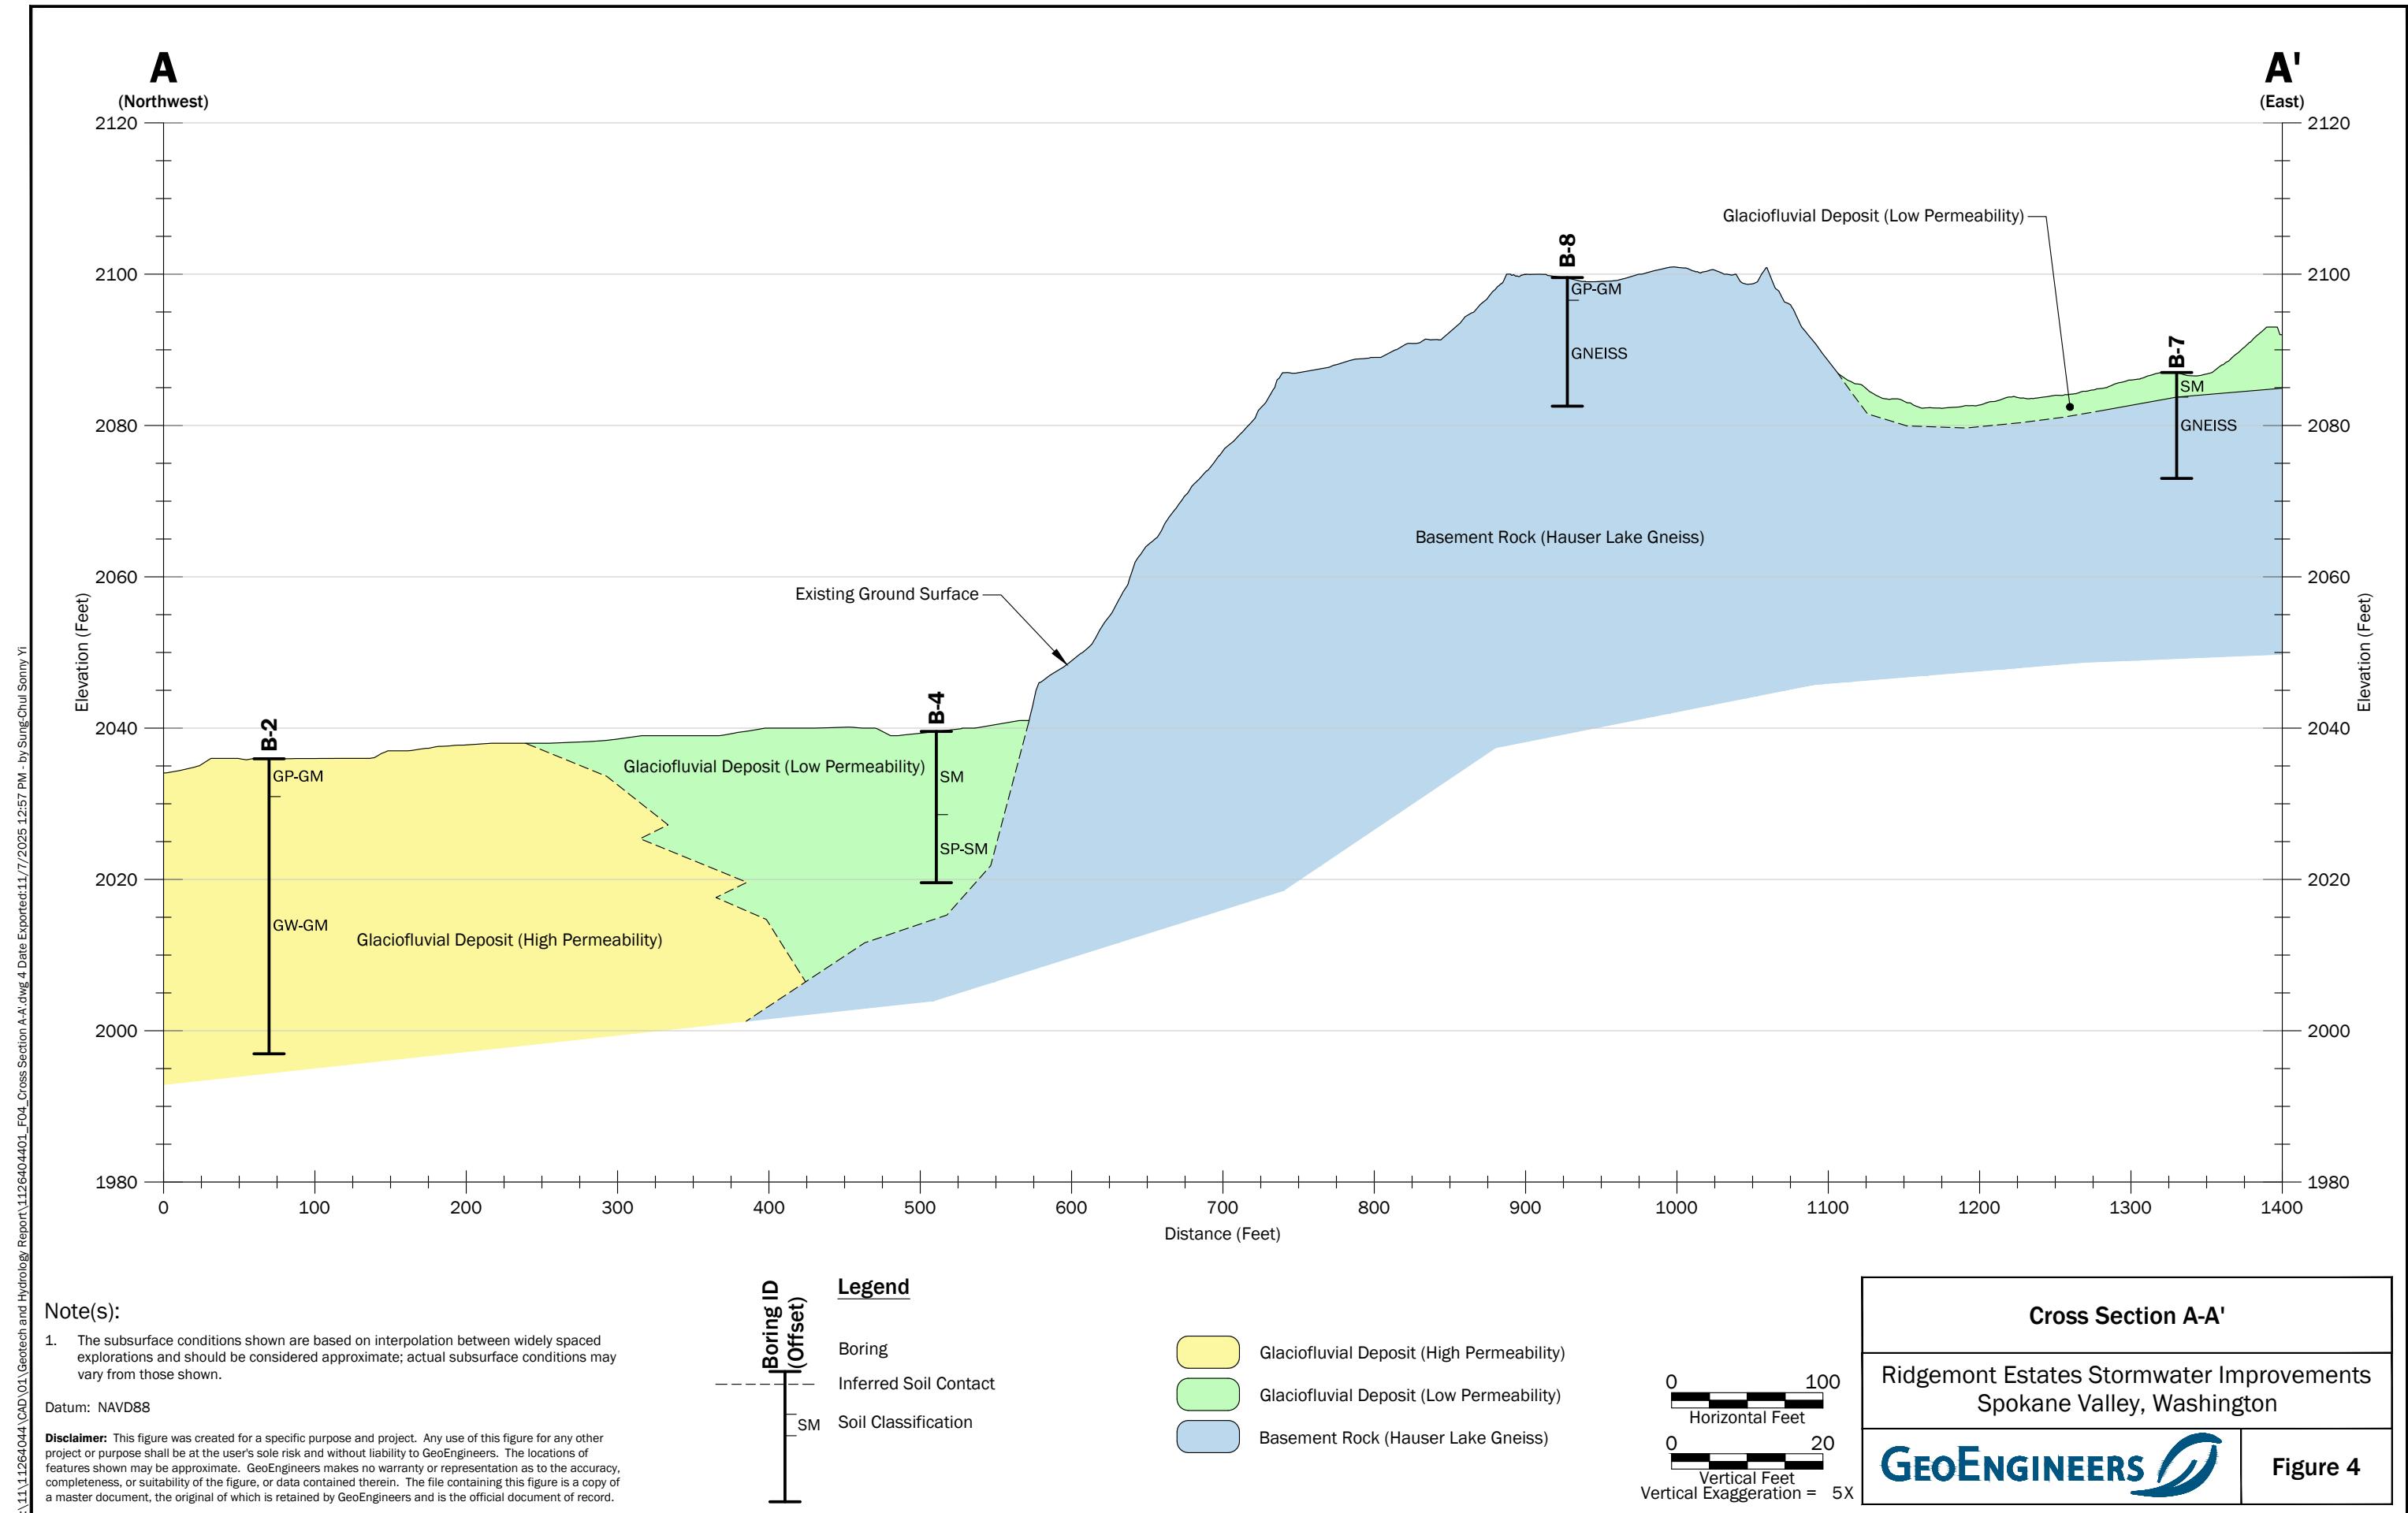
Shallow subsurface soil and rock conditions within the Project Area are composed of a complex sequence of coarse- and fine-grained glacial deposits and basement rock, as shown in Cross Section A-A', Figure 4 (cross section transect is shown in Figure 2). Observed subsurface conditions generally consisted of the following:

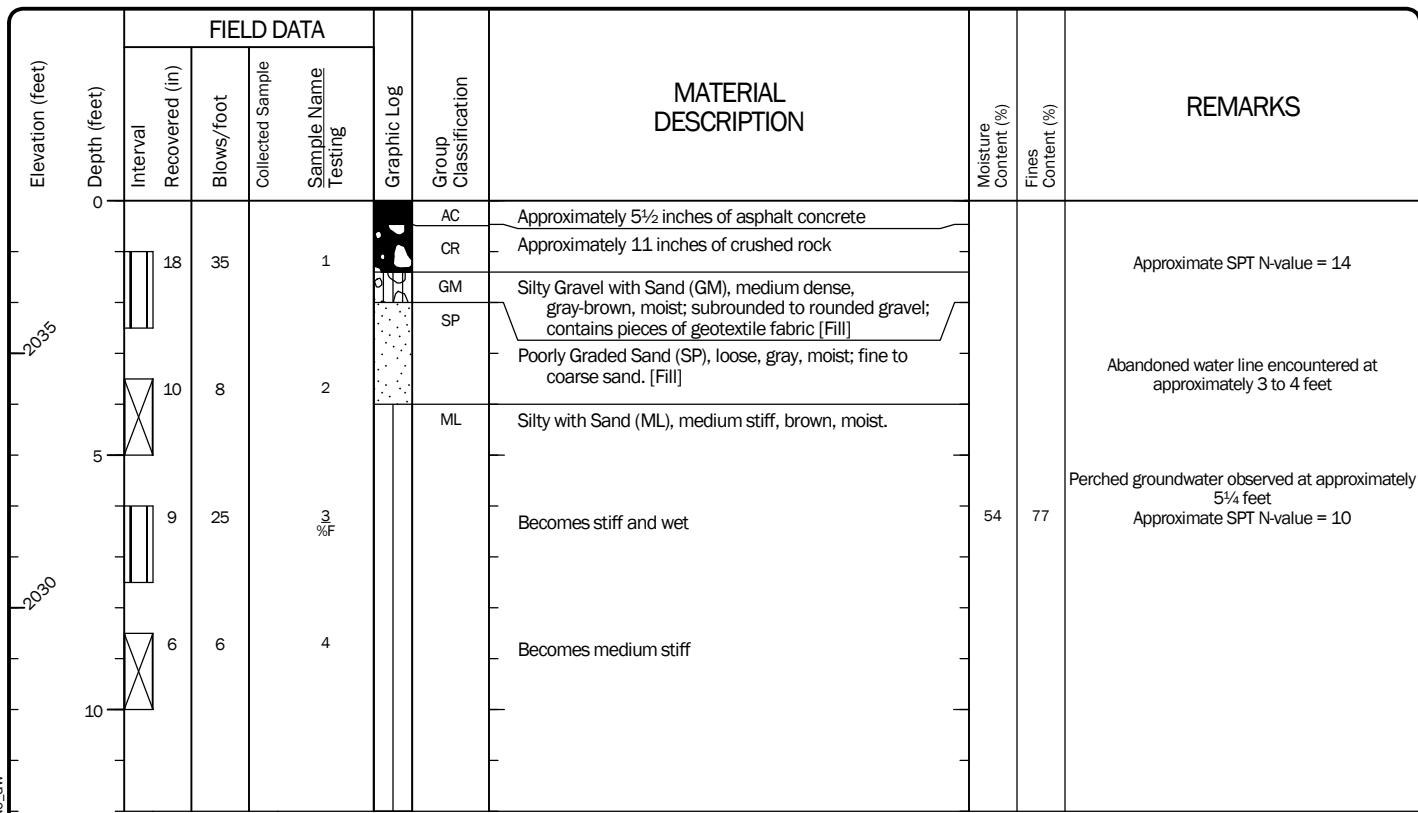
Drilled	Start 8/25/2025	End 8/25/2025	Total Depth (ft) 12	Logged By AMN Checked By BKH	Driller GeoEngineers, Inc.	Drilling Method	Hollow-stem Auger
Surface Elevation (ft) Vertical Datum	2038 NAVD88	Hammer Data	Autohammer 140 (lbs) / 30 (in) Drop	Drilling Equipment	Truck-mounted CME 75		
Easting (X) Northing (Y)	2537810 252914	System Datum	WA State Plane North NAD83 (feet)	See "Remarks" section for groundwater observed

Boring completed at approximately 12 feet due to auger deflection

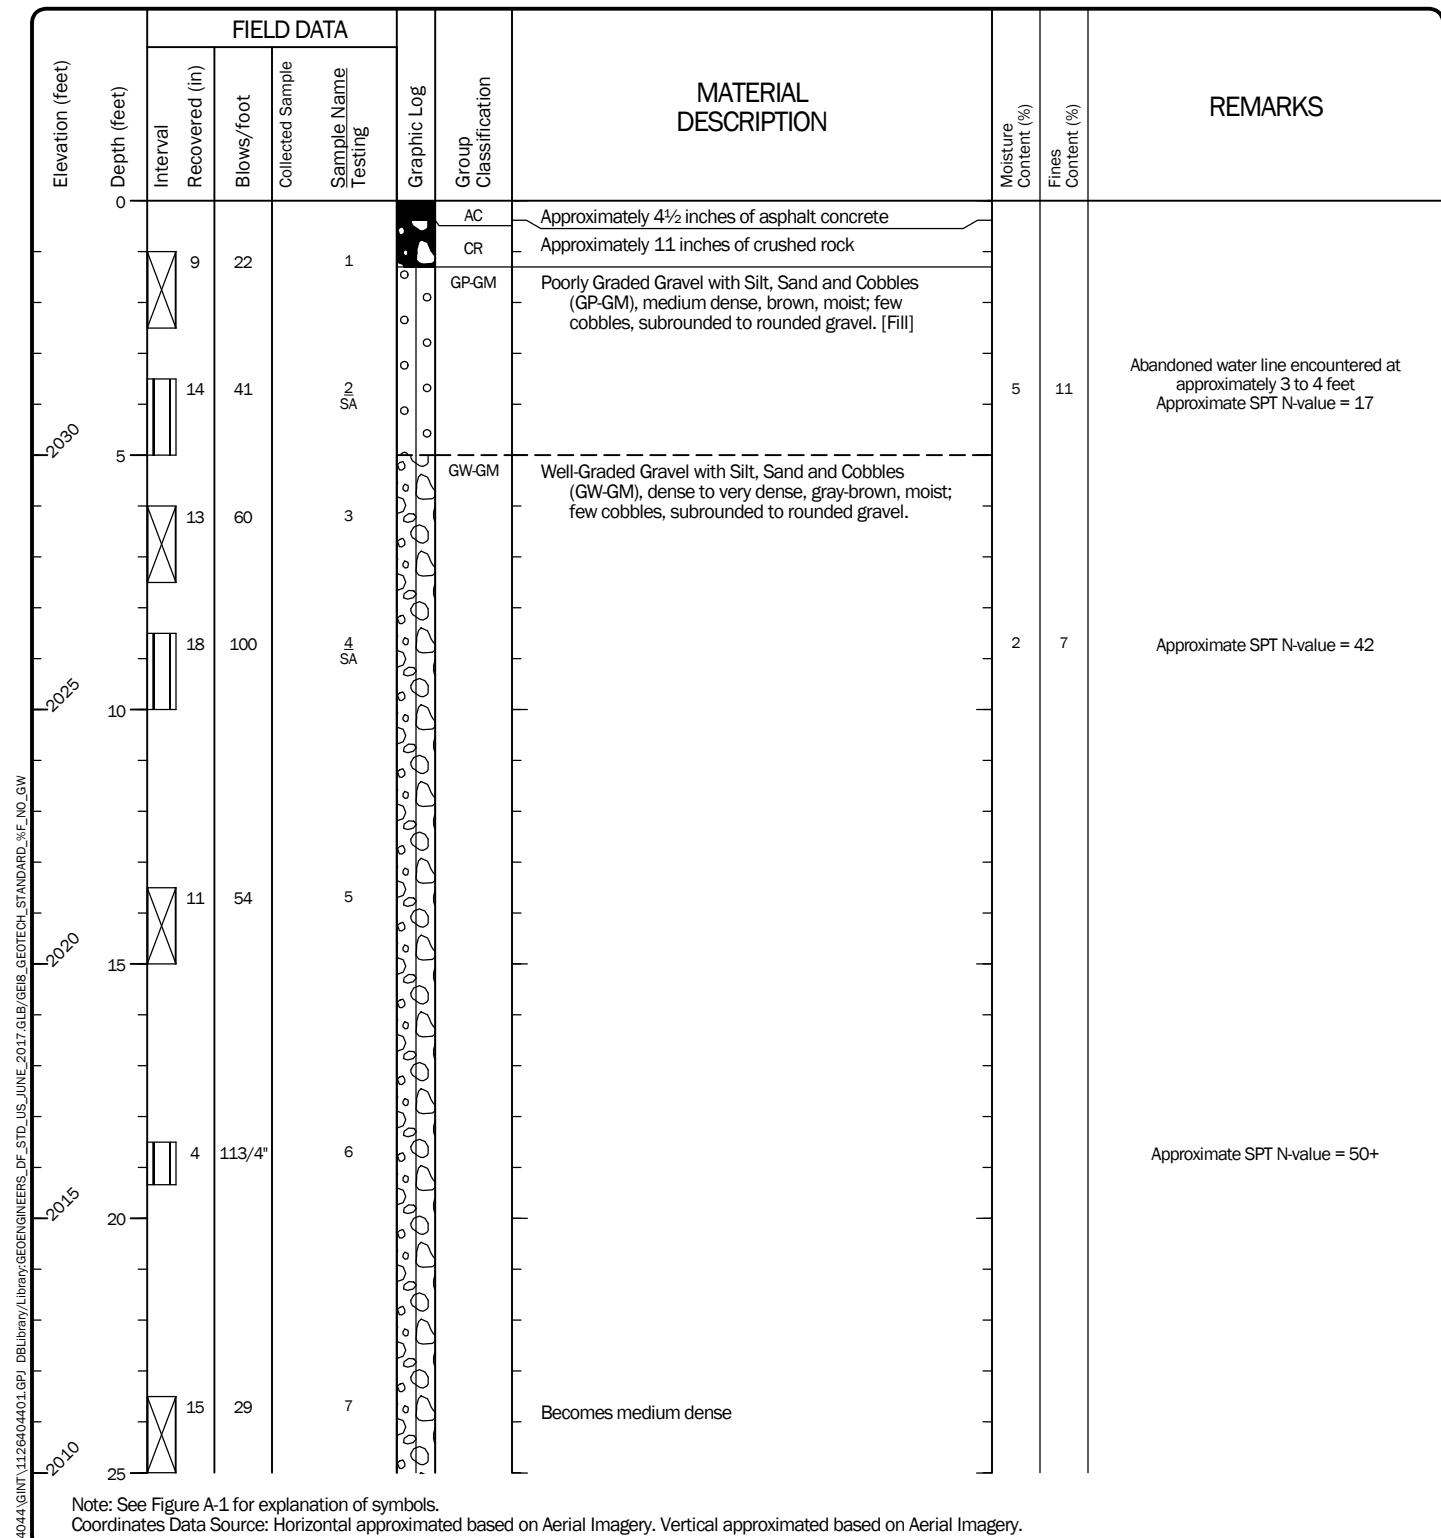
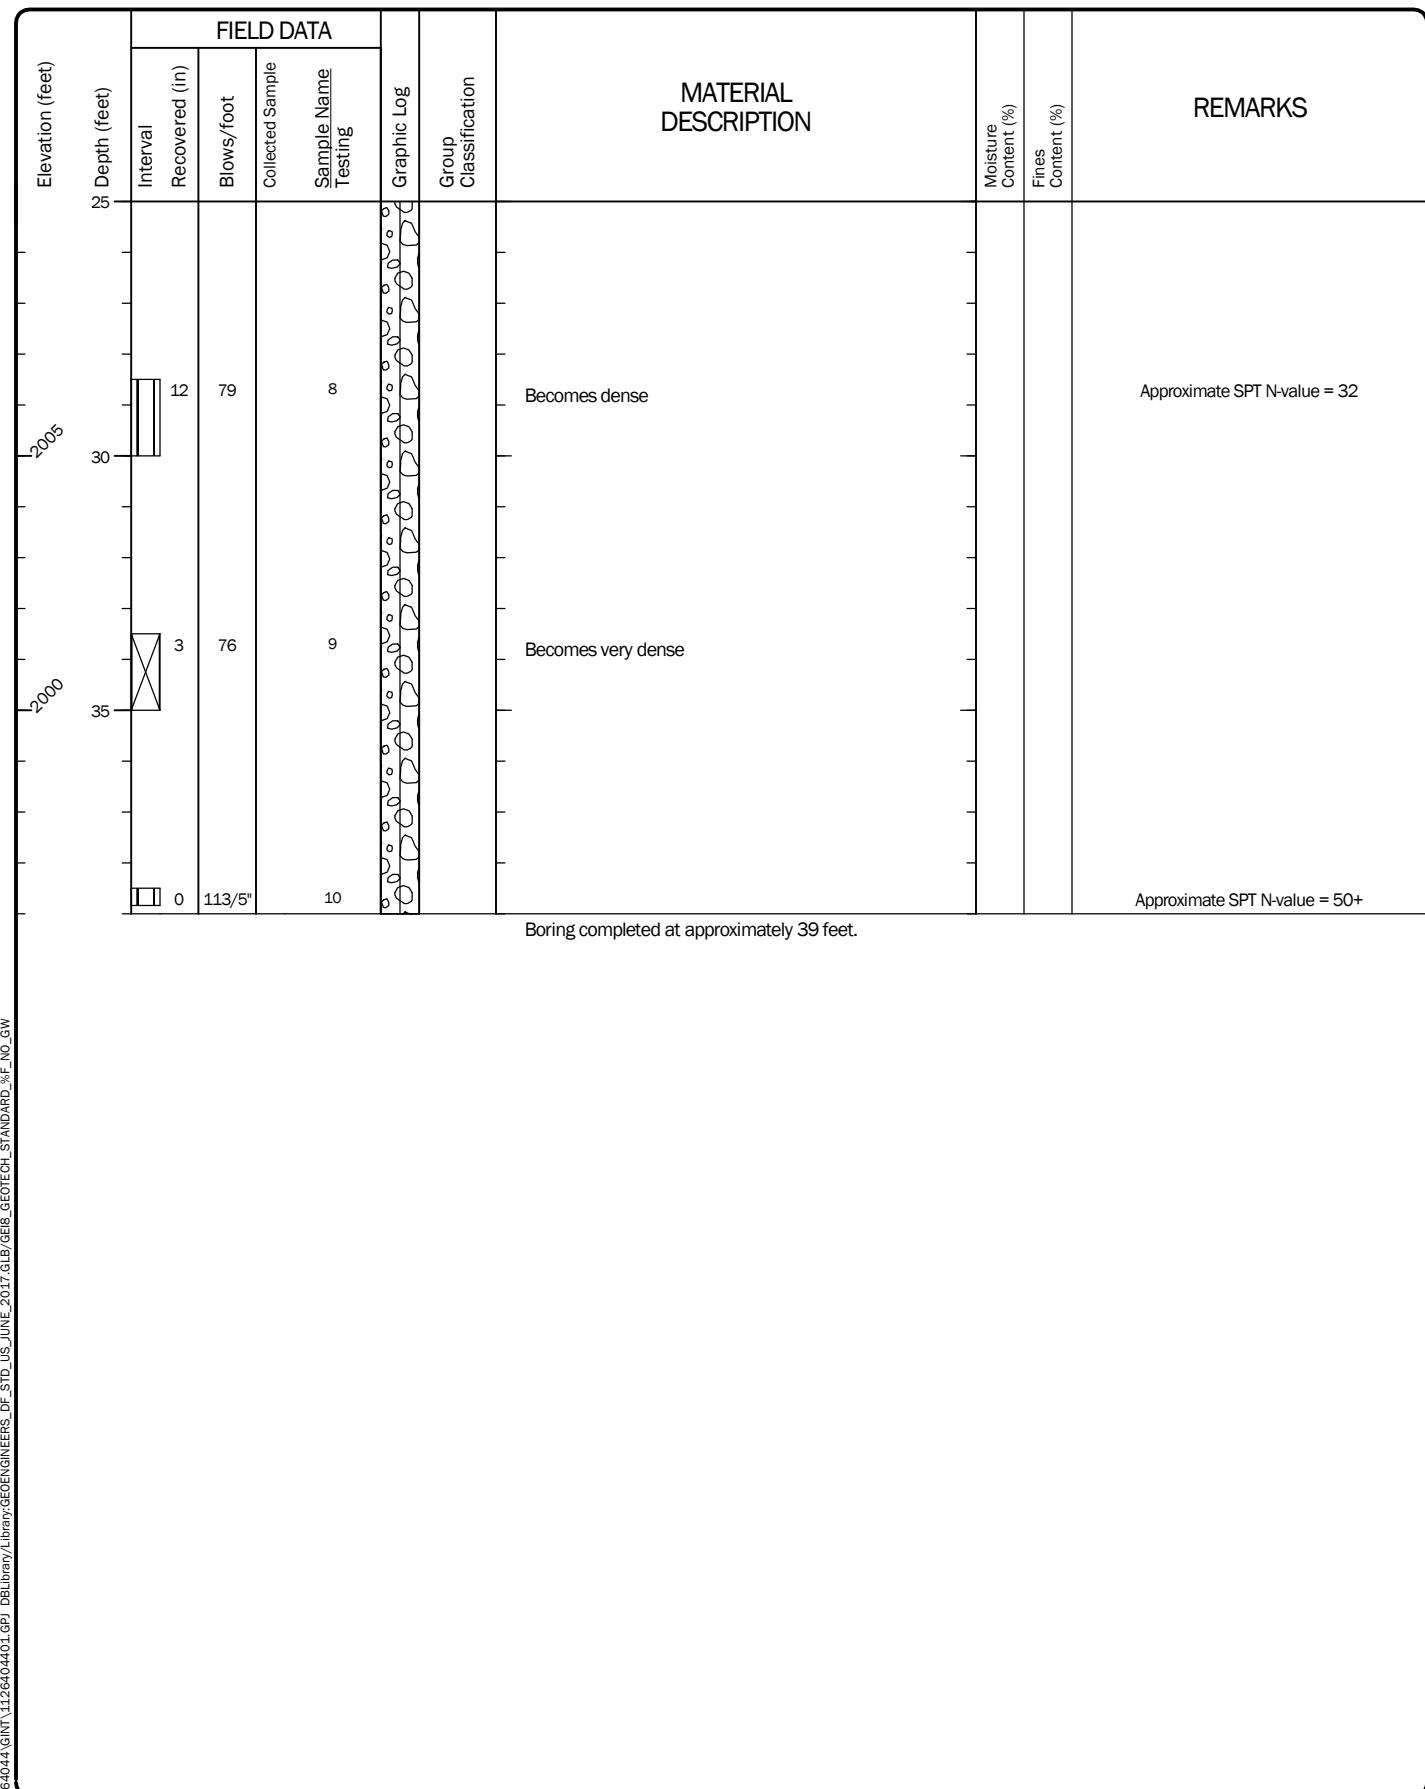
## Log of Boring B-2

Drilled	Start 8/25/2025	End 8/25/2025	Total Depth (ft) 39	Logged By AMN BKH	Checked By	Driller GeoEngineers, Inc.	Drilling Method	Hollow-stem Auger
Surface Elevation (ft) Vertical Datum	2035 NAVD88		Hammer Data	Autohammer 140 (lbs) / 30 (in) Drop		Drilling Equipment	Truck-mounted CME 75	
Easting (X) Northing (Y)	2537163 252882		System Datum	WA State Plane North NAD83 (feet)		Groundwater not observed at time of exploration

- Relatively high permeability rounded to subrounded gravels with variably low silt content. This unit is typical of the gravels that make up the Spokane Valley/Rathdrum Prairie (SVRP) Aquifer and was observed in borings B-2 and B-3 to depths of up to 39 feet bgs (maximum depth explored).

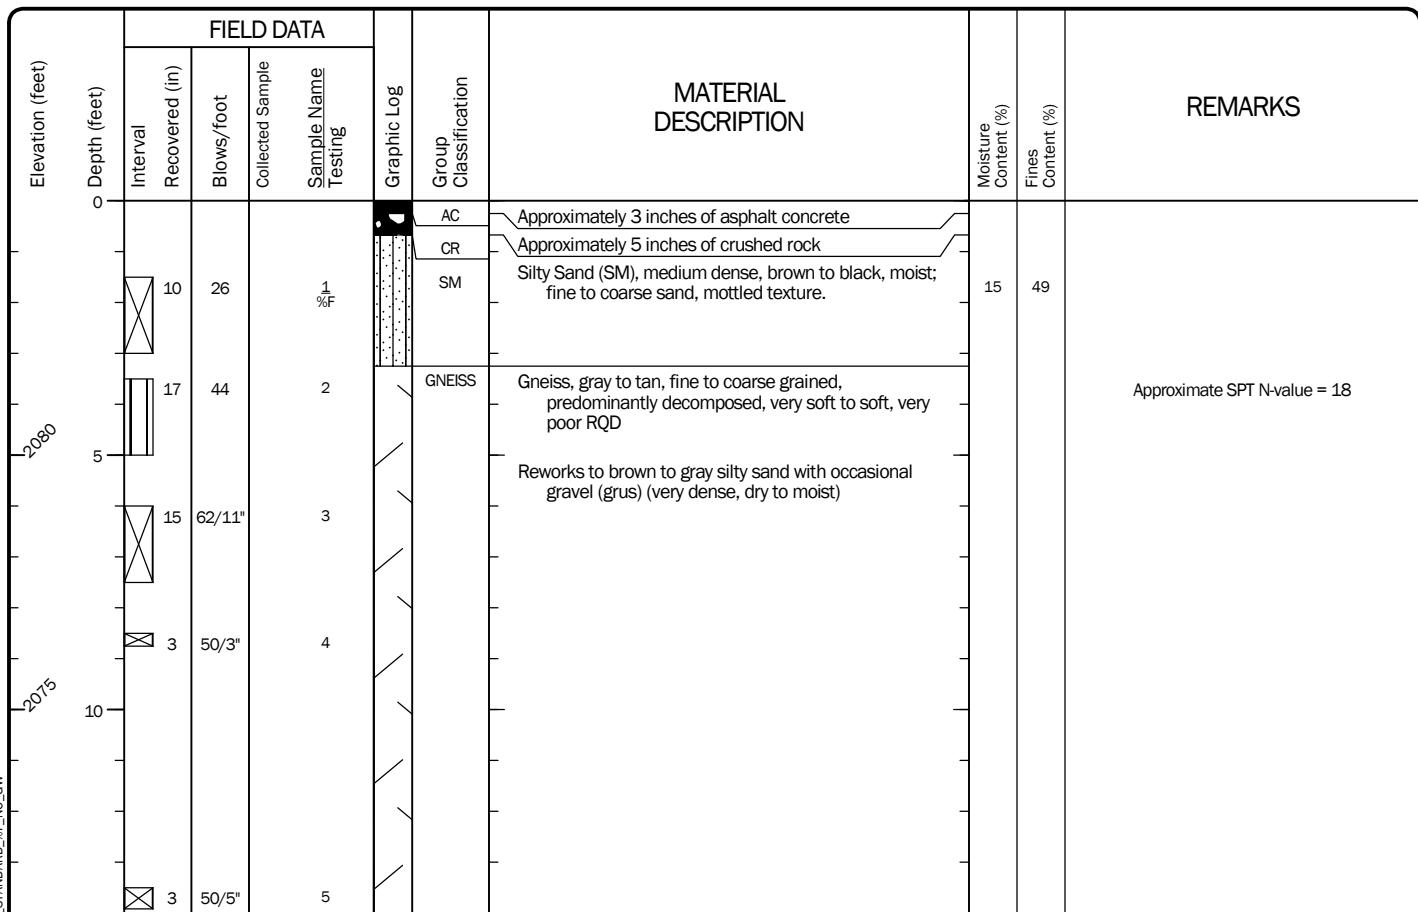
Drilled	Start 8/27/2025	End 8/27/2025	Total Depth (ft) 14	Logged By AMN Checked By BKH	Driller GeoEngineers, Inc.	Drilling Method Hollow-stem Auger
Surface Elevation (ft) Vertical Datum	2085 NAVD88	Hammer Data	Autohammer 140 (lbs) / 30 (in) Drop	Drilling Equipment	Truck-mounted CME 75	
Easting (X) Northing (Y)	2538270 252510	System Datum	WA State Plane North NAD83 (feet)	Groundwater not observed at time of exploration

Boring completed at approximately 14 feet due to auger refusal.

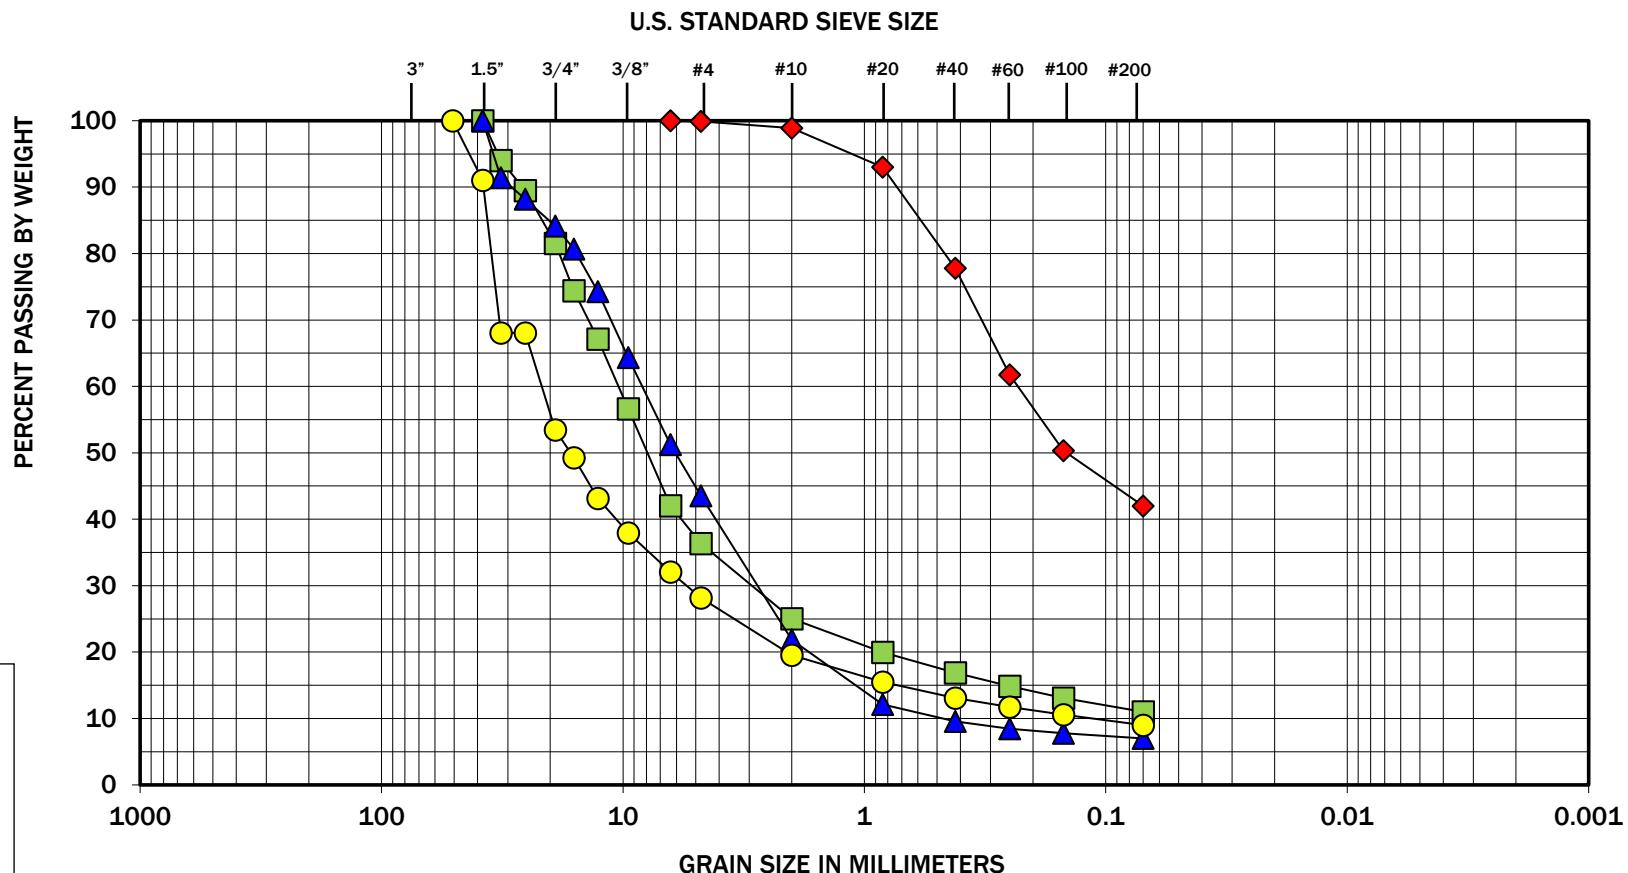
Symbol	Boring Number	Depth (feet)	Moisture (%)	Soil Description
◆	B-1A	8.5 - 10	17	Silty Sand
■	B-2	3.5 - 5	5	Poorly graded gravel with silt and sand
▲	B-2	8.5 - 10	2	Well graded gravel with silt and sand
●	B-3	3.5 - 5	4	Poorly graded gravel with silt and sand

The grain size analysis results were obtained in general accordance with ASTM D 6913.

GeoEngineers analyzed 11 discrete soil samples for grain-size distribution by ASTM International (ASTM) Method C136 and four discrete soil samples for moisture content by ASTM Method D2216. Results of our grain-size distribution analyses are presented in Appendix B.
