Supplemental Hydrogeologic and  
Geotechnical Assessment Report

Ridgemont Estates Stormwater Improvements  
Spokane Valley, Washington

File No. 11264-044-01  
December 4, 2025

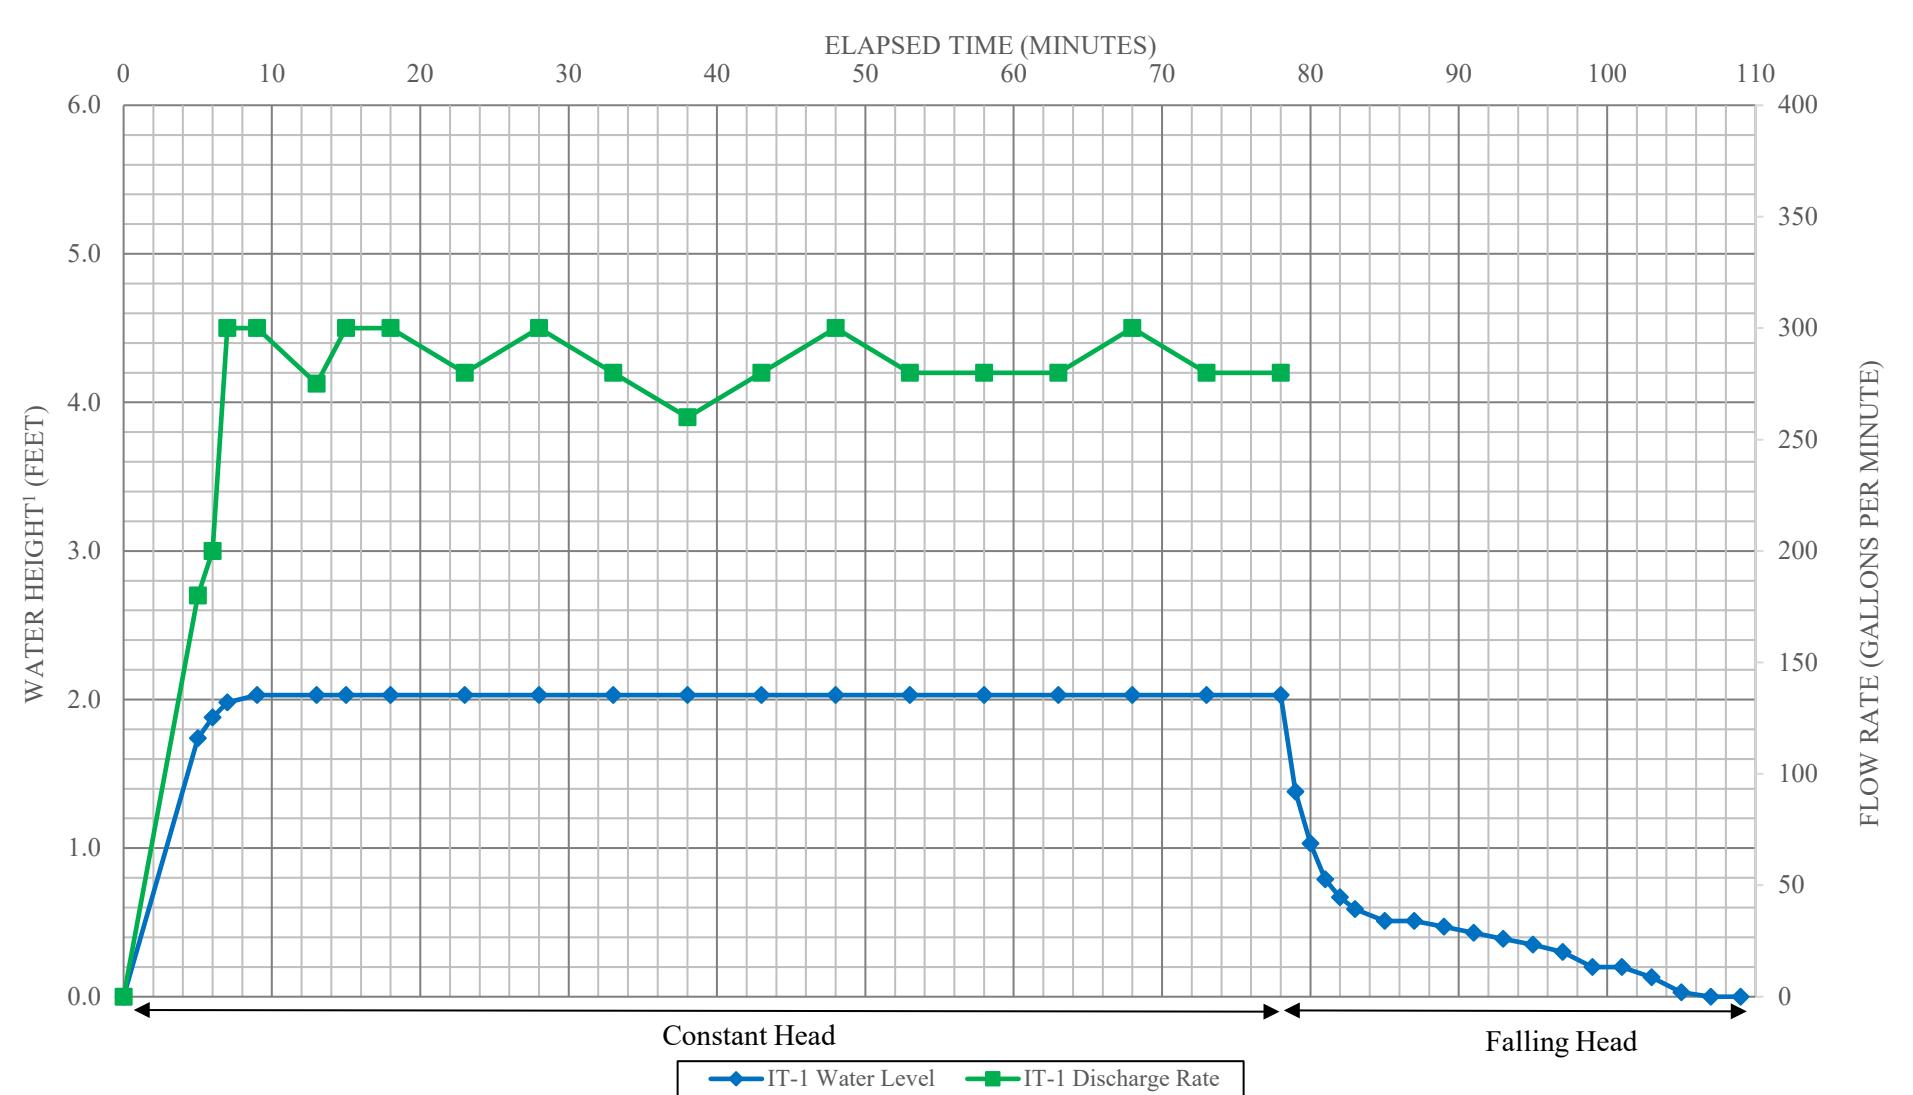
1. Water height refers to water level above the apparent base of the drywell.

The selected drywell included a cylindrical concrete double-drum construction with a 4-foot-diameter active barrel section extending from about 4 feet bgs to the apparent bottom measured at 11.8 feet bgs. Silt, sand, gravel and concrete debris were observed at the base of the drywell. The drywell is constructed with a concrete reduction and extension from the top of the active barrel to the manhole cover. A lateral inlet pipe was observed near the top of the active barrel from a north adjacent catch basin. The bottom of the inlet was measured at 4.2 feet bgs.

The duration of the falling head period was 29 minutes, which was the time required for the drywell to go dry. The falling-head infiltration rate generally diminished over time as head decreased, potentially reflecting the impact of accumulated sediment and debris at the bottom of the drywell. Full-scale drywell testing data for IT-1 are presented in Table C-1 and Figure C-1 of Appendix C.

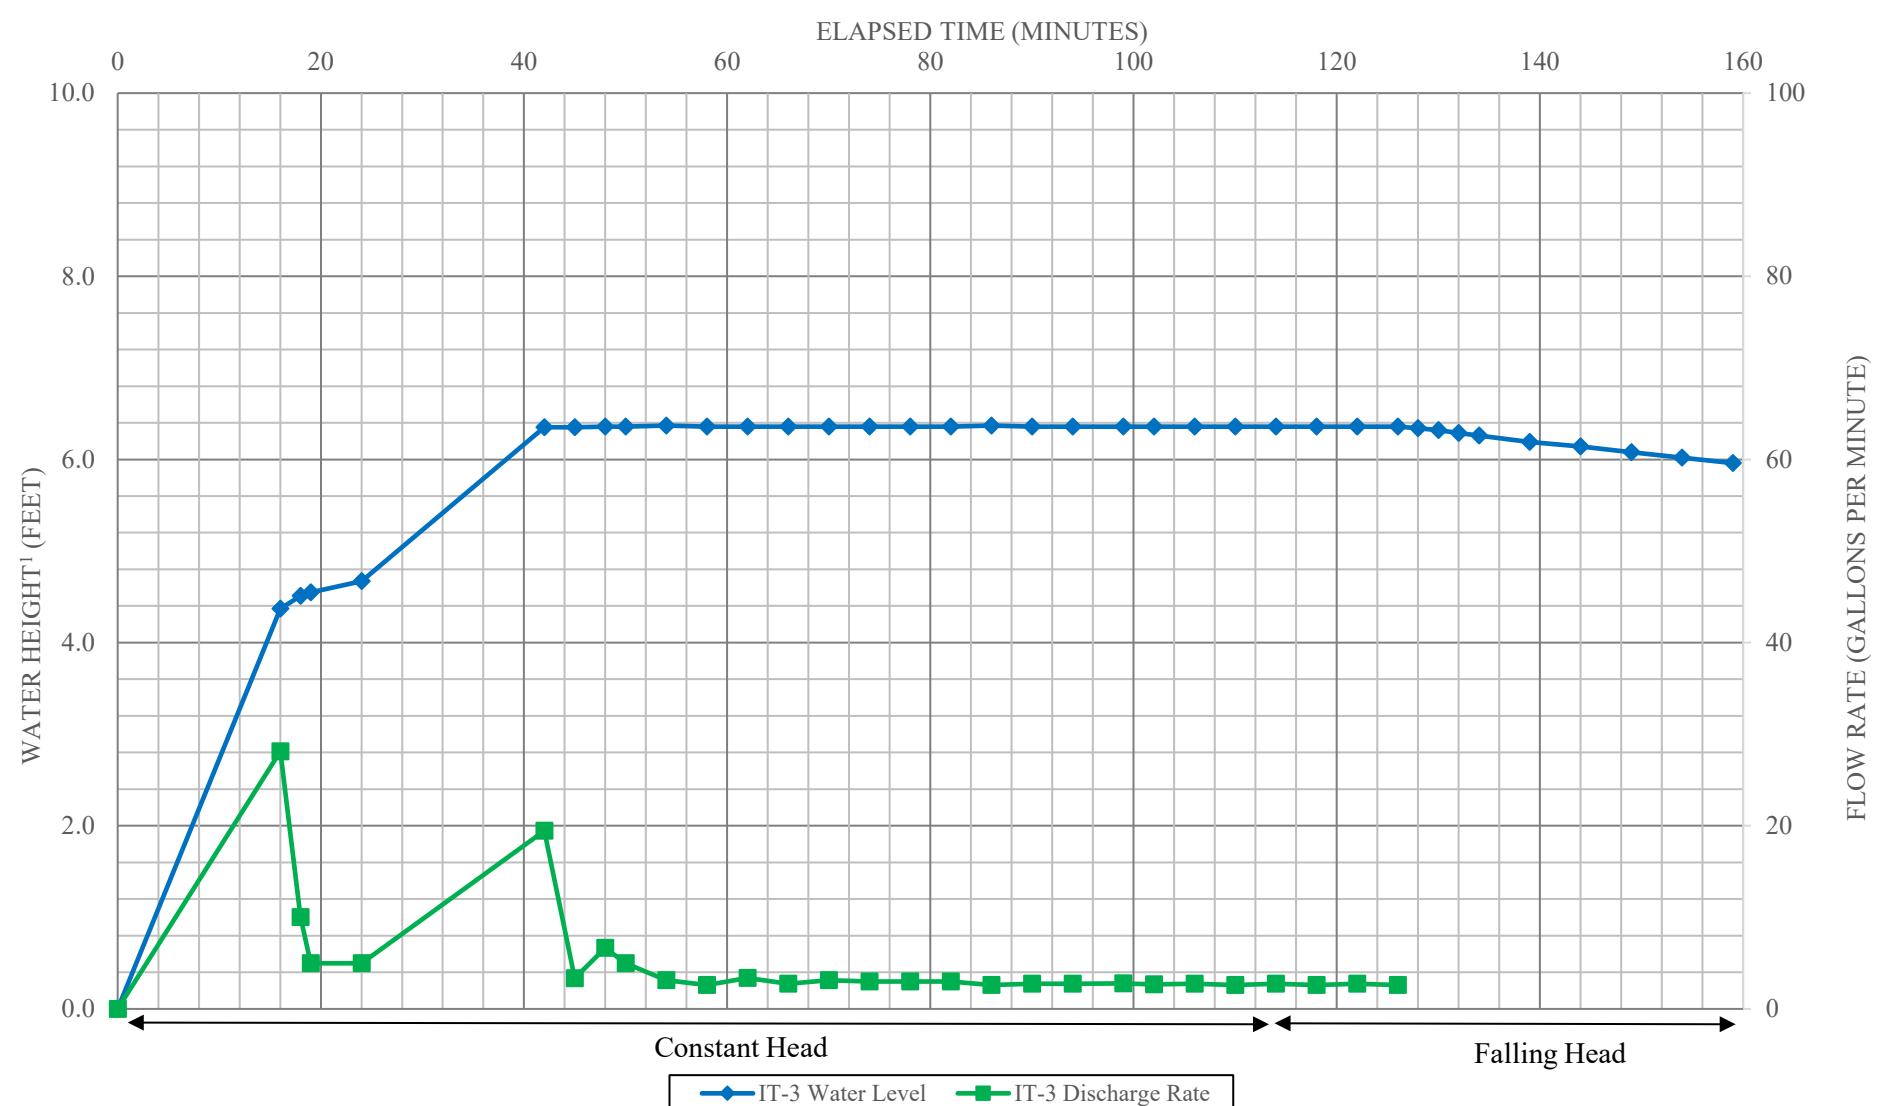
### IT-3 Water Height and Discharge Rate

Drywell Condition: hexagonal double-depth concrete; width at widest = 4.0 ft; total depth = 10.4 ft; active barrel = 7.2 ft (base to bottom of outfall pipe at 3.2 ft bgs).

The selected drywell included a pentagonal concrete triple-drum construction with a 4-foot-diameter active barrel section extending from about 1.4 feet bgs to the apparent bottom measured at 10.4 feet bgs. Silt, sand, gravel and detritus were observed at the base of the drywell. The drywell is constructed with a concrete reduction and extension from the top of the active barrel to the manhole cover. A lateral inlet pipe was observed near the top of the active barrel from a northwest adjacent catch basin. The bottom of the inlet was measured at 3.2 feet bgs.

The design outflow rates associated with the drywell tests described herein vary over a wide range. At IT-1 and IT-2, design outflow rates are approximately 1.7 and 5.7 cfs, respectively. At IT-3, the design outflow rate is approximately 0.004 cfs. Relatively poor drywell performance at IT-3 is corroborated by Spokane 200 Method grain size correlations using adjacent borings. This supports the conclusion that, while some of the poor performance in IT-3 could be the result of drywell siltation, poor drywell performance can primarily be attributed to hydrogeologic conditions at the IT-3 drywell location.
